PROMISED LAND PLANTATION MAGUIRE-LIVSEY HOUSE

Snellville, Gwinnett County, Georgia

HISTORIC STRUCTURE REPORT

OCTOBER 8, 2018

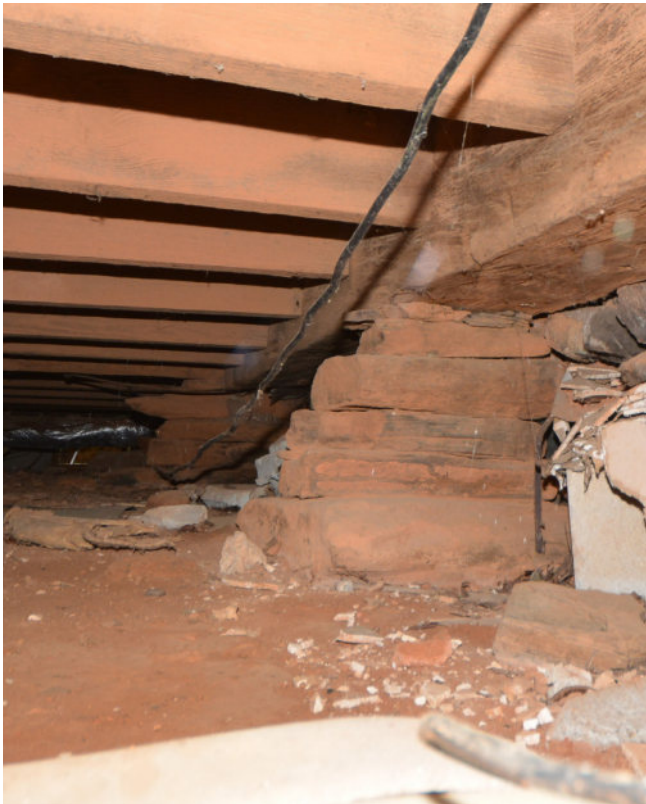
Foundation piers appear to be in stable condition but with typical signs of settlement and erosion/compaction of the surrounding earth. Mortar is present but has eroded significantly in most places. Repairs appear ad-hoc. Significant termite damage and dry rot is visible in most of the primary load-bearing, un-treated wood structure.

Figure 5: Stone foundation pile supporting large sill beam.

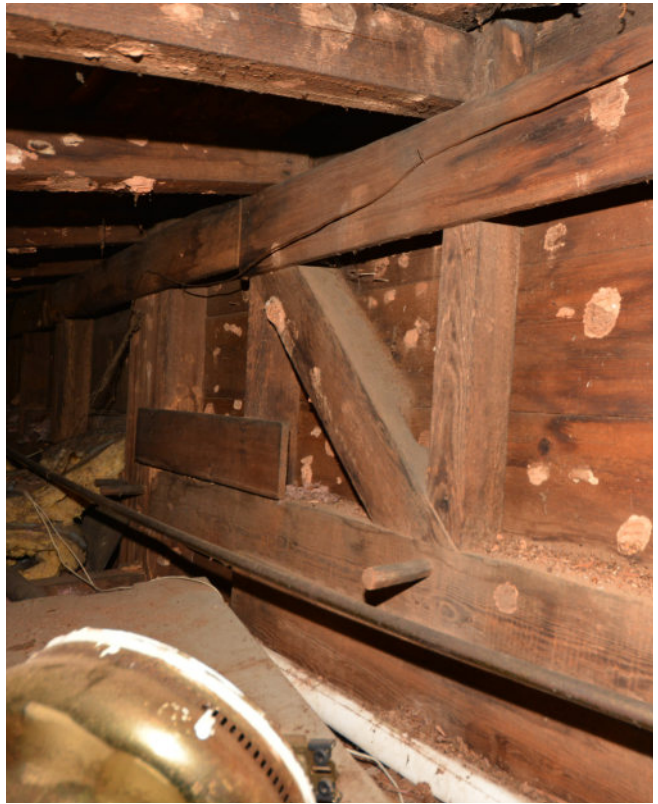
Much of the wood framing shows signs of significant termite damage and past infestation. No live infestations were observed. There also appear to be areas where the historic framing was cut and removed to make new openings or passages. It is not clear yet how these interventions have impacted the structural integrity of the framing system, though no critical failures were observed.

Figure 6: Mortise and tenoned timber framing.

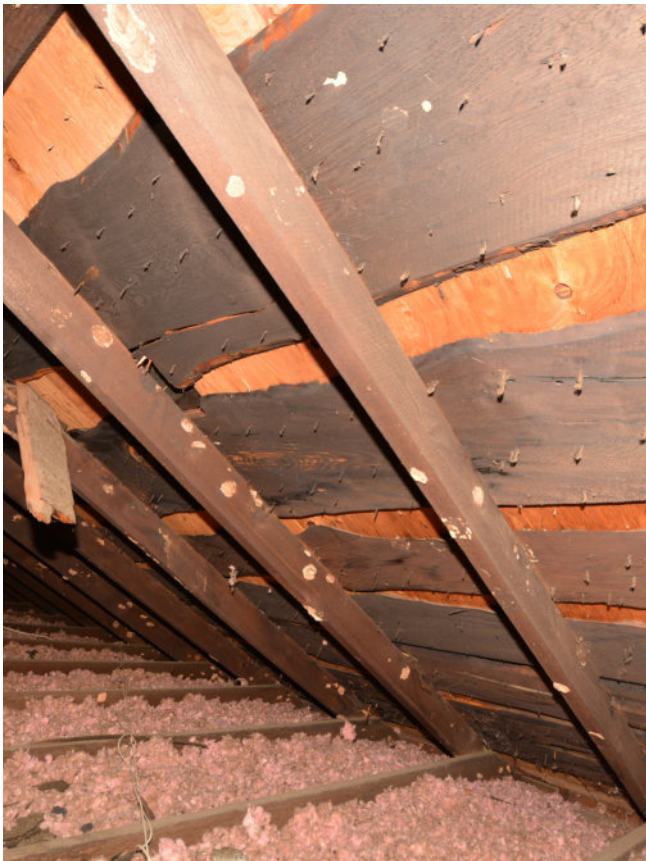
Figure 7: Typical roof framing and live-edge board decking.

The roof framing and decking appear to be in stable condition, though evidence of termite infestations in many areas of the house suggest that a thorough inspection of framing members be undertaken. The roofing, from visual aerial inspection, appears to be at or beyond its functional life, though no active leaks were observed.

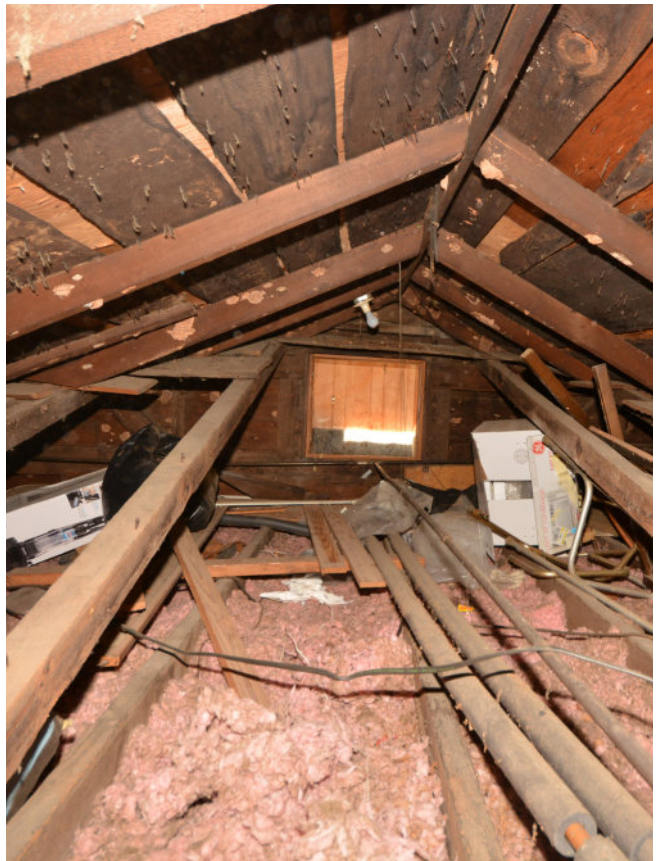
Figure 8: Gabled framing above sloped framing in the attic.

In the attic above the rear porch, sloped framing below gabled framing supporting existing roofing indicates a change in the roof between the Big House and Kitchen. Likely, the rear porch of the Big House originally had a shed roof that terminated several feet from the wall of the kitchen and later a new gabled roof was built to join the Big House and Kitchen. It appears that the live-edge roof deck boards were reused for the new roof. Saw marks and lumber sizing may support this observation.

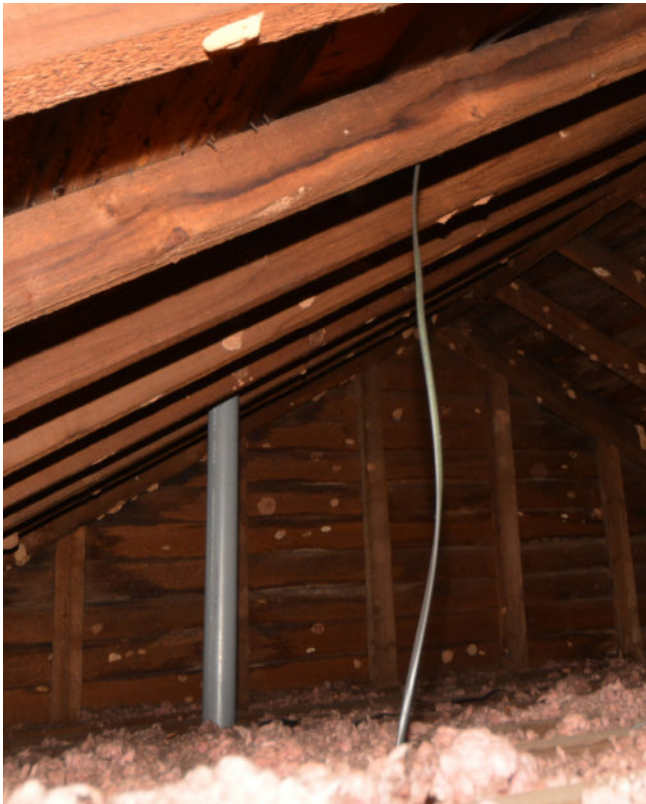
Where visible, the historic weatherboard cladding appeared stable. However, considering the extent of termite damage visible in other wood building systems, it would be reasonable to assume that some of the historic cladding is similarly damaged. It is also likely that many areas of historic cladding have been removed to make way for modern interventions.

Figure 9: One of several locations where wood clapboards are visible.

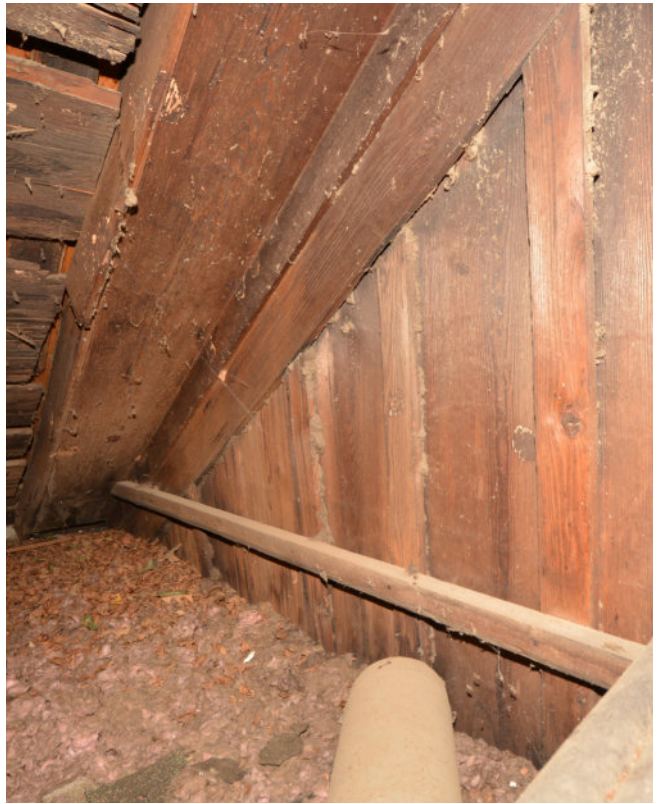
Figure 10: Board and batten siding on Kitchen. Note the boxed eaves.

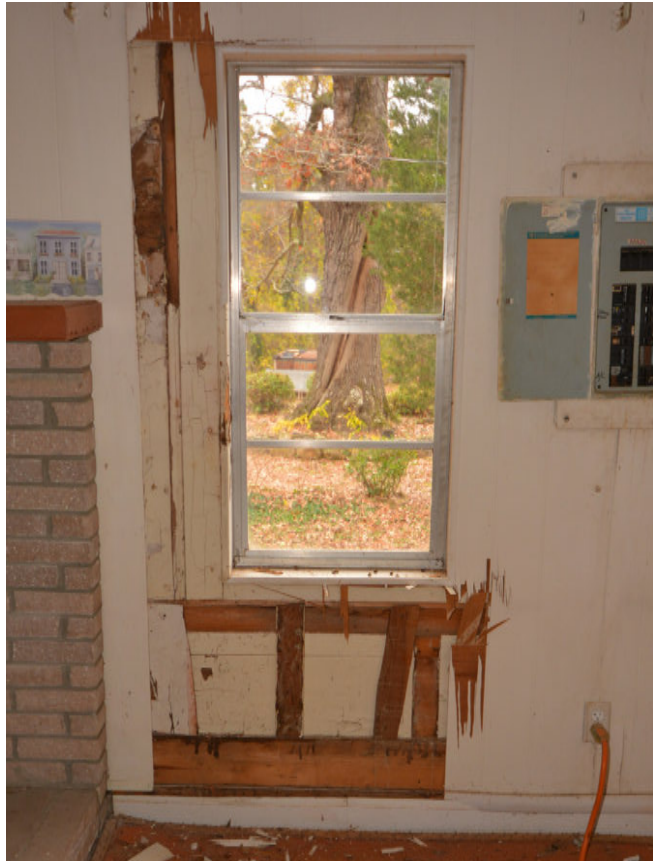
Existing windows throughout the building are non-historic and range in style, type, and material. Portions of the historic window jambs and/or casings were observed in situ during this assessment, however; further investigation is necessary to understand the historic window condition precisely. One window location was excavated to reveal a segment of historic wood casing with a corner bead, which is presumed to be the historic window casing.

Figure 12: Aluminum window in a larger opening. Note the corner bead wood trim, removed sill/stool, and wainscot below.

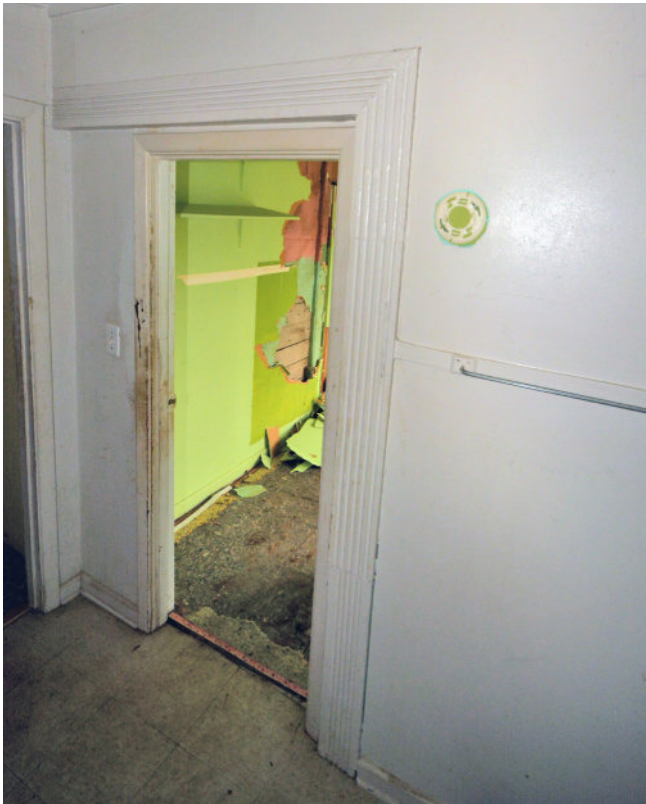
There are two locations where portions of what appear to be historic door casing is exposed (noted in drawings). This trim is composed of vertical and horizontal fluted trim boards with no plinth or corner blocks, which is unusual for the presumed period and style. In one location, a roughly 24-inch segment of fluted casing has a different profile from that present in the remainder of extant trim.

Figure 13: Fluted trim exposed in the former kitchen.

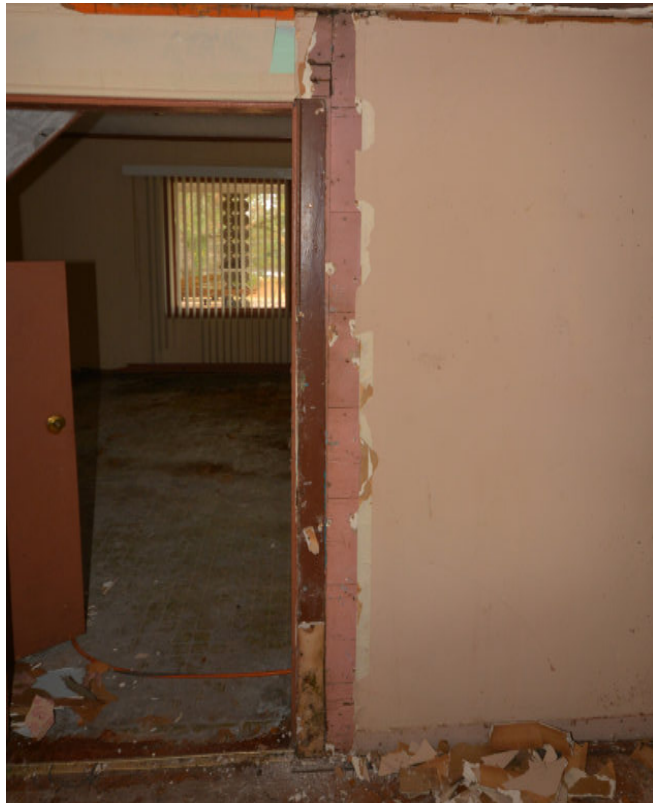
There are other locations where corner beaded trim is present at existing door surrounds and presumed to be the historic door trim (noted in drawings).

Figure 14: Corner bead door trim and tongue and groove wall boards exposed behind modern materials.

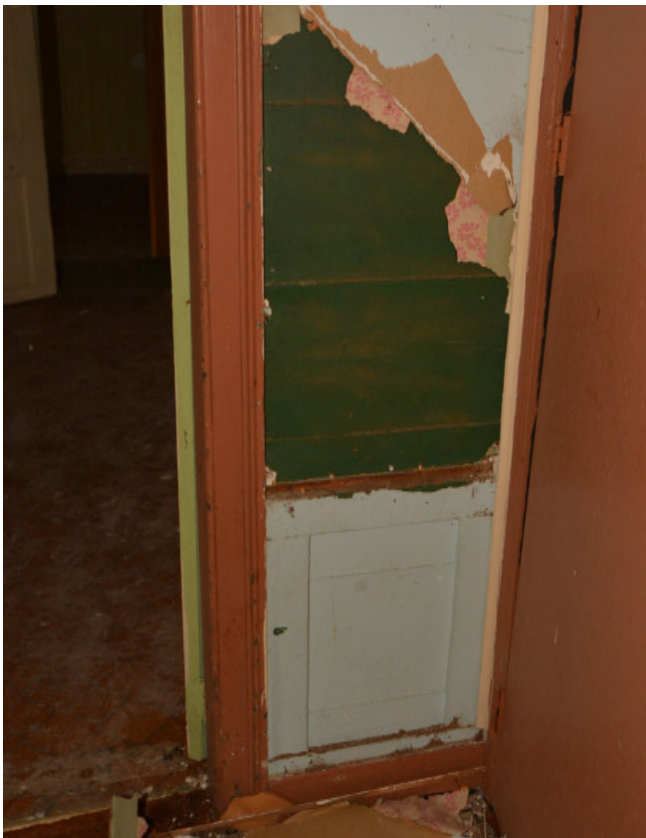
Figure 15: Tongue and groove wall boards above judge's paneling wainscot with original door trim to the left.

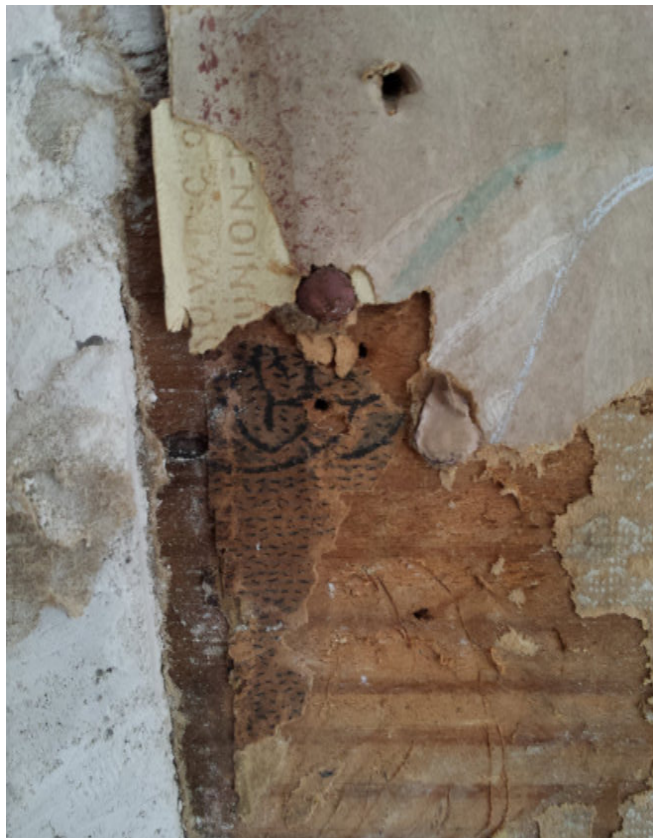
Evidence suggests that in the primary rooms, the wall above the wainscot was papered. Several campaigns of early wall paper exist in situ behind modern sheathing in the north wall of the southern room on the first floor of the main house. One of the earliest layers has printed in the margin, "UWPC of NA; Union-Made". This wallpaper was made by workers belonging to United Wall Paper Crafts of North America sometime between 1923 and 1938. There are at least two layers of paper below this one.

Figure 16: Detail of wallpaper discovered beneath layers of modern sheathing.

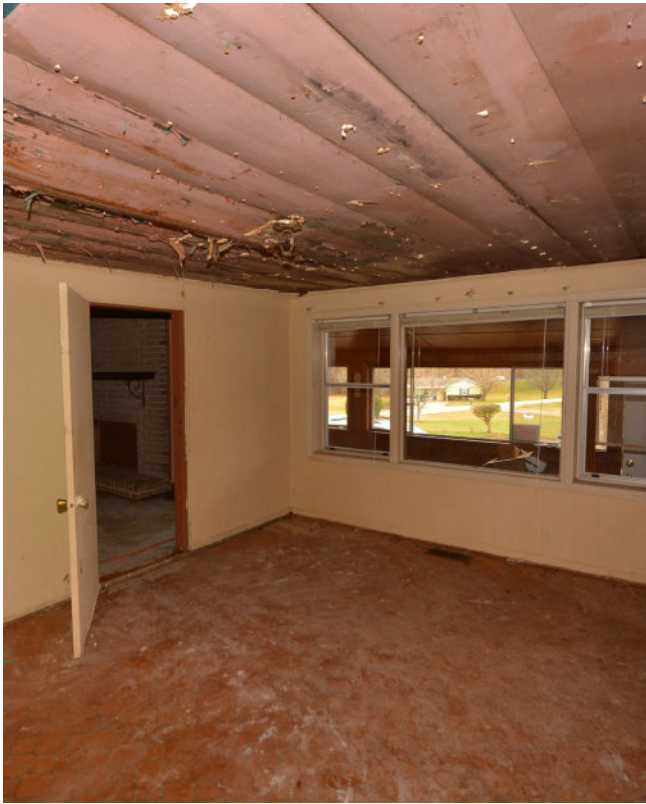
All ceilings have a slight sag towards their center points. Individual boards also exhibit slight to moderate cupping. It is likely that the material sitting on top of the boards in interstitial spaces and attics has attracted moisture and pests, exacerbating the warping.

Figure 17: Exposed tongue and groove board ceiling.

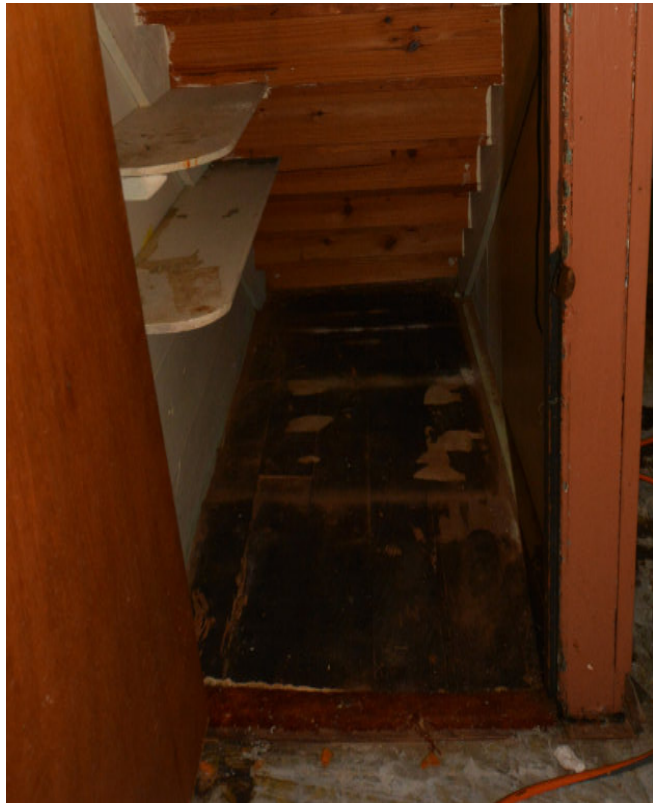
Hardwood floors are present under modern flooring. In the small closet under the stairs in main house, 6 to 6-1/2-inch boards are visible. As well, similarly sized floor boards, with no sub floor, are visible from crawl spaces.

Figure 18: Exposed original flooring in original under-stair closet.
