ADDENDUM #1

North Chattahoochee Interceptor Pumping Station Electrical Rehab Project

Report of Limited Asbestos and Lead-Based Paint Surveys

North Chattahoochee Interceptor
Electrical Rehabilitation
M-0745.39
4858 River Hollow Run
Duluth, Gwinnett County, Georgia 30096

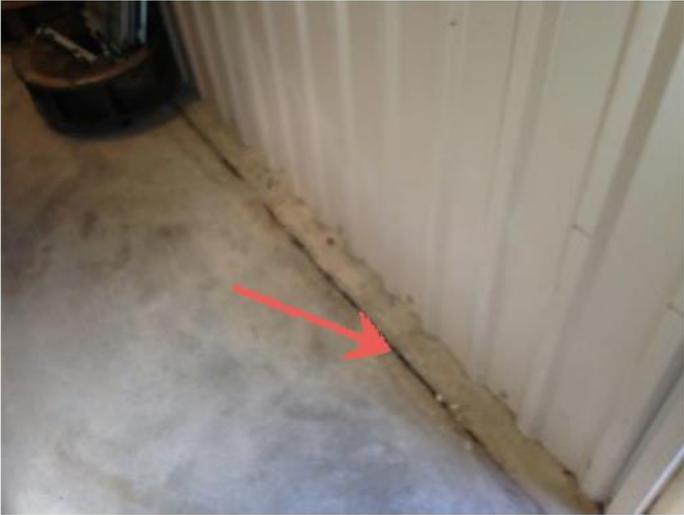
Photograph No. 1: EJ-01-01 through 02: All
Perimeter Flooring
No Asbestos Detected

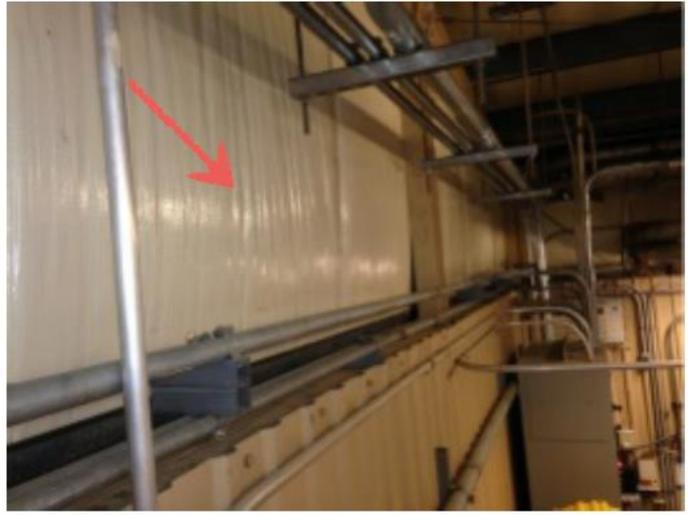
Photograph No. 2: WS-01-01 through 03: All
Upper Wall Systems
No Asbestos Detected

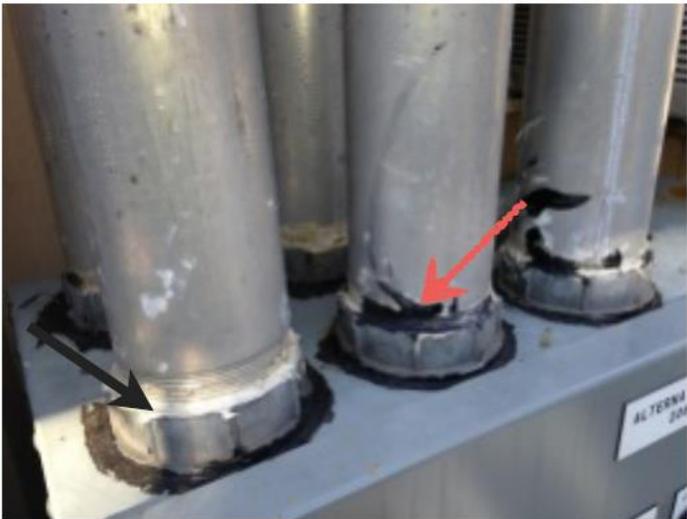
Photograph No. 3: EC-01-01 through 03:
Pipes on East Wall (White Caulk) EC-02-01
through 03: Pipes on East Wall (Black Caulk)
No Asbestos Detected

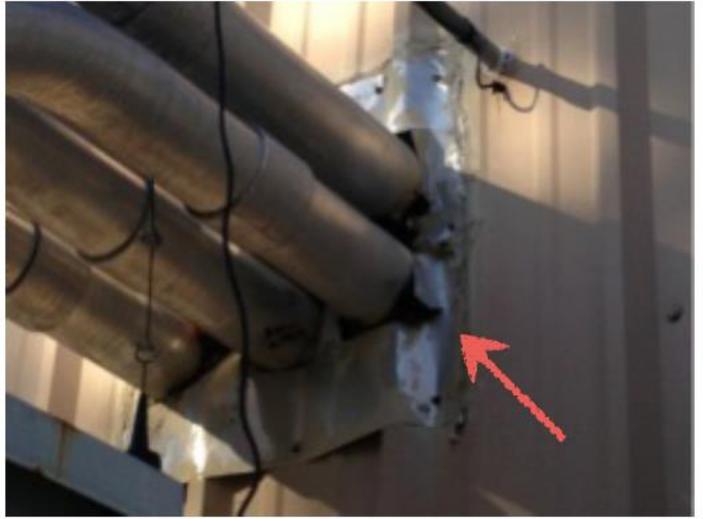
Photograph No. 4: EC-03-01 through 03:
Pipes on East Wall Attached to Structure
No Asbestos Detected

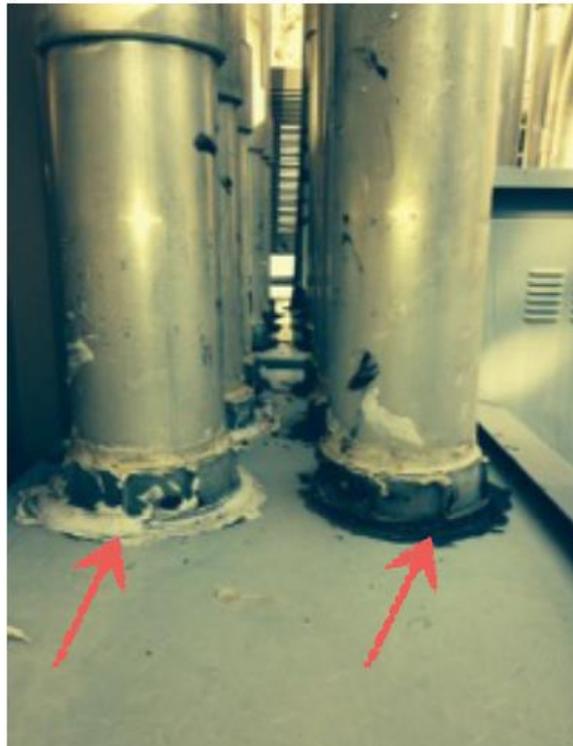
Photograph No. 5: EC-04-01 through 03:
Roof (Gray Caulk)
EC-05-01 through 03: Roof (White Caulk)
No Asbestos Detected
