RHODES JORDAN PARK MASTER PLANS

Gwinnett County Department of Human Services
Parks and Recreation Division

**Master Plan Report for
Rhodes Jordan Park**

Rhodes Jordan Park Master Plan Update

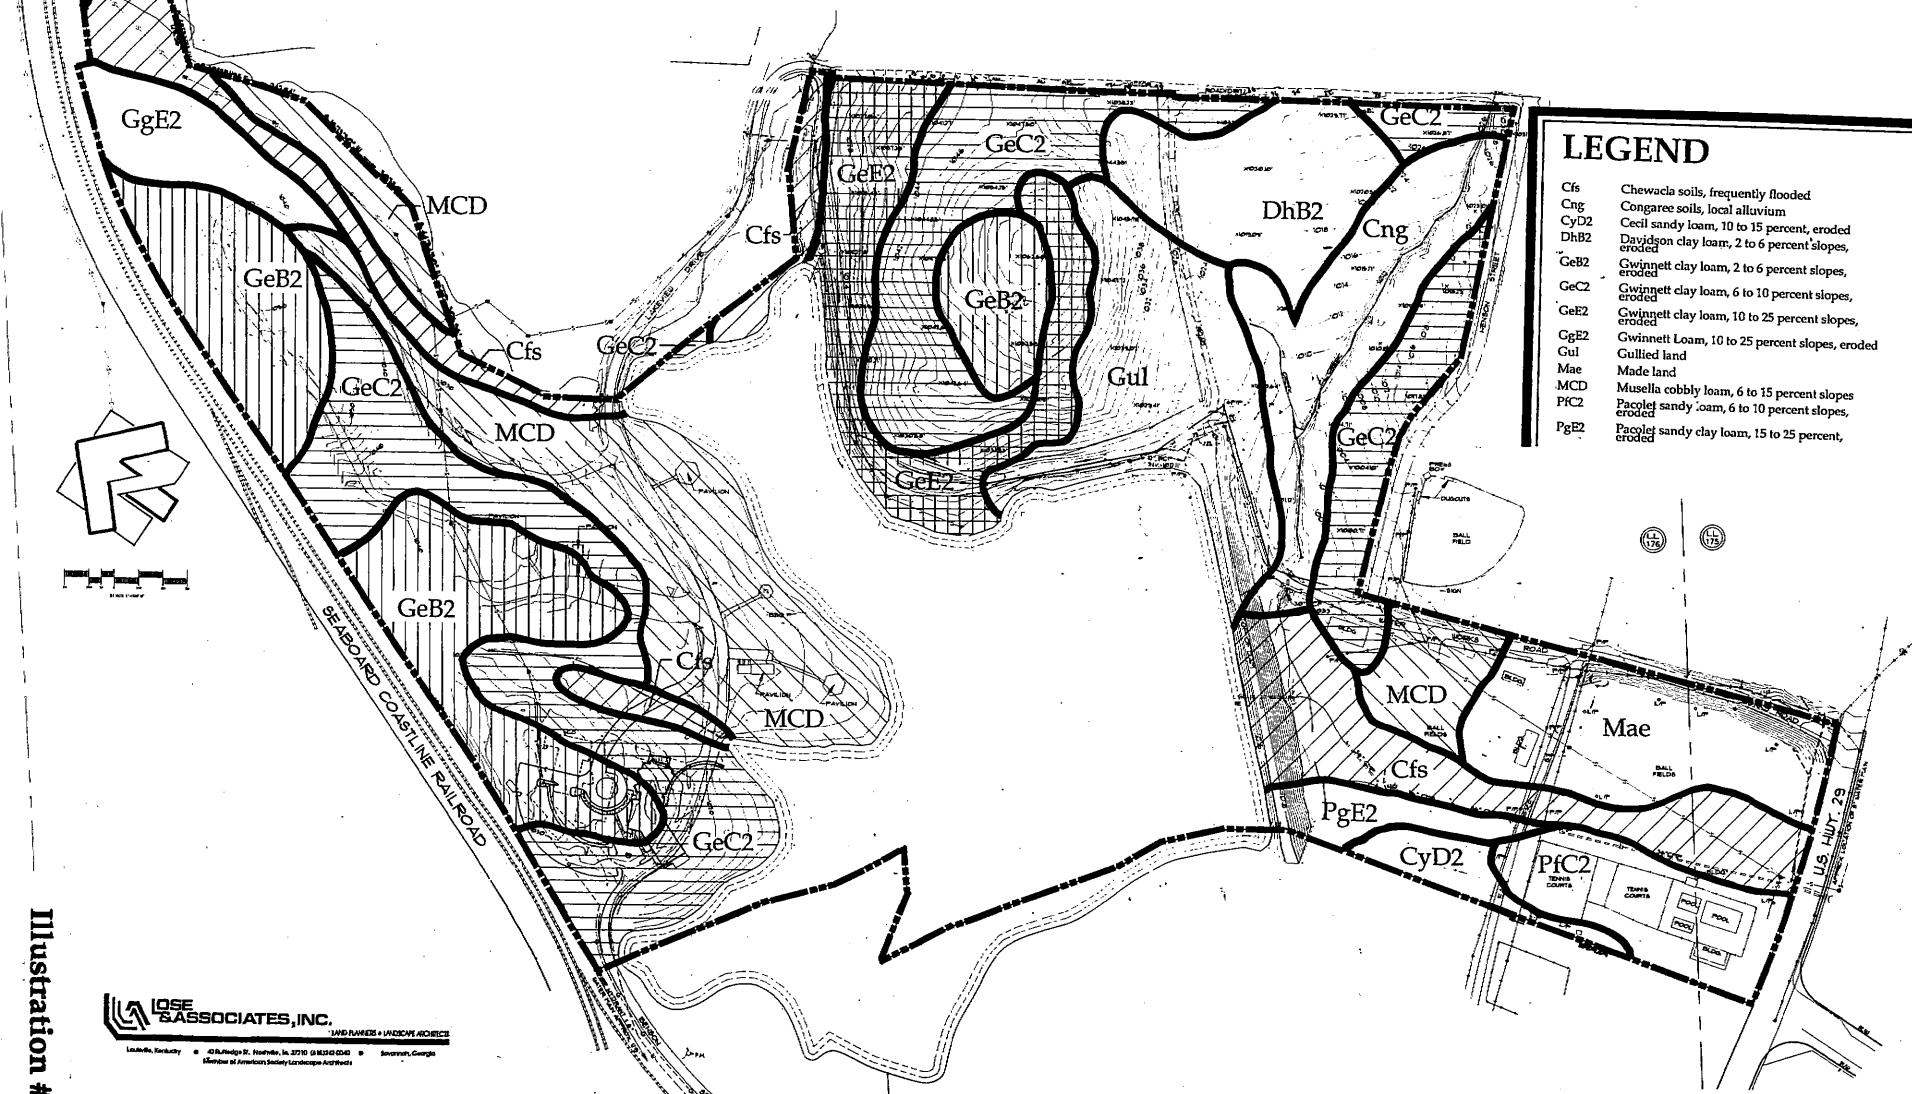
SOILS ANALYSIS

The soils found on the site are in the fair range for recreation developments. The limiting factor is the slope, not the physical property. The acceptability of these soils for ballfield construction is further supported by the Geotechnical Evaluation prepared by ATEC Associates. The fertility of the soils on the uplands of this site is in the fair to good range. This is beneficial in establishing and maintaining a healthy stand of turf for playing fields.

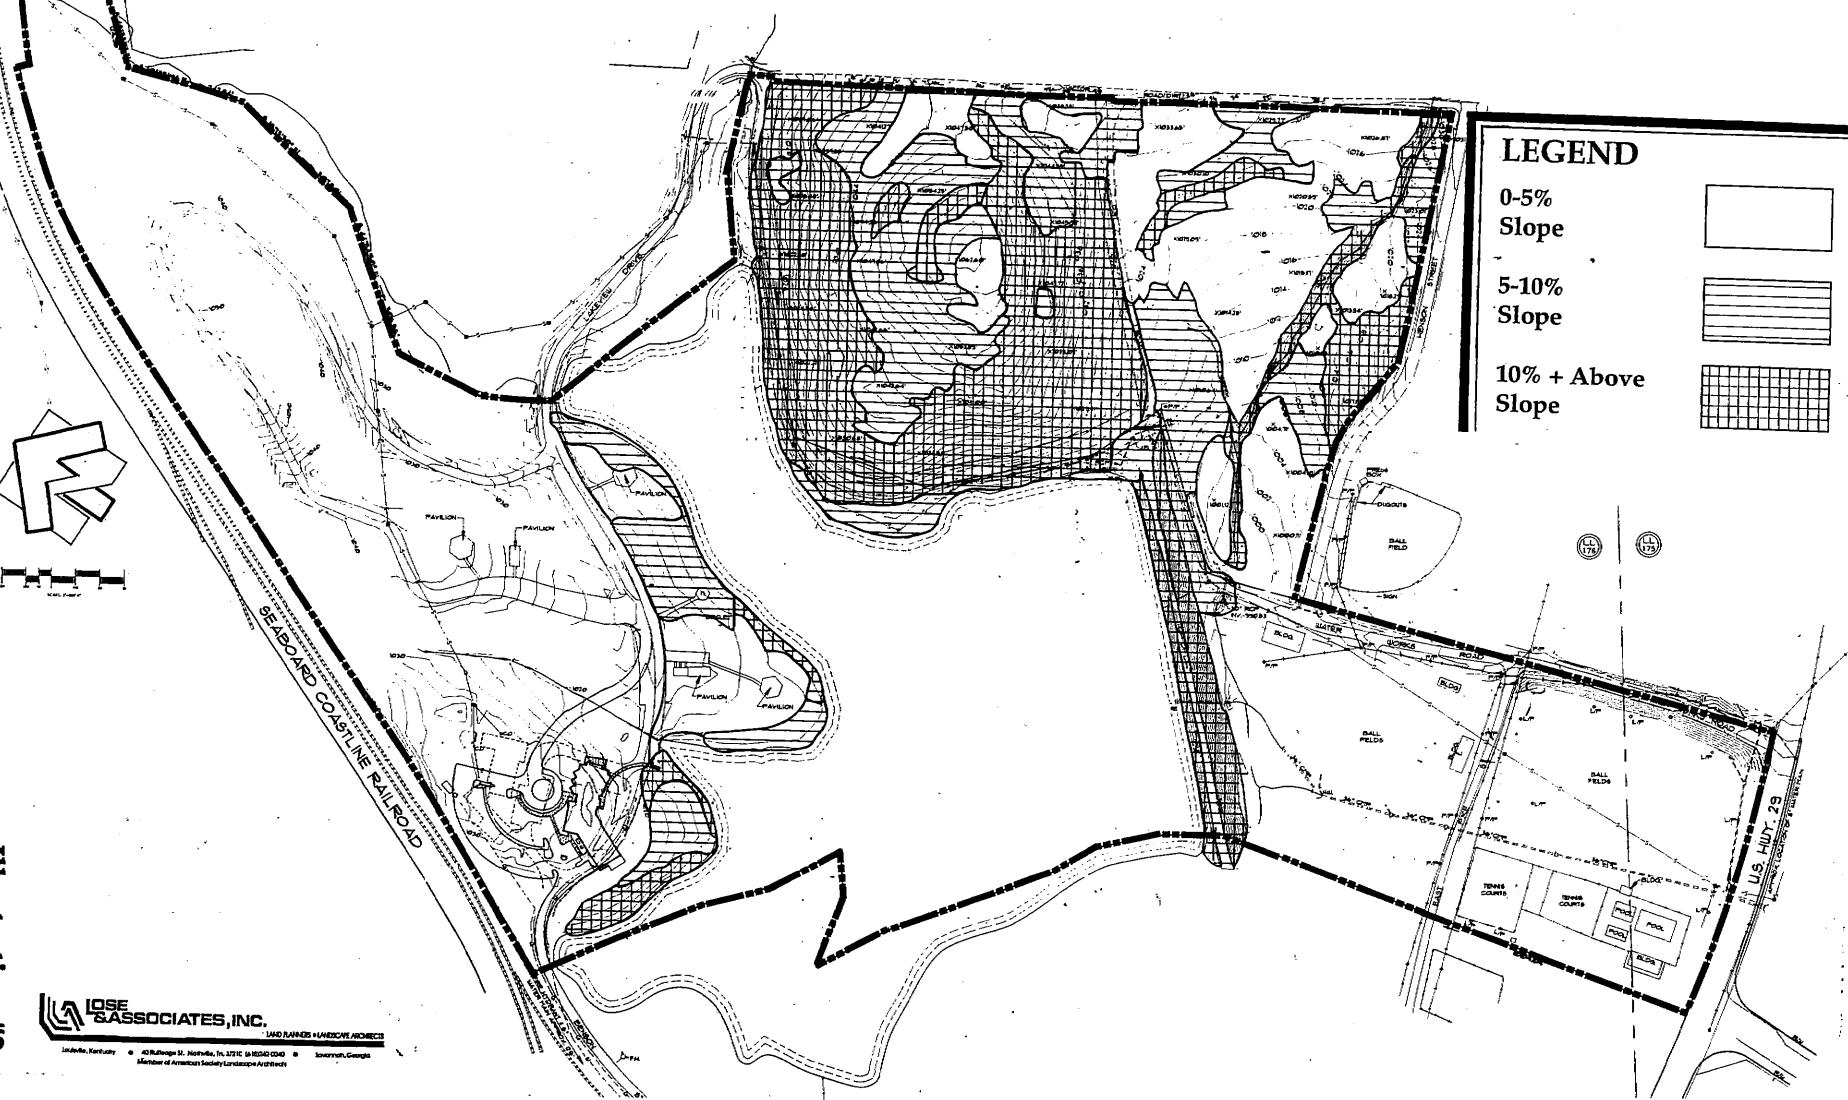
Illustration #2

SLOPE ANALYSIS

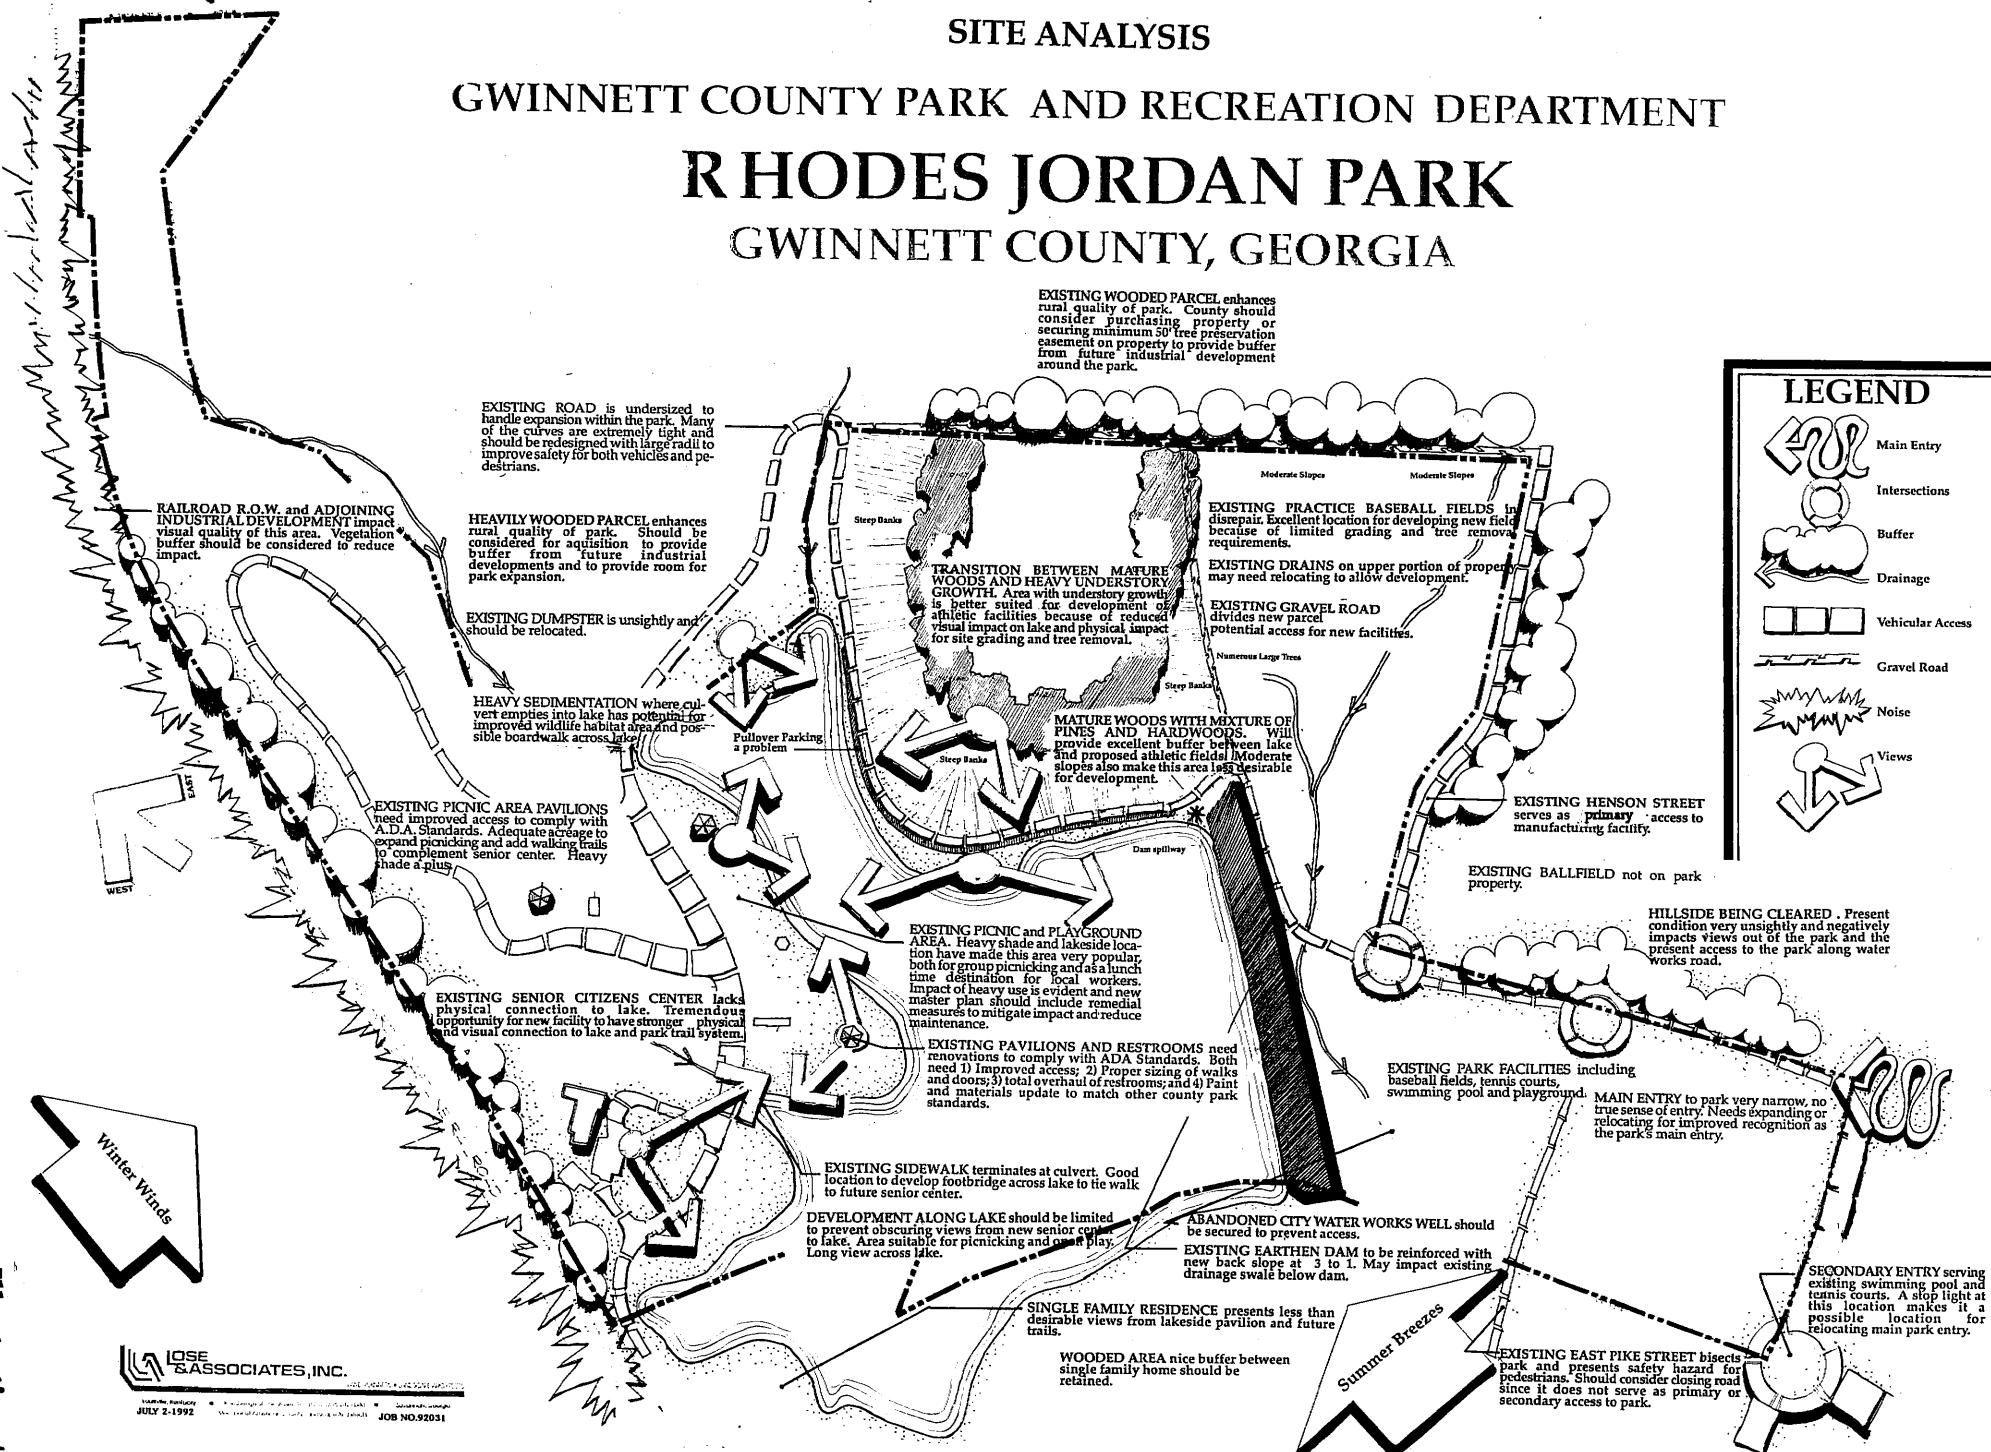
SITE ANALYSIS

Many uses and structures currently occupy the site. In addition to ballfields, tennis courts, and a pool, the picnic and playground area attracts many visitors. The shady picnic area with views of the lake has made this area very popular for picnicking. It also serves as a lunchtime destination for local workers. Heavy use of this area has worn the ground in the picnic area making it look abused.

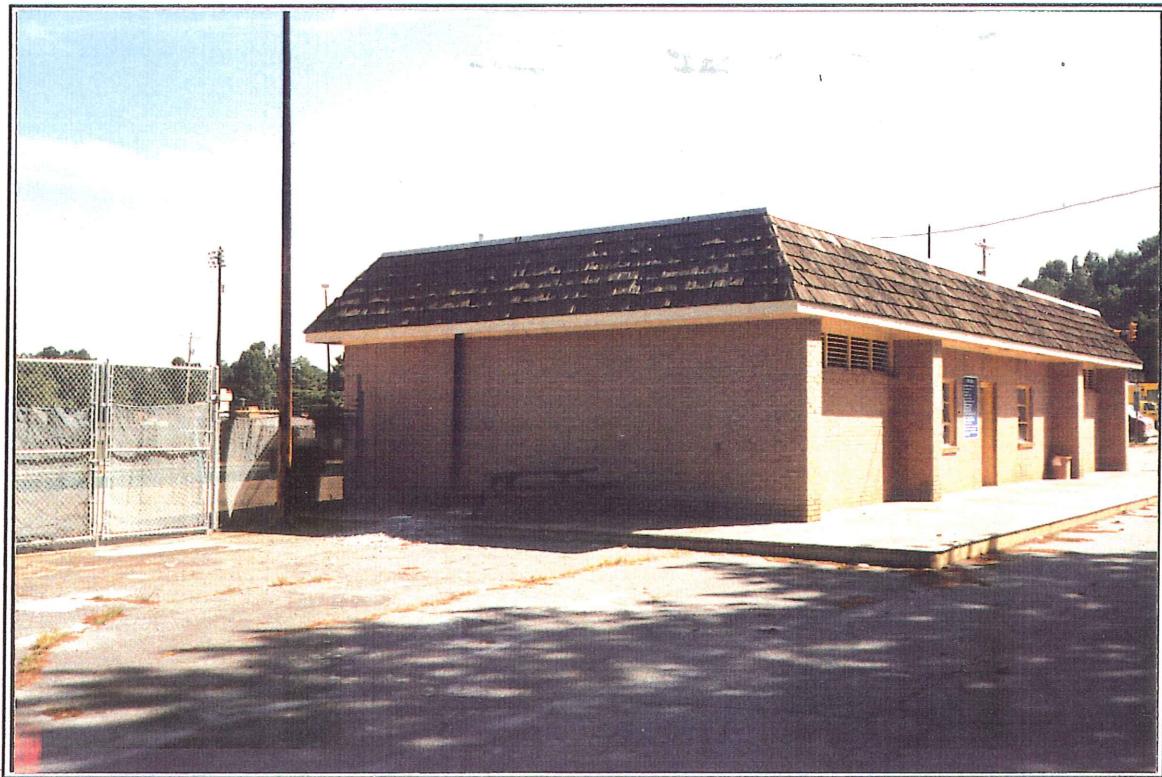
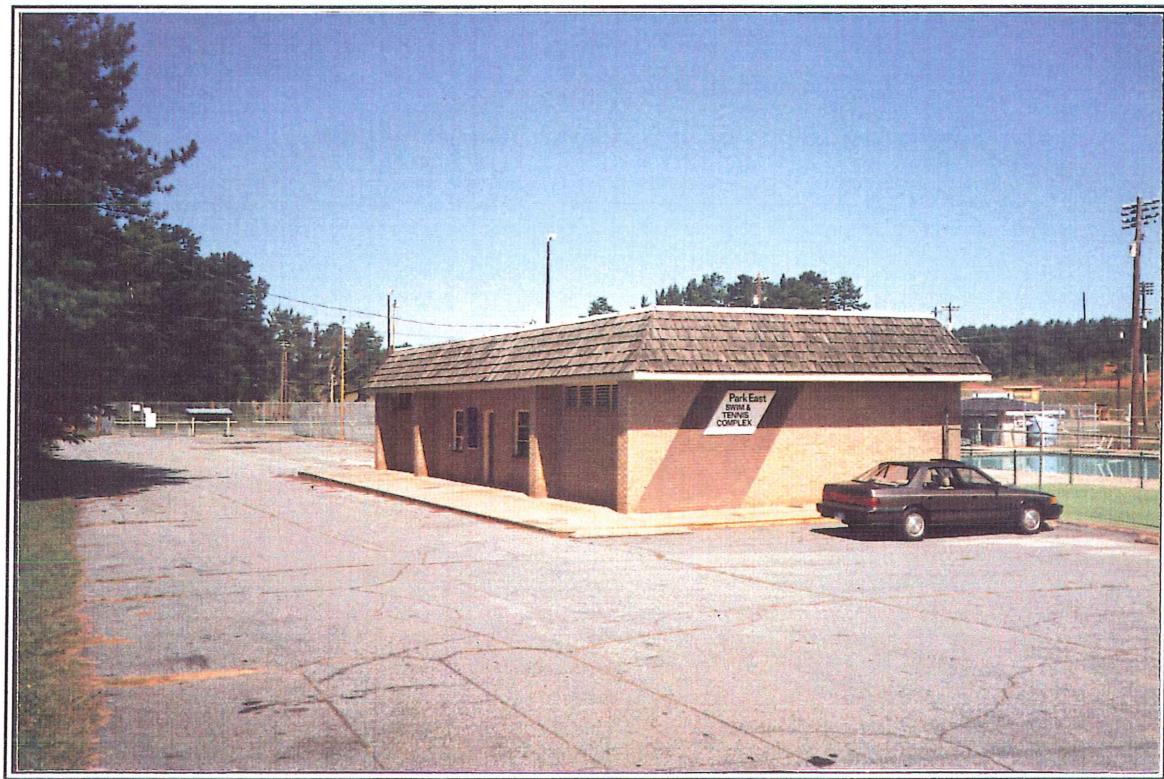
Illustration #7

In general, the exterior of the facility appears to be in good repair with little evidence of mortar bed deterioration or efflorescence. Even though the roof was inaccessible, the roofing surface is in obvious disrepair as evidenced by the ceiling stains in the concession area. The interior finishes are in fair condition, with the ceramic tile in the men's room in need of replacement at the urinal along with one of the water closets. The entry doors to both the men's and women's changing room has been removed, and the toilet stall doors have been removed from the men's rooms water closet compartments.

Bath House at Lawrenceville City Park East Swimming Pool

1. The refill pipe for large pool extends from pump unit on top of decking. This limits access and presents a hazard for visually impaired individuals.
2. Hose bib through fence presents a hazard for visually impaired individuals. NOTE: "Employee only" areas are exempt from Title III Barrier Removal.

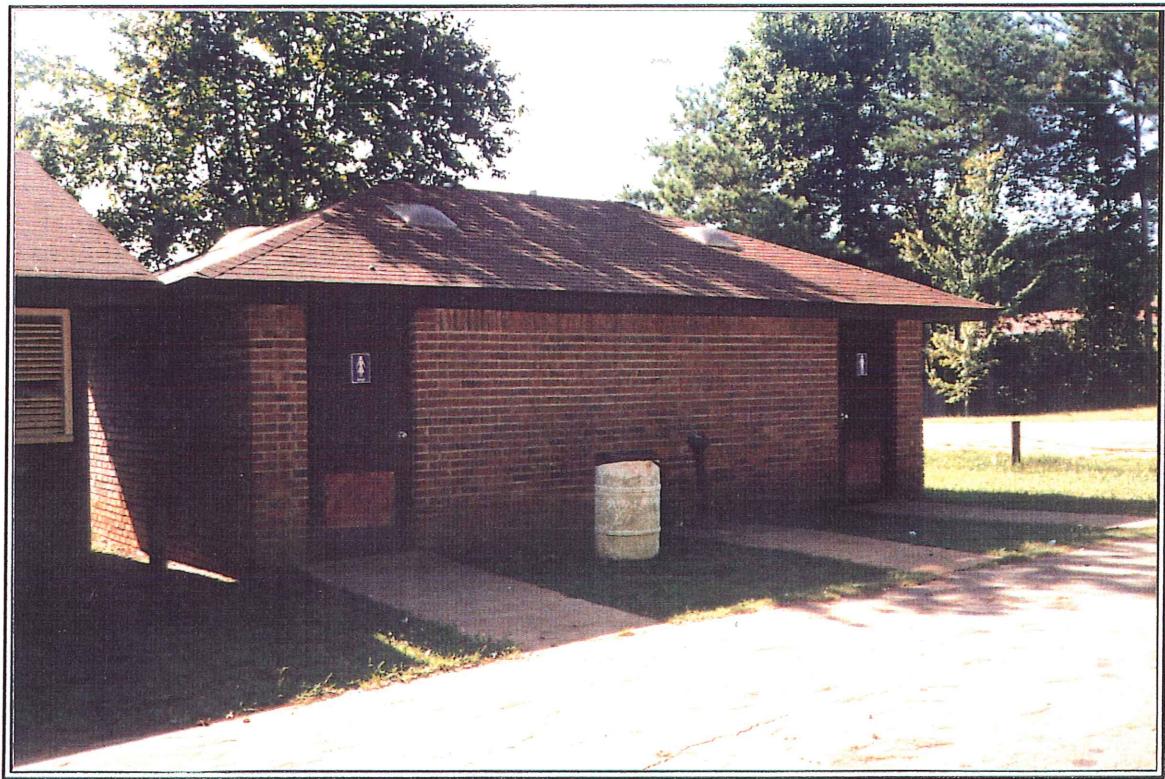
In general, the three structures appear to be in good repair. The roof surfaces appear to have been replaced recently, and the interior of the restrooms are also in good repair. The restrooms are not mechanically ventilated, and have roof top sky lights for natural lighting.

Rhodes Jordan Park Restroom Facilities

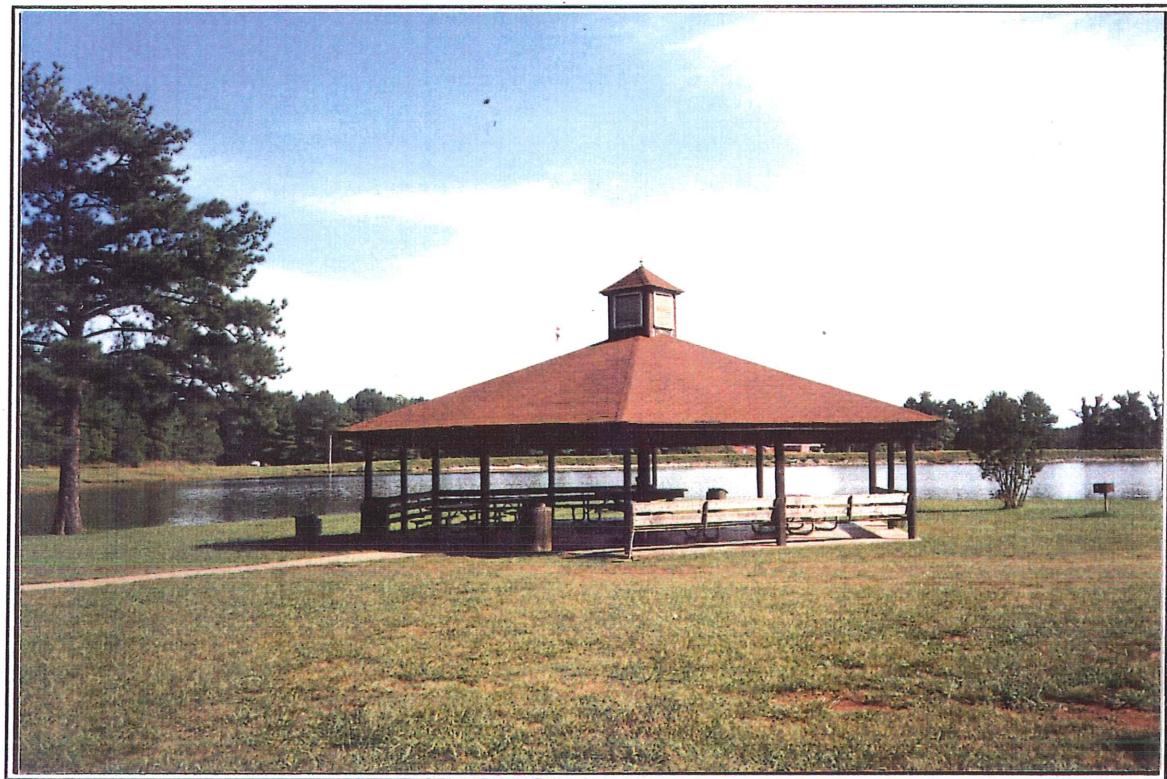
Illustration#8

Current interior circulation deficiencies for the restroom facilities include: none observed. Current interior circulation deficiencies for the octagonal picnic pavilions include: none observed.

Rhodes Jordan Park Octagonal Picnic Shelters

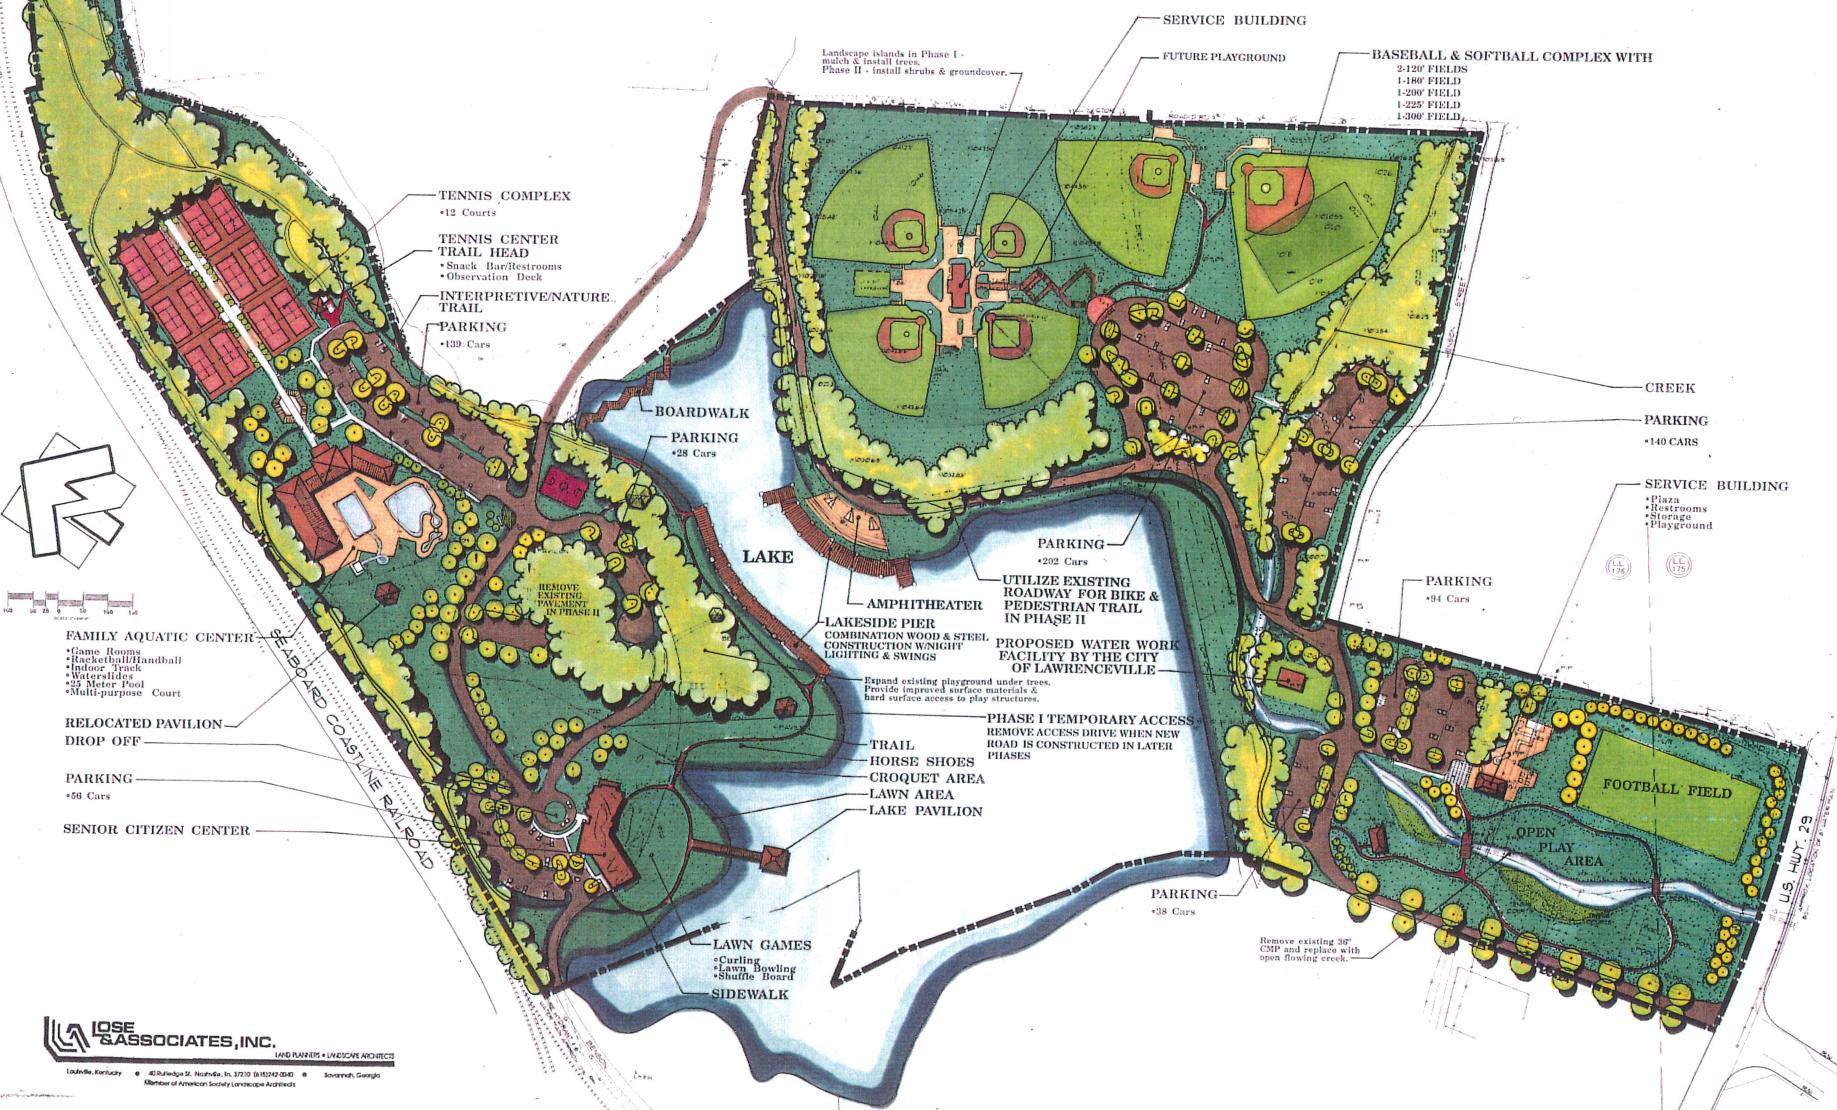
GWINNETT COUNTY PARK AND RECREATION DEPARTMENT
RHODES JORDAN PARK
 GWINNETT COUNTY, GEORGIA

The Tennis Center, north of the Family Aquatic/Community Center, contains 12 tennis courts. A central sidewalk allows access to each pair of courts. Bleachers face each court and provide tournament seating and general spectator use. A 139-space parking lot serves the Tennis Center, Family Aquatic/Community Center and the Interpretive Trail Head. The Tennis Shop and Interpretive Trail Head share the same building. Lockers for storing gear, bulletin boards for tournament sign-ups, clinic & lesson sites and an observation deck are within the Tennis Shop building. The interpretive trail stretches to the far north end of the property, makes a loop to return to the trail head, then continues around the site.

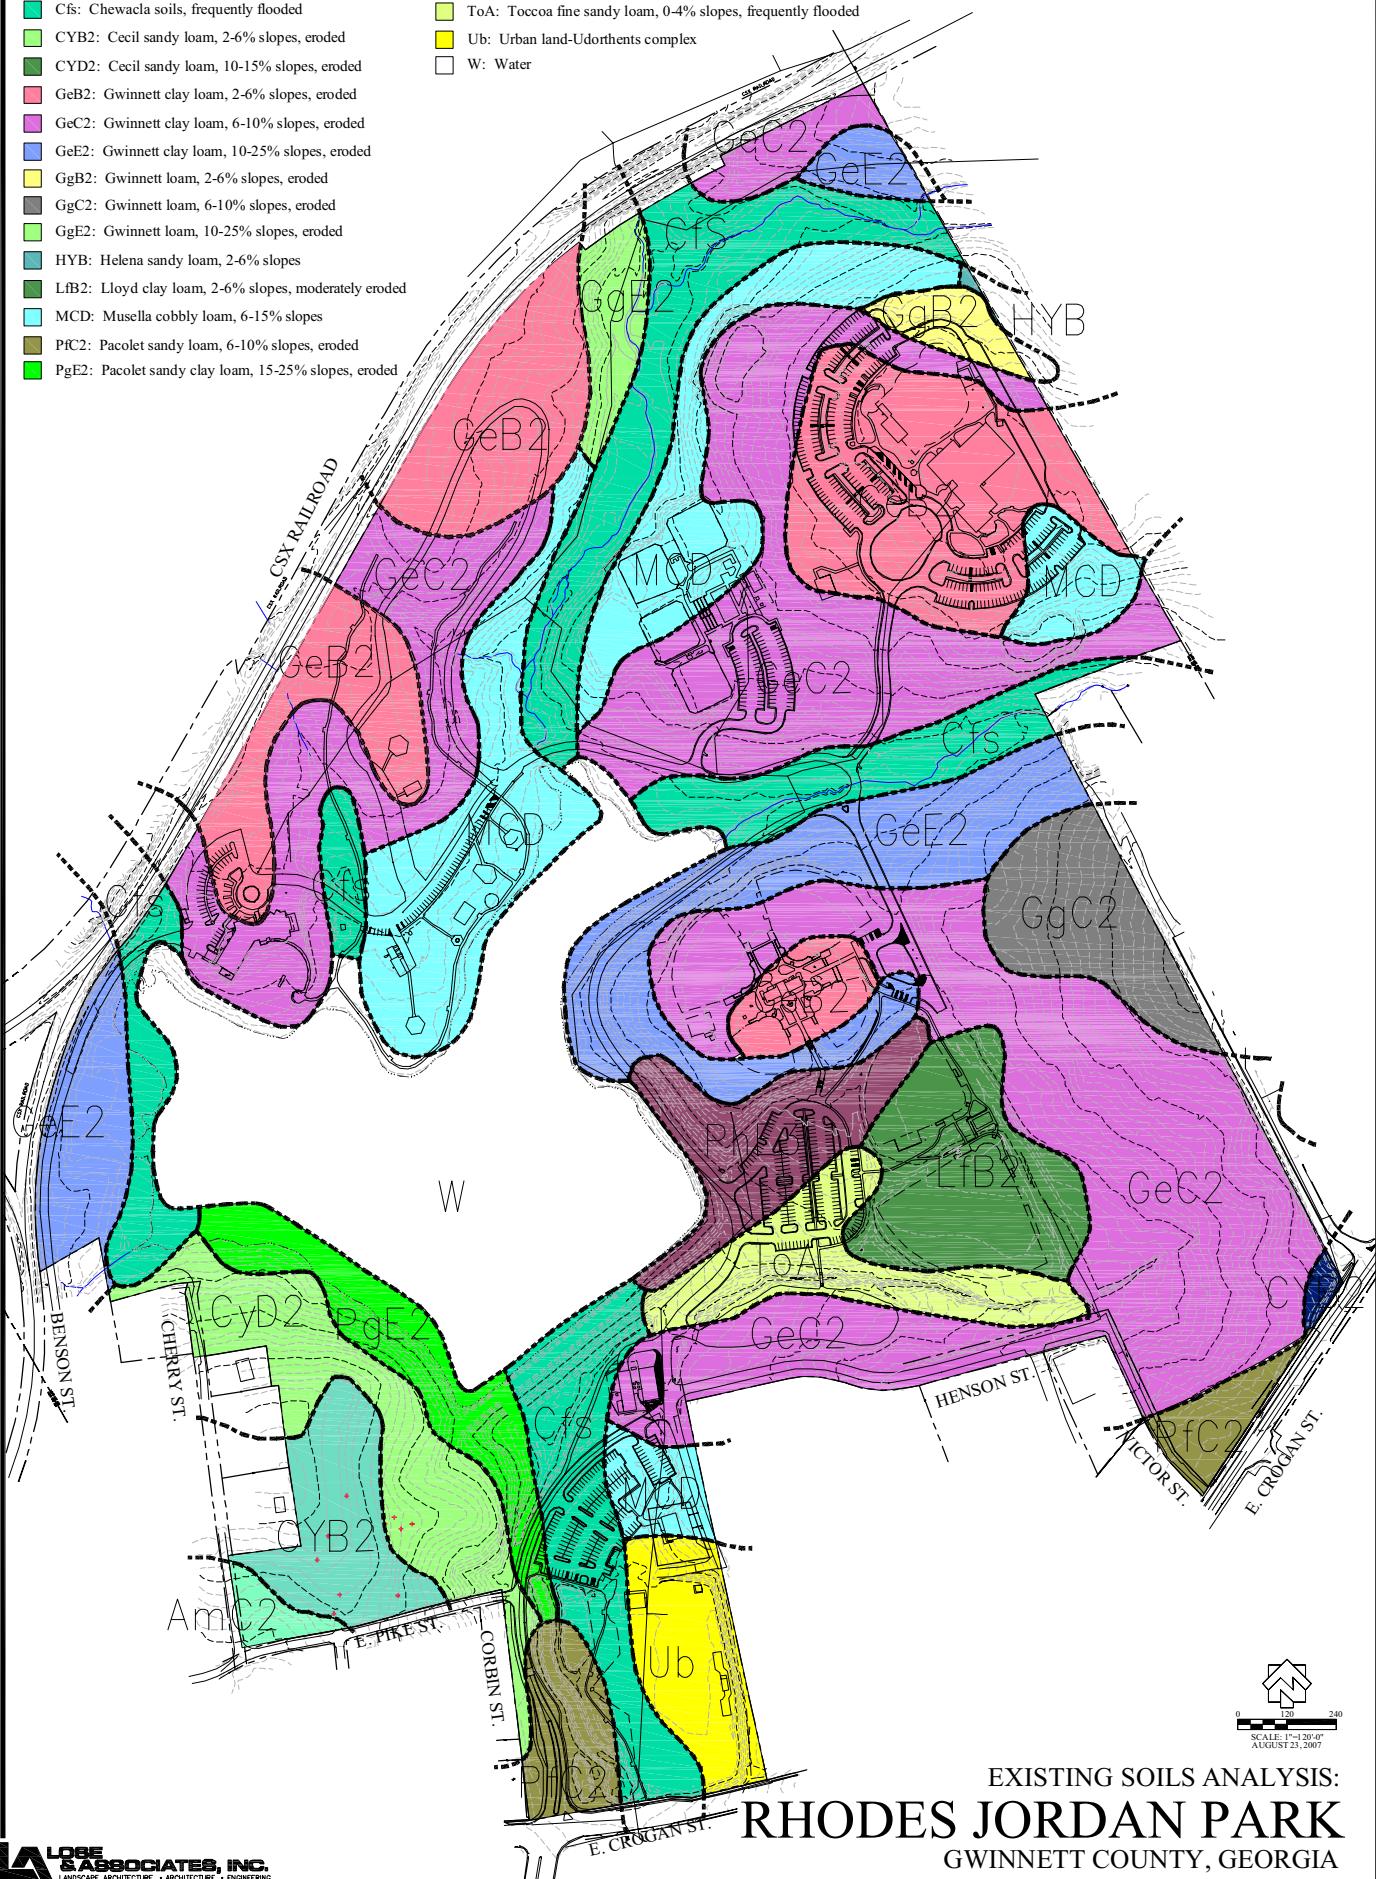
Figure 2

The underlying soils of the site consist of two main categories: The larger category consists of upland loamy soils suitable for development; the second category is made up of lowland loams and silts unsuitable for development due to poor strength or frequent flooding. The following Soils Analysis map (**Figure 2**) was derived from the USDA and Soil Conservation Service soil survey of Gwinnett County. The Chewacla soils (noted as Cfs and colored green) are the only soils on the site that would be poor for heavy development. The suitability for development of other soils shown is determined more by slope than by bearing capacity.

AmC2: Appling sandy loam, 6-10% slopes, eroded	PhE3: Pacolet-gullied land complex, 10-25% slopes, severely eroded
Cf: Chewacla soils, frequently flooded	ToA: Toccoa fine sandy loam, 0-4% slopes, frequently flooded
CYB2: Cecil sandy loam, 2-6% slopes, eroded	Ub: Urban land-Udorthents complex
CYD2: Cecil sandy loam, 10-15% slopes, eroded	W: Water
GeB2: Gwinnett clay loam, 2-6% slopes, eroded	
GeC2: Gwinnett clay loam, 6-10% slopes, eroded	
GeE2: Gwinnett clay loam, 10-25% slopes, eroded	
GgB2: Gwinnett loam, 2-6% slopes, eroded	
GgC2: Gwinnett loam, 6-10% slopes, eroded	
HYB: Helena sandy loam, 2-6% slopes	
LfB2: Lloyd clay loam, 2-6% slopes, moderately eroded	
MCD: Musella cobbly loam, 6-15% slopes	
PfC2: Pacolet sandy loam, 6-10% slopes, eroded	
PgE2: Pacolet sandy clay loam, 15-25% slopes, eroded

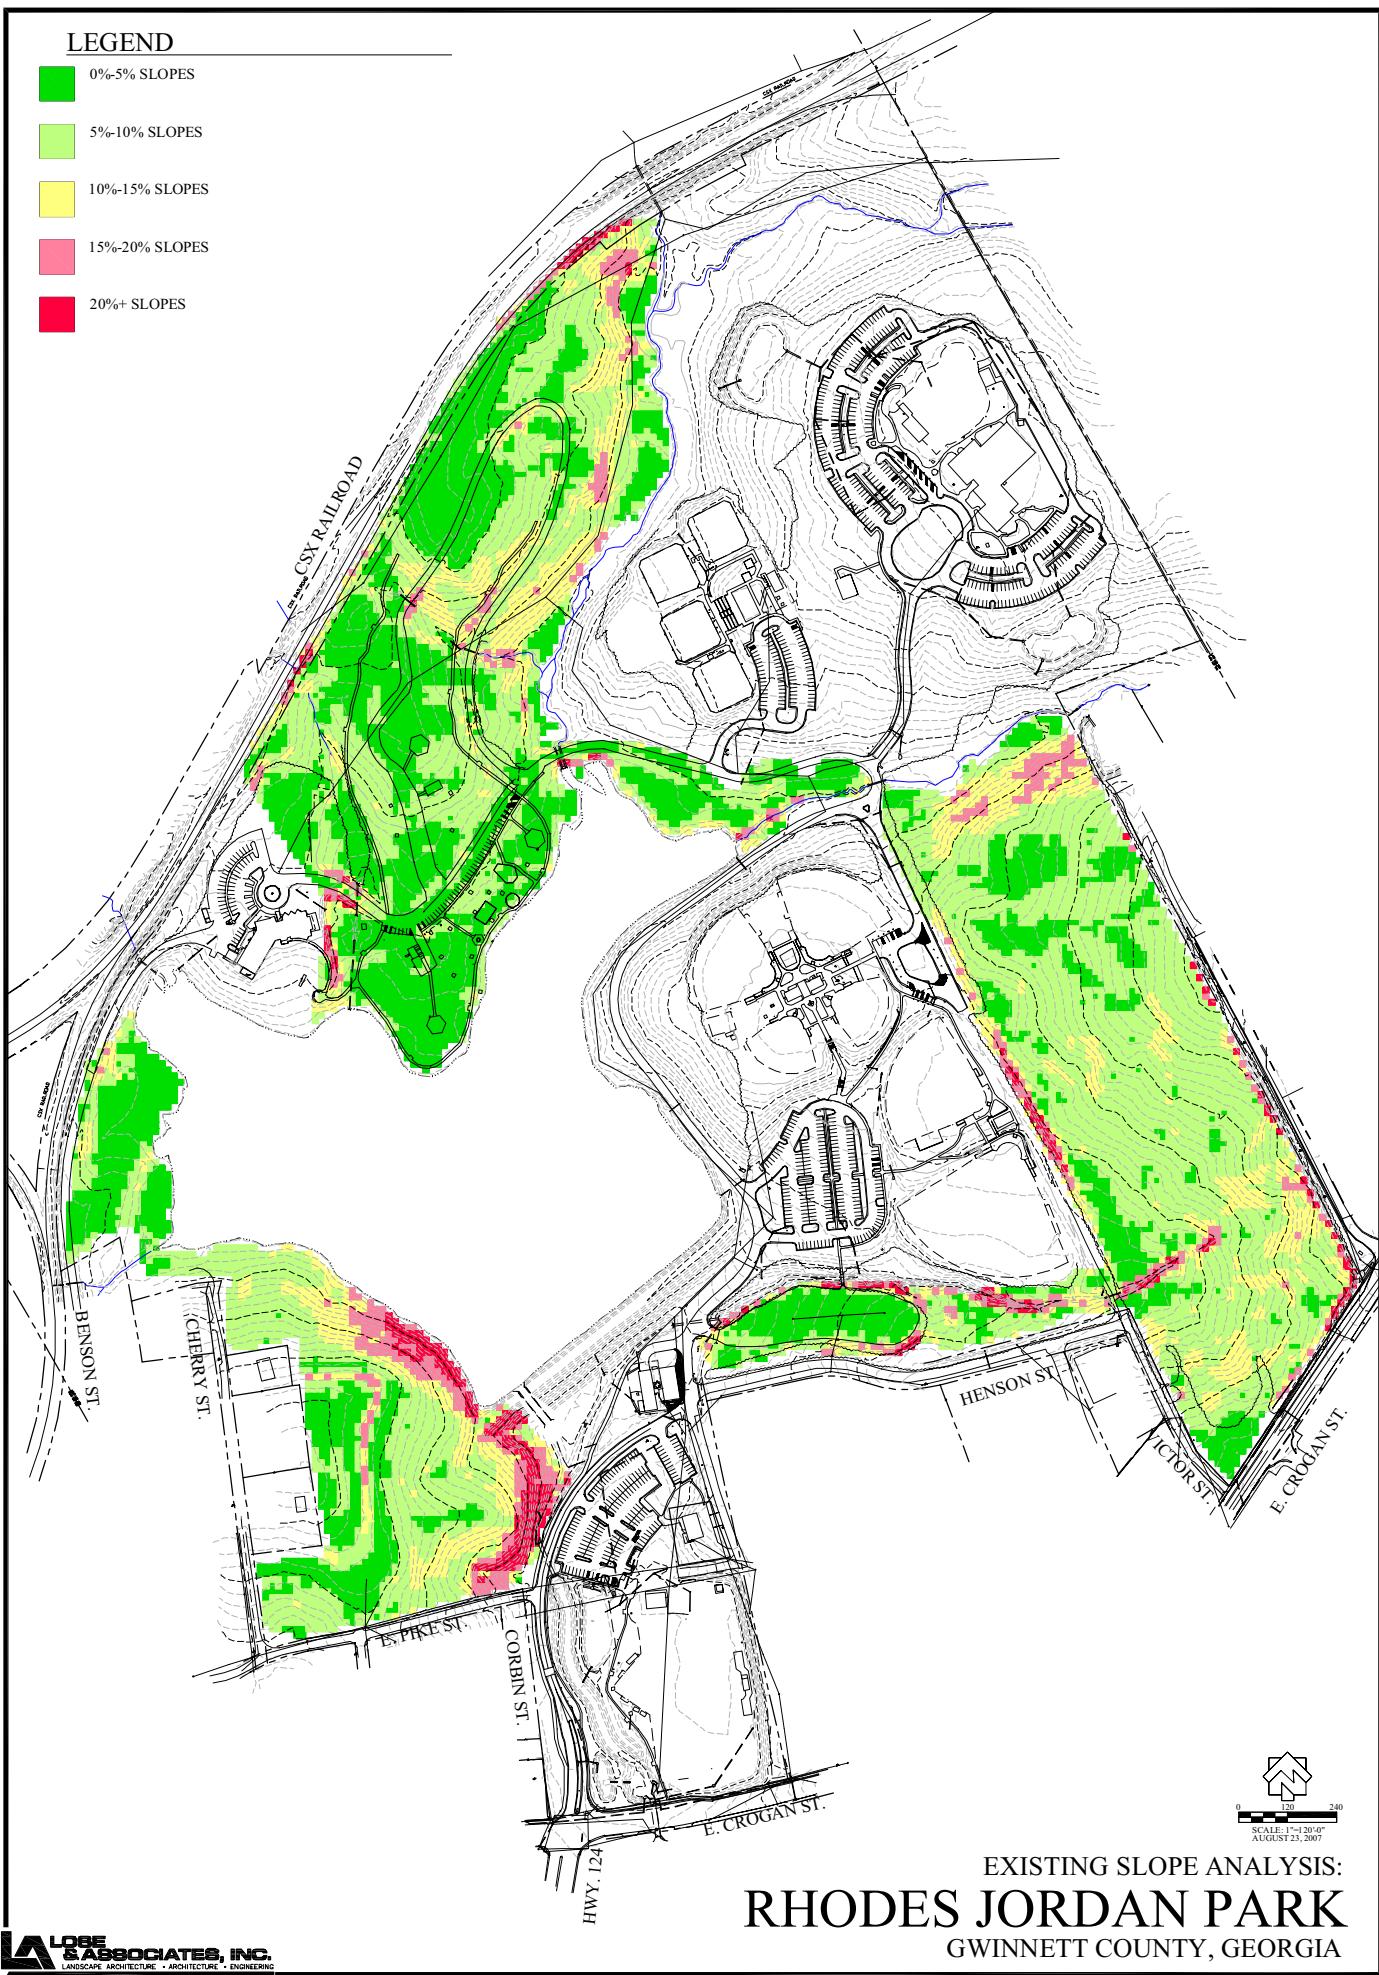
EXISTING SLOPE ANALYSIS:
RHODES JORDAN PARK
GWINNETT COUNTY, GEORGIA

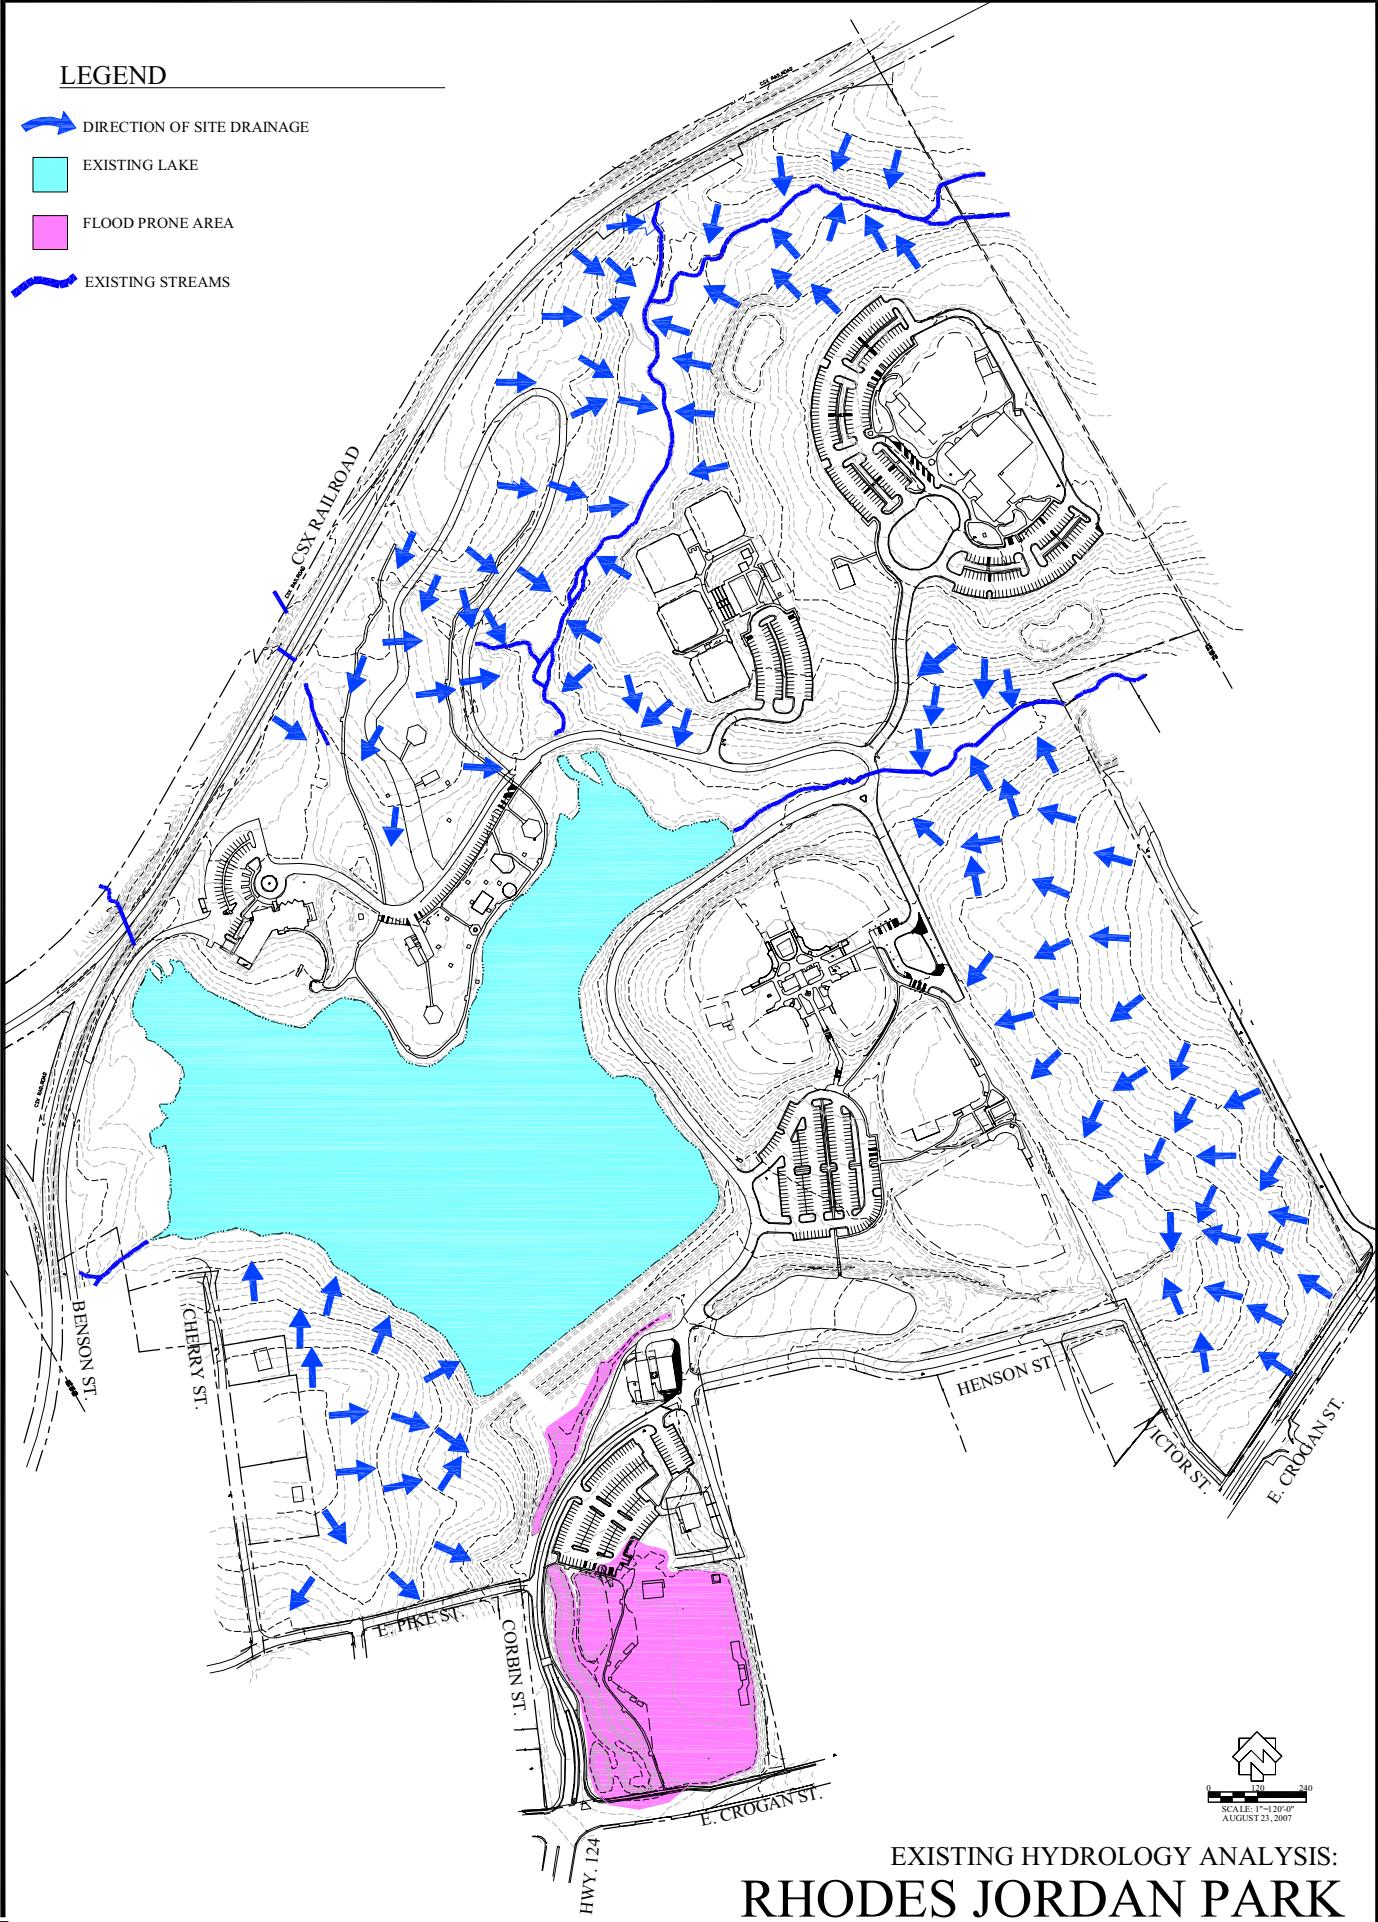
Figure 4

EXISTING HYDROLOGY ANALYSIS:
RHODES JORDAN PARK
GWINNETT COUNTY, GEORGIA
