RHODES JORDAN PARK MASTER PLANS

Gwinnett County Department of Human Services
Parks and Recreation Division

**Master Plan Report for
Rhodes Jordan Park**

Rhodes Jordan Park Master Plan Update

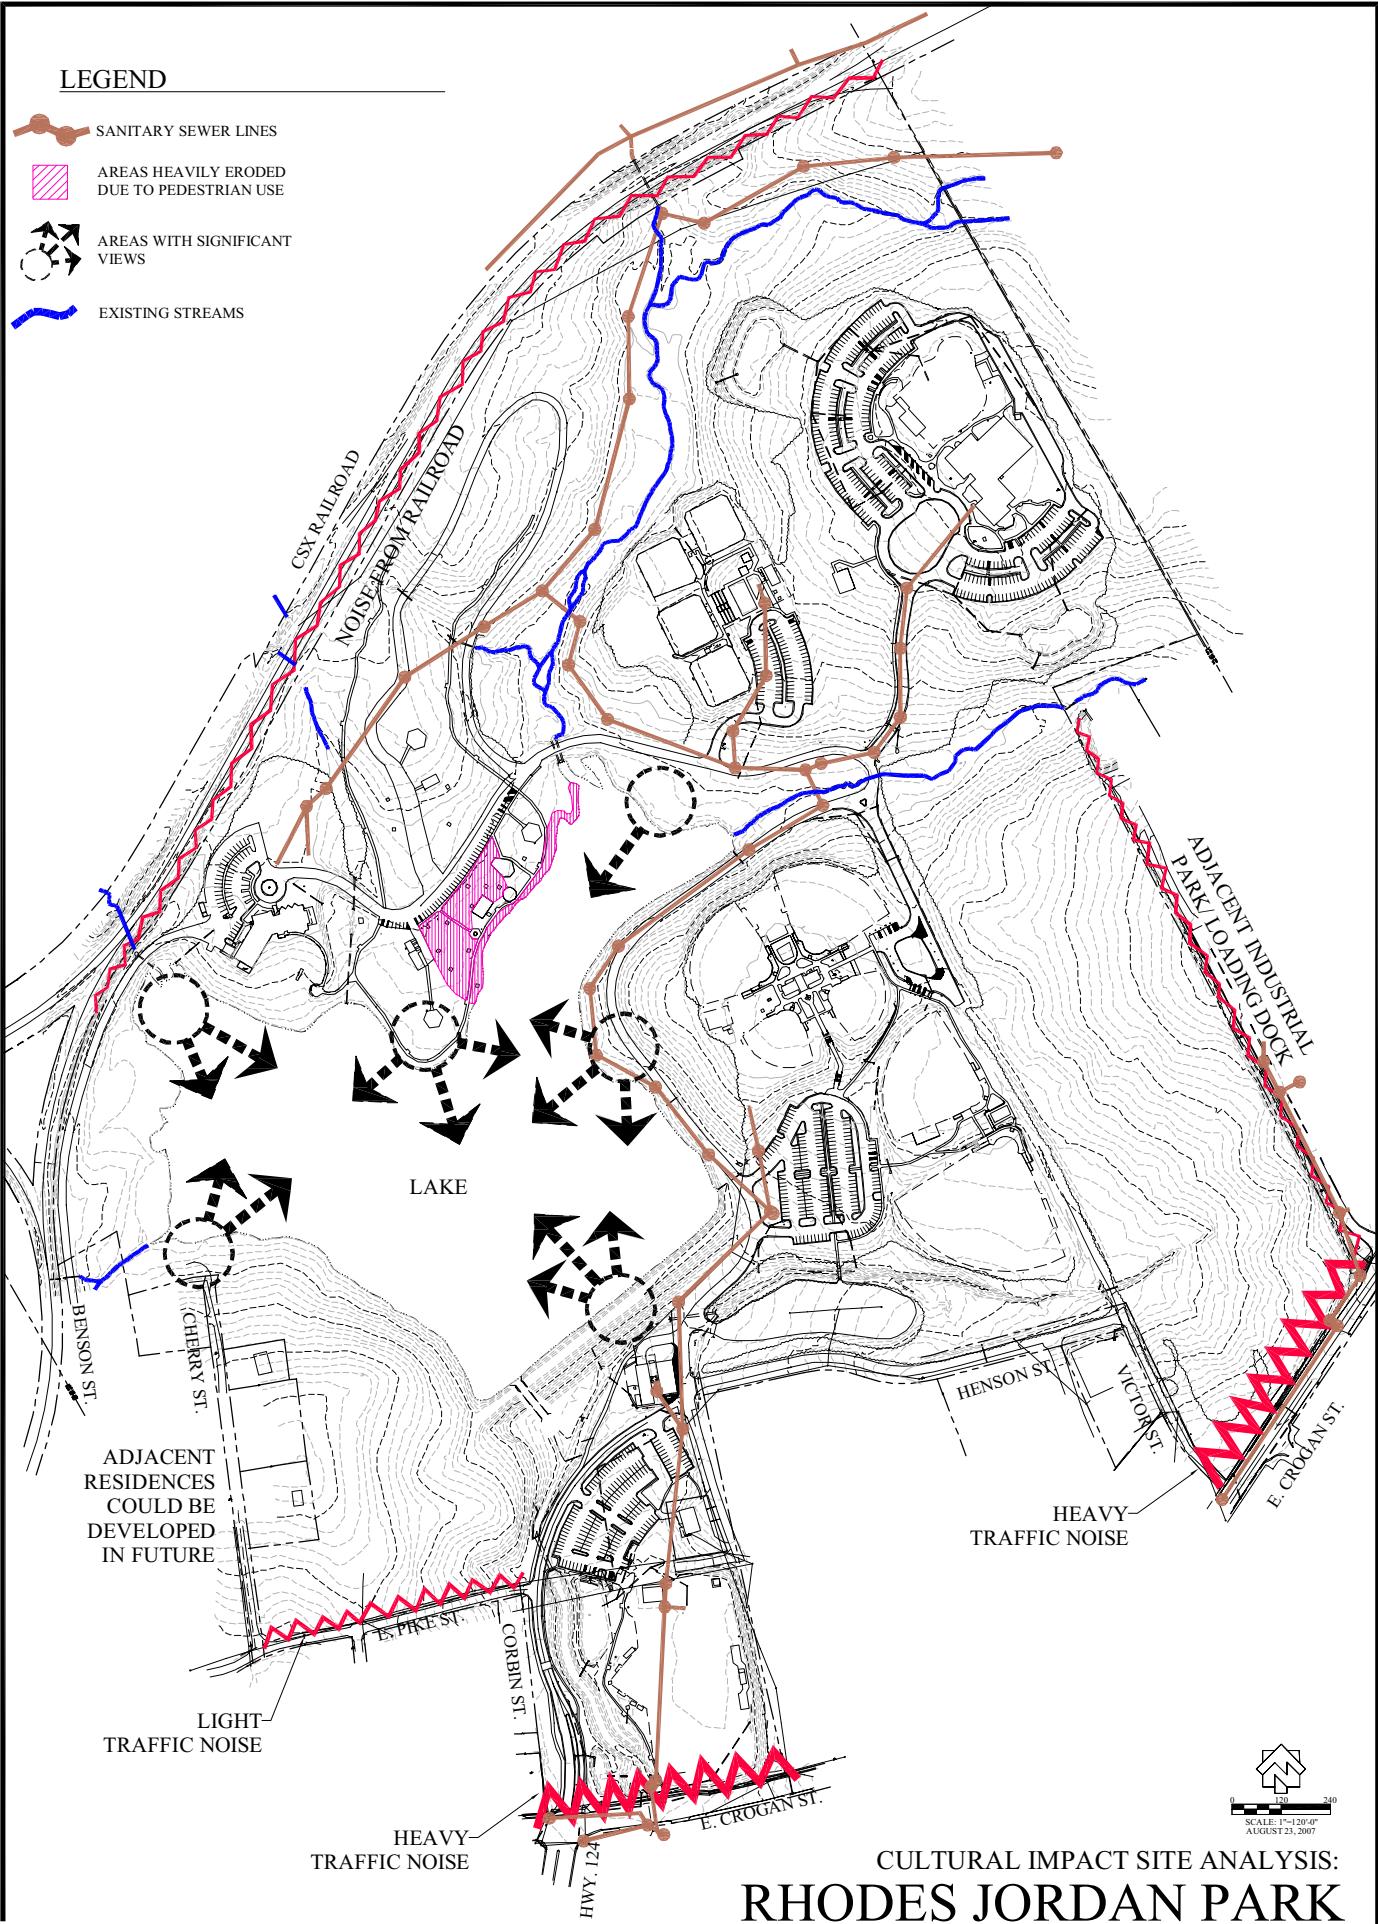
As noted above, the Northern, Eastern and Southern borders of the property provide opportunities for external noise. With this in mind, any site development should include leaving vegetation buffers around the park's perimeter. Additionally, there are localized areas of erosion at the lake's edge near the existing playground, providing the opportunity for creative design solutions. Furthermore, several locations around the lake's edge provide appealing views across the park, which need to be preserved. The following **Figure 9** is a graphic representation of the cultural impacts on the site.

CULTURAL IMPACT SITE ANALYSIS:
RHODES JORDAN PARK
GWINNETT COUNTY, GEORGIA

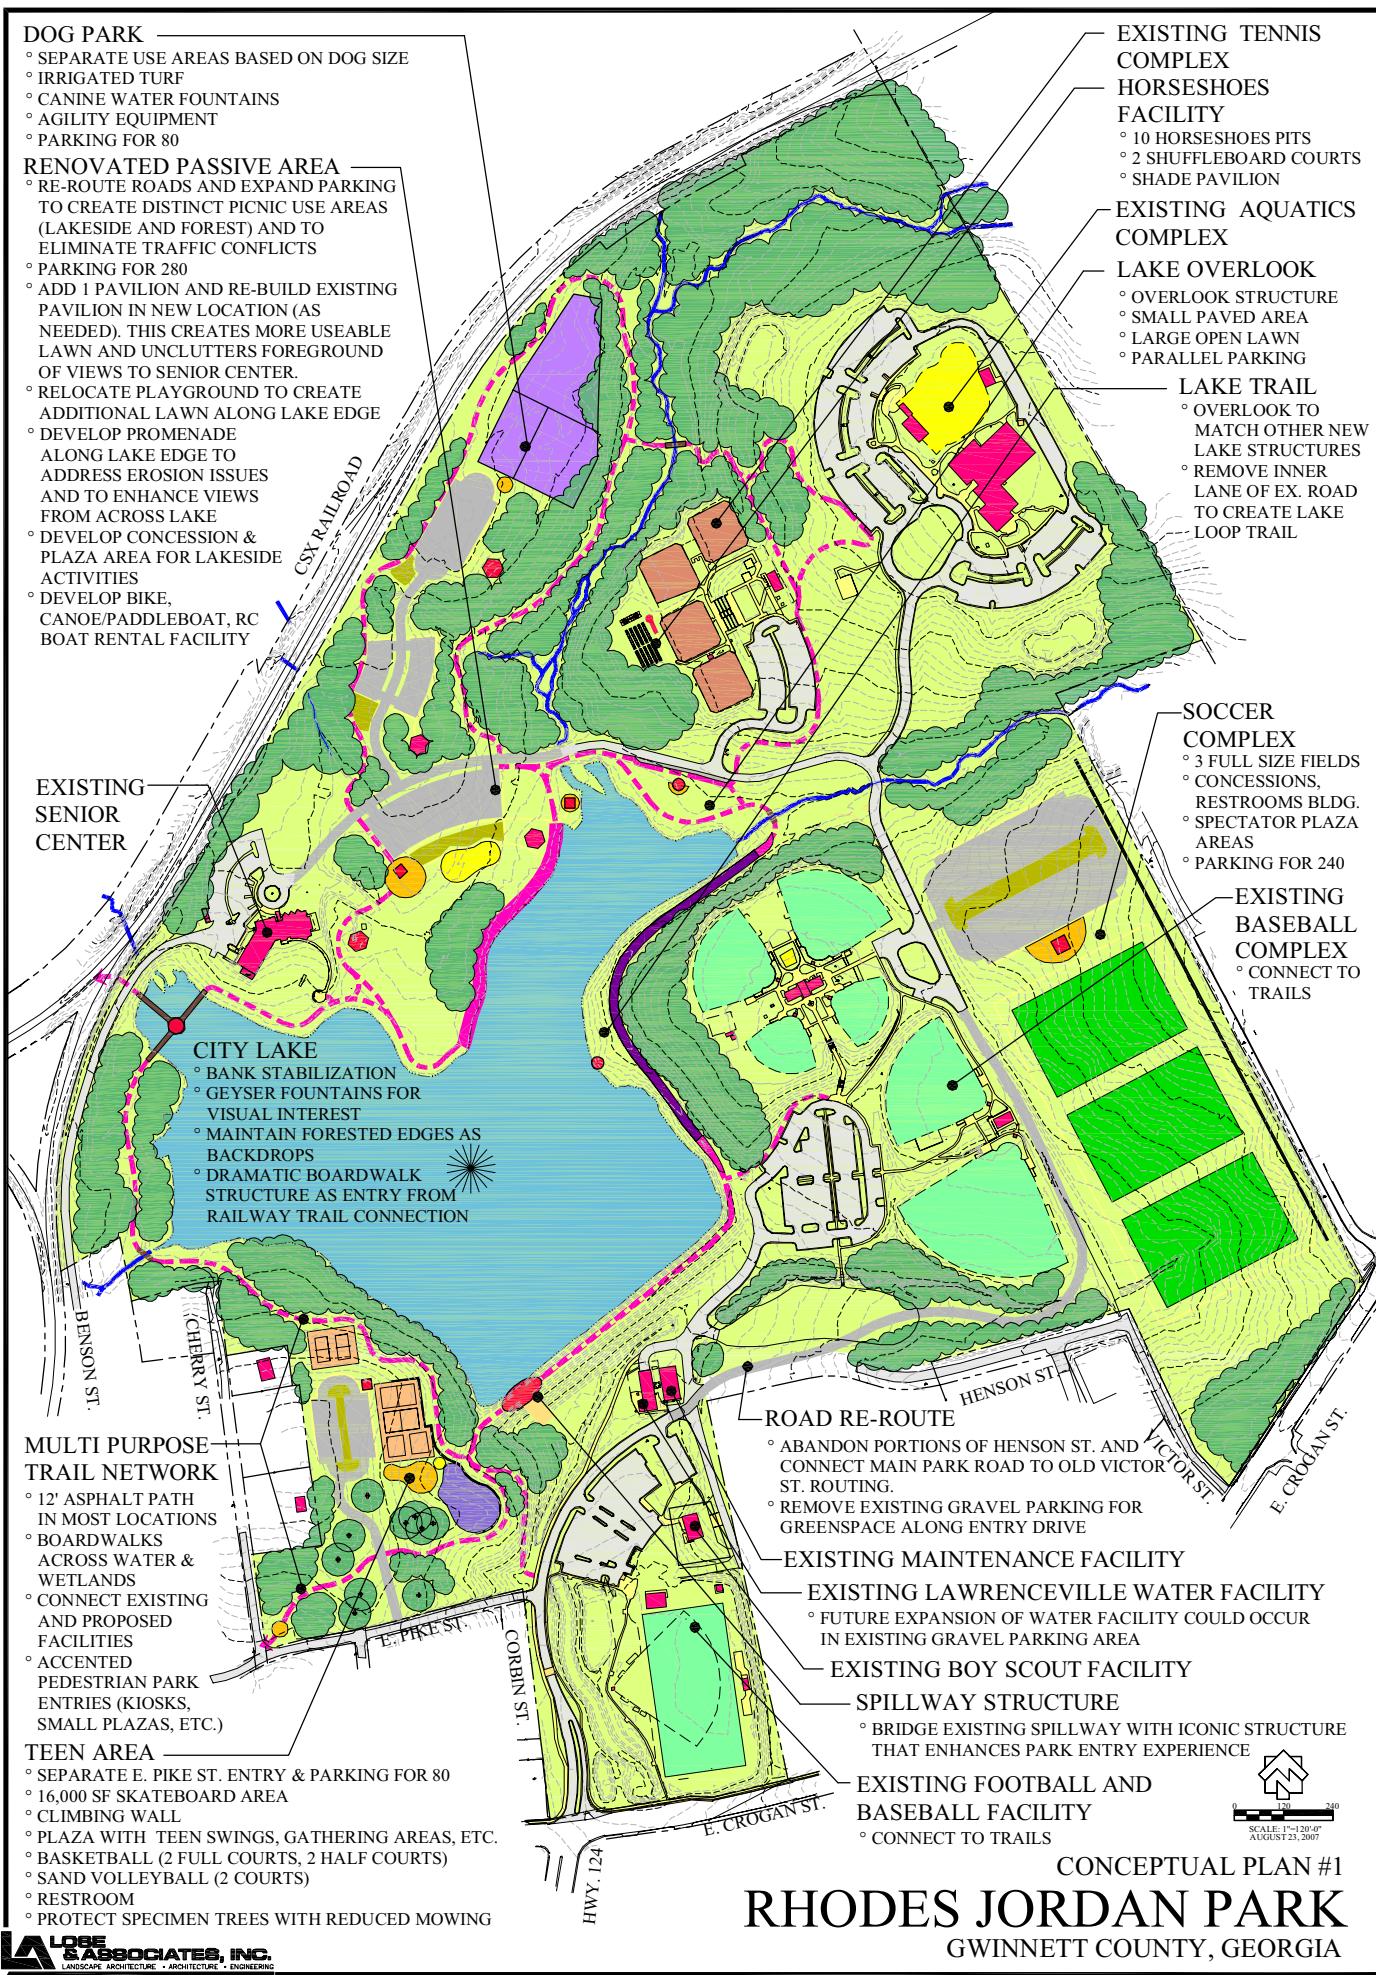
Figure 10

Soccer Area: Of the three concepts presented for this area, the concept with the parking area at one end, with the three fields all next to each other, was initially preferred (**Figure 10**). Although this layout would place one of the fields a long distance away from the concessions/restroom building, the fact that the placement of the parking lot would provide an option for additional

On August 23, 2007, the site analysis effort and three alternative conceptual plans (**Figures 10, 11, 12**) for the park were presented at the Rhodes Jordan Park Community Center to representatives of the City of Lawrenceville, the Lawrenceville Senior Center, the Lawrenceville Youth Athletic Association and Gwinnett County Parks and Recreation staff. The meeting began with the presentation of the aerial photographs to demonstrate the progression of this property over the last 50+ years. The presentation continued with an explanation of the site analysis, specifically the areas which were to be redeveloped, including information related to the site's vegetation, soils, slopes and cultural impacts. The summary of this presentation was that all areas for redevelopment would be acceptable with the understanding that large retaining walls would be necessary to accommodate certain features, such as the area where the soccer fields were intended to be located.

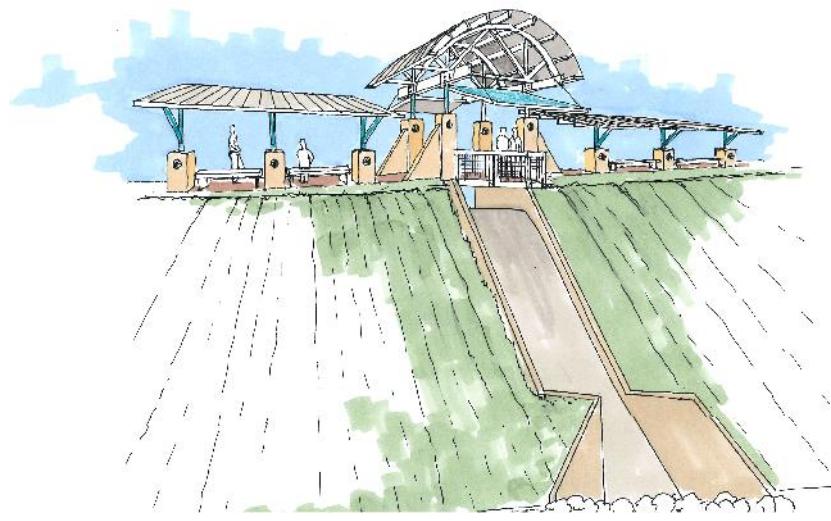
SPILLWAY BRIDGE STRUCTURE

In order to accommodate the additional stormwater runoff, the existing spillway will need to be modified to accommodate approximately 3" of storage. It is also suggested that dredging occur in a few places where streams empty into the lake. A large aeration fountain, which serves as a dramatic focal point from many vantage points around the lake, is also shown.

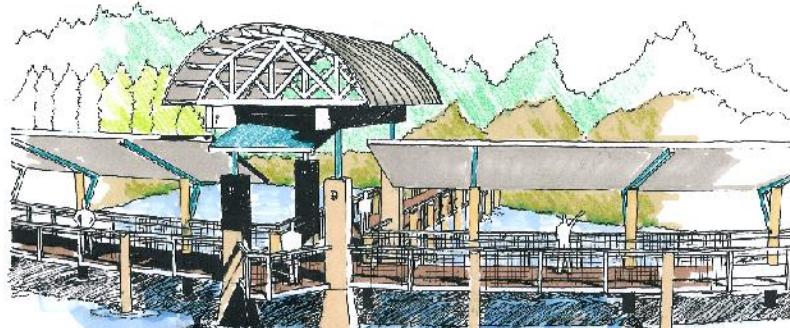
LAKE BOARDWALK STRUCTURE

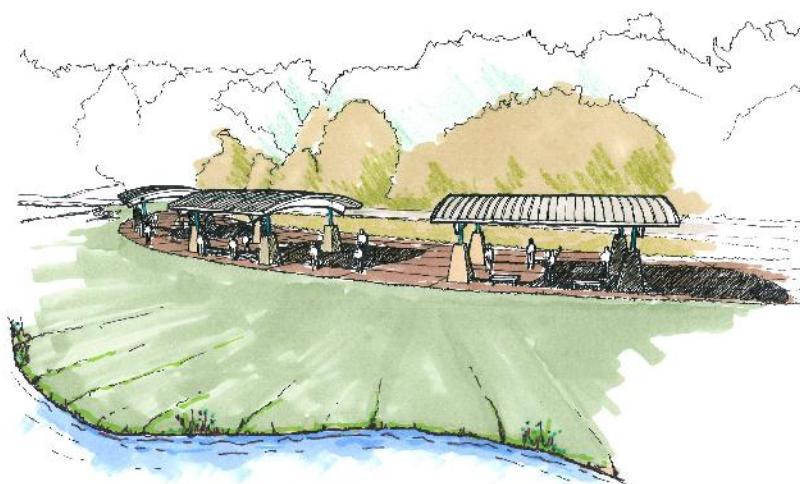
LAKE OVERLOOK STRUCTURE
