**ARCHAEOLOGICAL AND HISTORICAL MASTER PLAN
FOR THE HUDSON-NASH FARM
AND YELLOW RIVER POST OFFICE**

Final Report
July 2000

**HUDSON-NASH FARM AND
YELLOW RIVER POST OFFICE
ARCHAEOLOGICAL AND HISTORICAL
MASTER PLAN**

**The Jaeger Company
Gainesville, Georgia**

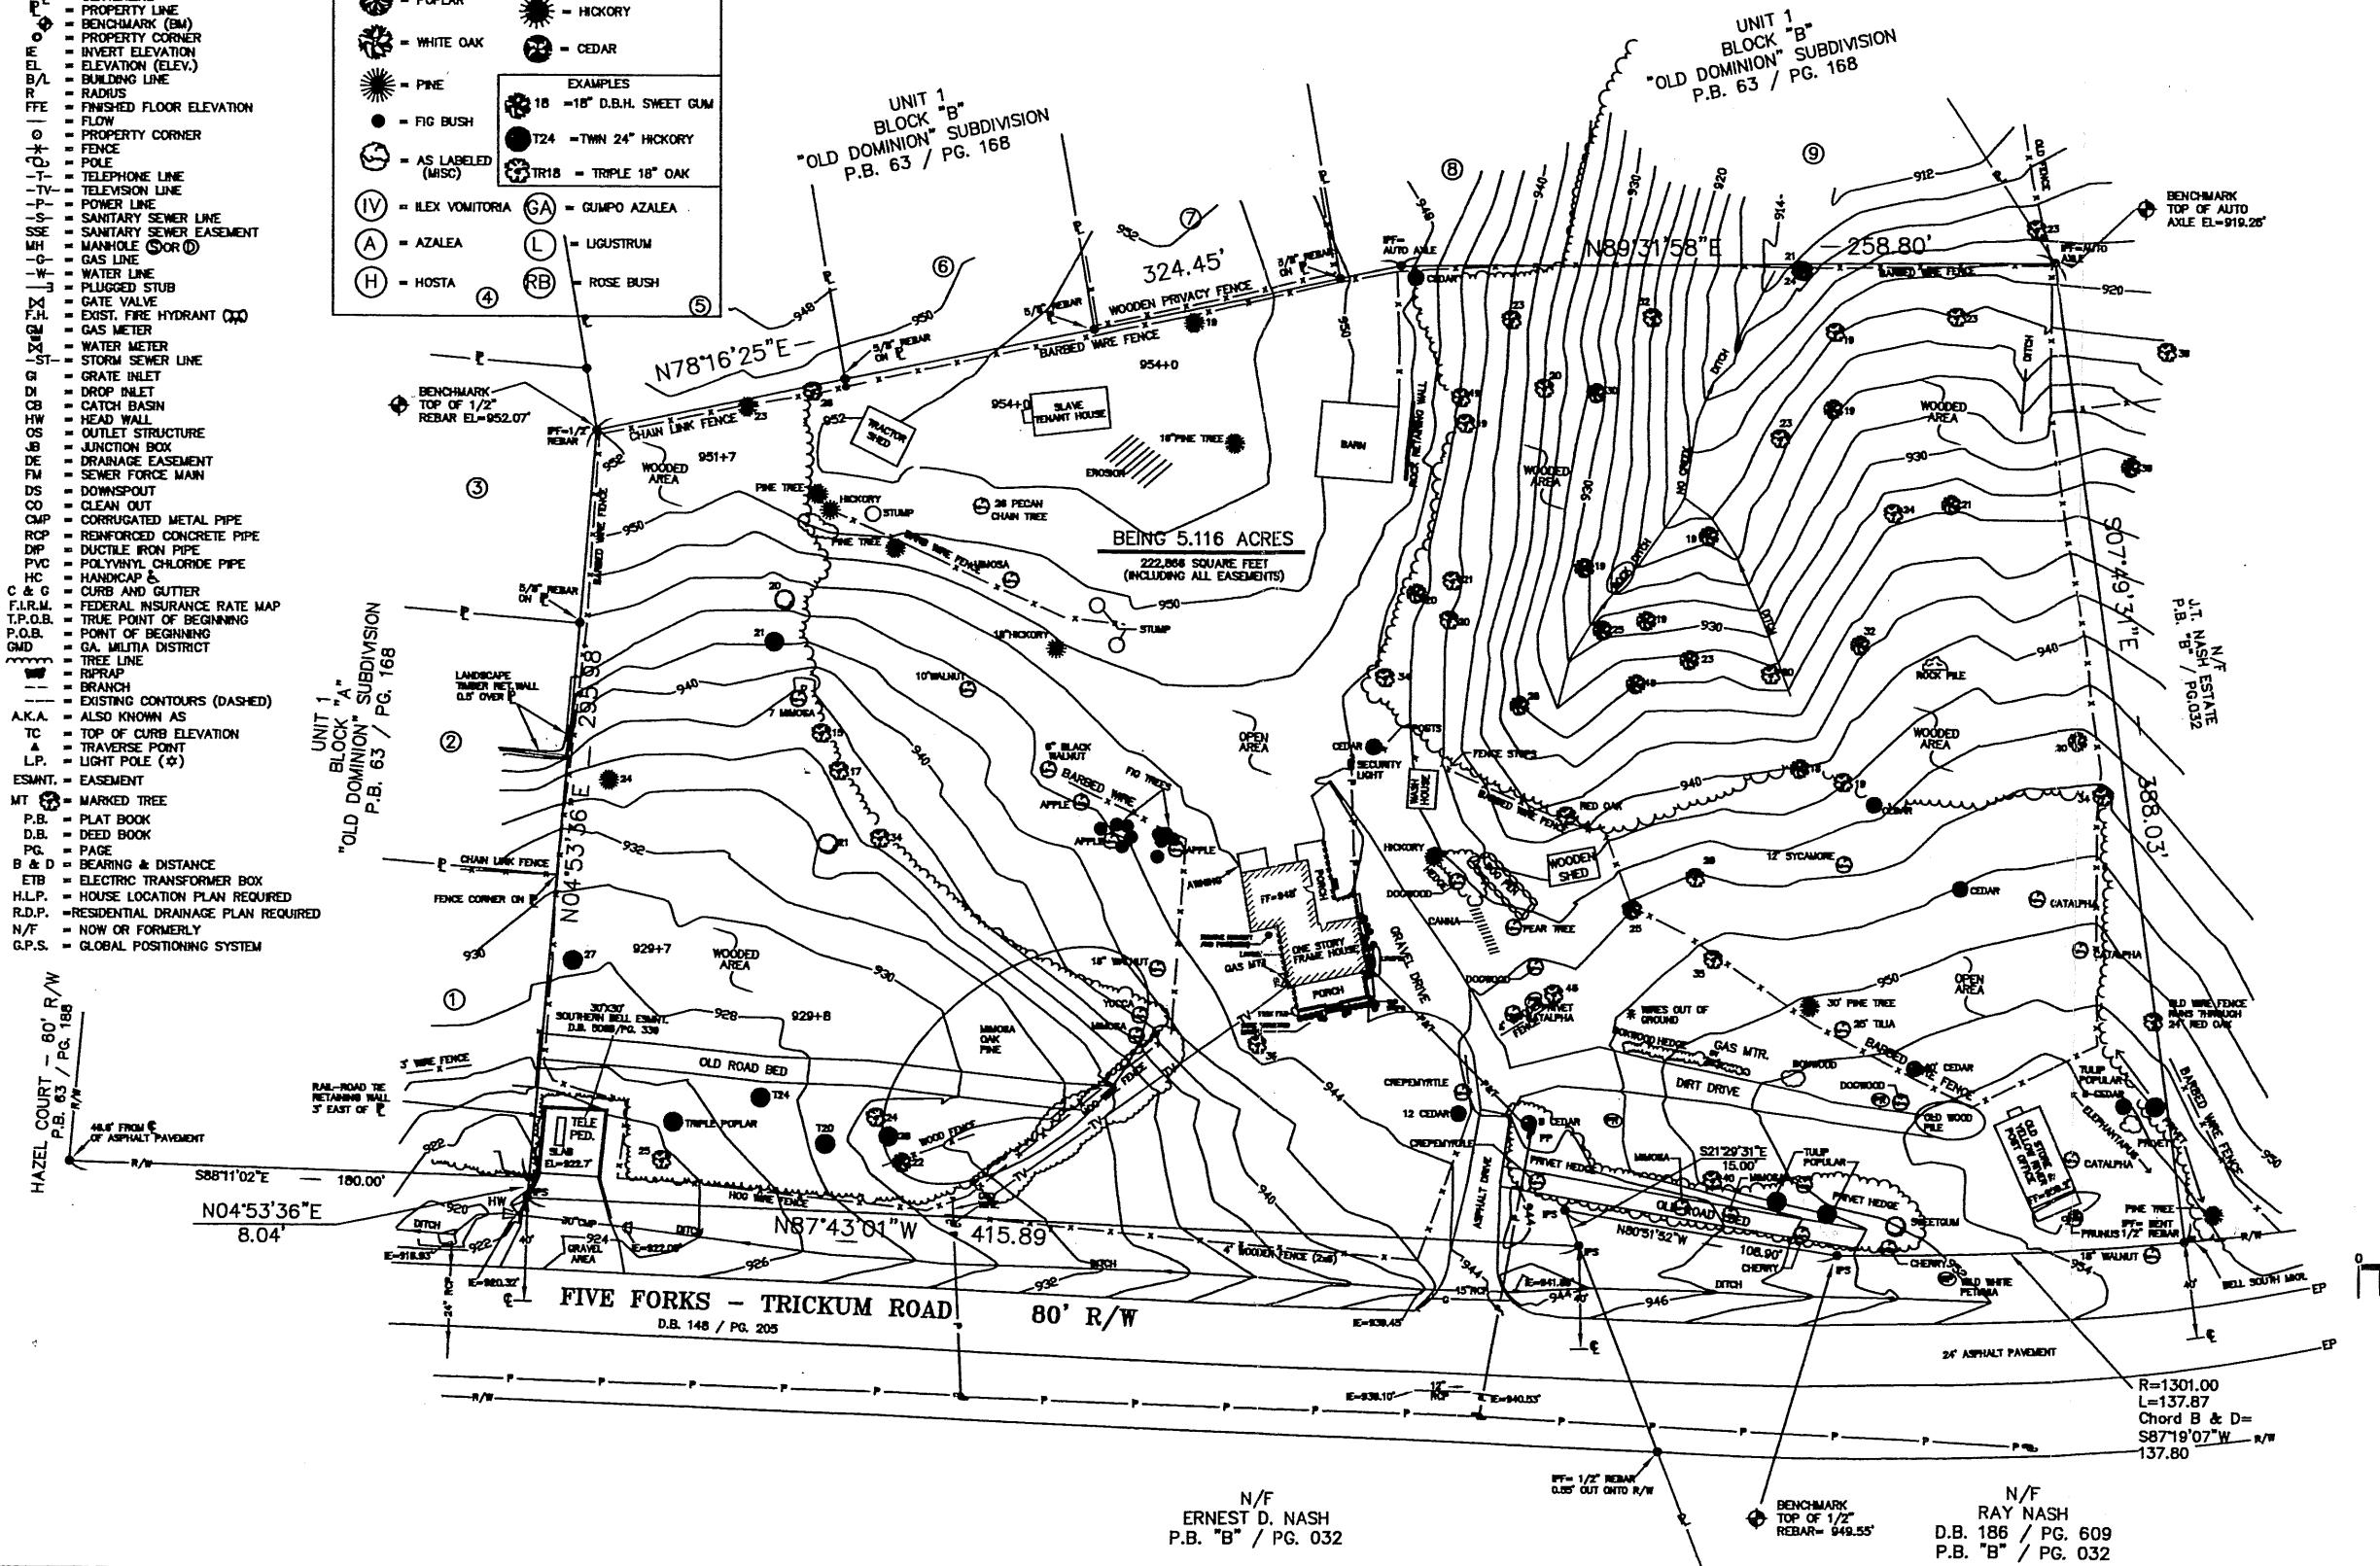
TOPOGRAPHIC SURVEY

Date: 1 OCTOBER 1999
Revisions: 13 OCTOBER 1999
9 NOVEMBER 1999
12 MAY 2000
Project No.: 590022
Scale: 1:100
Drawn: I.H.M.
Sheet 1 of 11

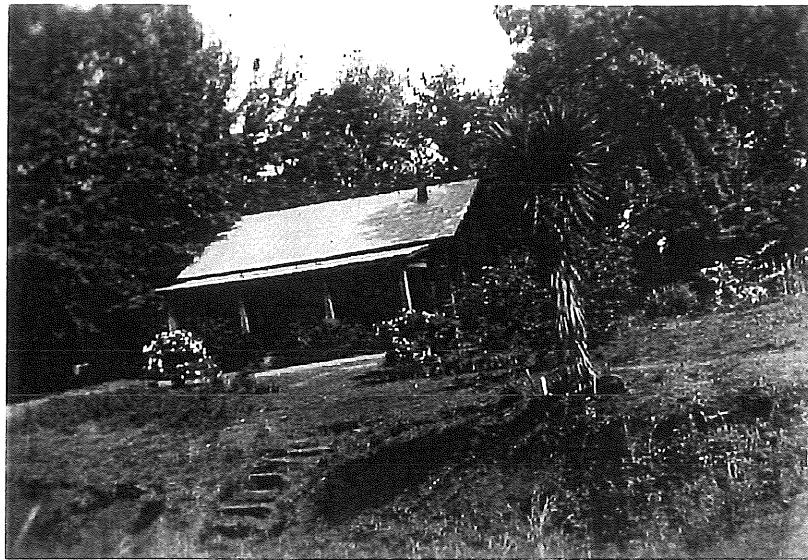
1. From the historic road looking at the Claude Nash House; note the rock steps and palmetto; photo taken shortly after 1936 when the house's front section was added and before the house was painted.

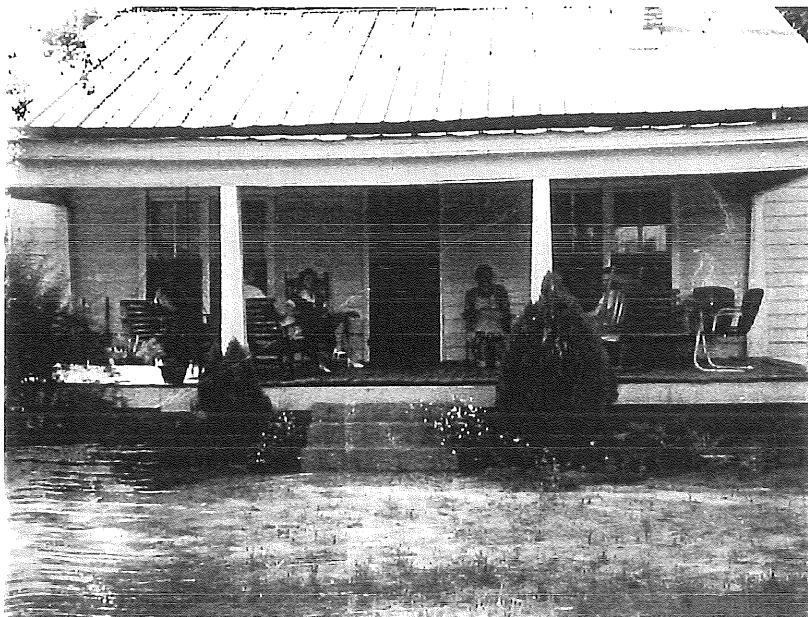
3. Front porch of the Claude Nash House added in 1936.

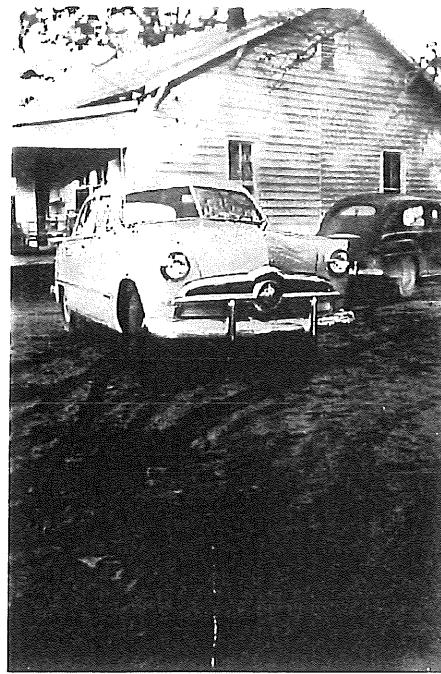
4. Driveway of the Claude Nash House, kept free of grass, c.1950s; note the addition of the house's front section seen in the seam visible in the siding.

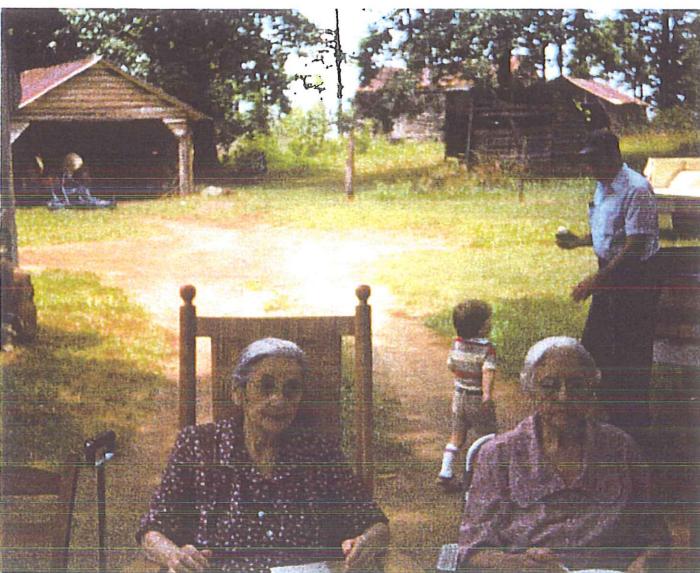
9. Family gathered in the kitchen yard of the Claude Nash House; note the sheds and slave/tenant house in the background.

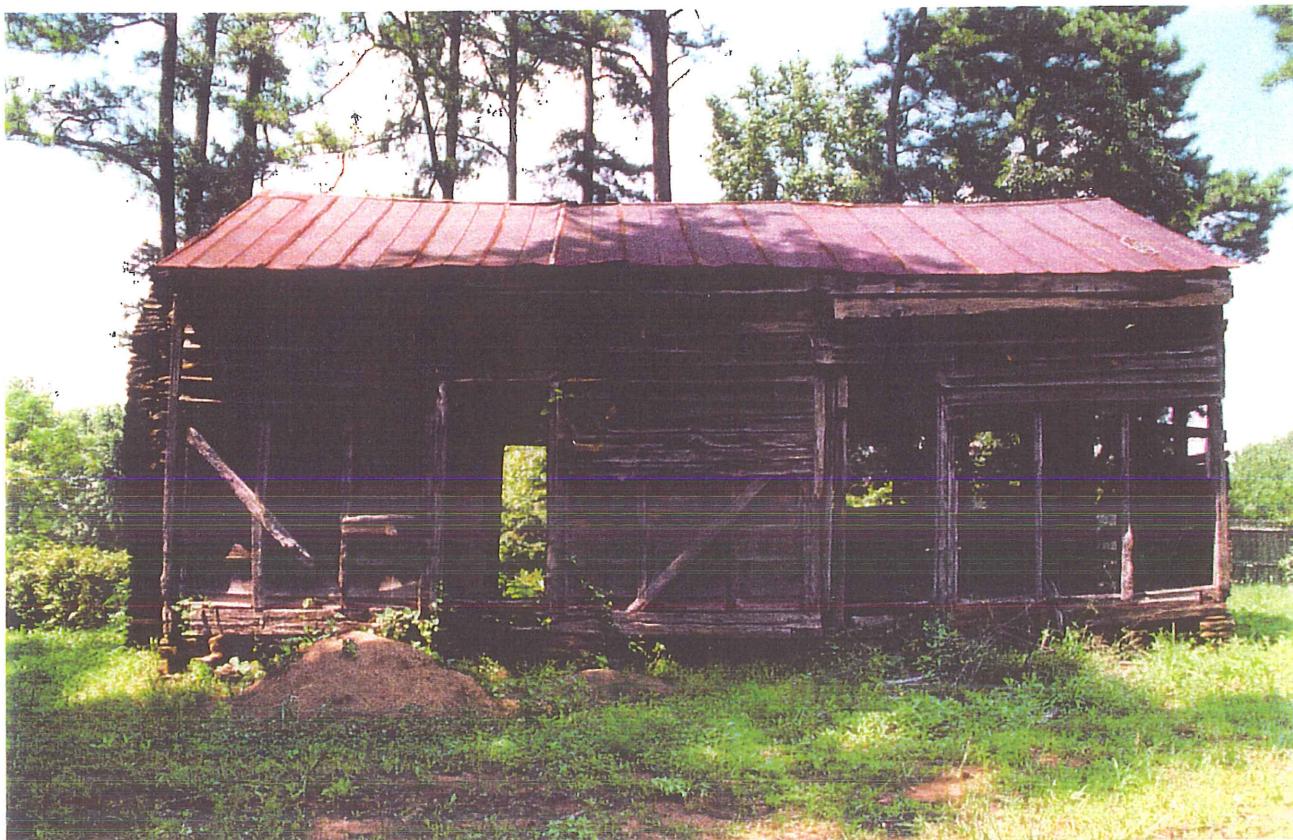
Store/Post Office

Parts of the *store/post office* are in very poor condition and need extensive repairs. Many of the structural sills, joists, and piers that support the building are greatly deteriorated, causing structural instability. The front porch structure is completely missing in some places. Siding is missing from portions of the exterior walls, and the masonry chimney is in poor condition. Three of the four window shutters are missing, and both doors have been removed. The building is becoming more and more exposed to the elements, causing further deterioration.

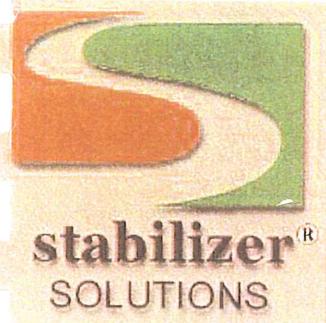
Stabilizer Crushed Stone Paving

- Golf Cart Paths
- Walkways
- Parking Areas
- Service Areas
