# 4.0 BMP Assessment

**Figure 14**  
 BMPs Identified From Drainage Inventory  
 Crooked Creek Storm Water Master Plan  
 Gwinnett County DPU

**Figure 15**  
 BMPs (Existing and Potential) Screened for Watershed-Wide Benefits  
 Crooked Creek Storm Water Master Plan  
 Gwinnett County DPU

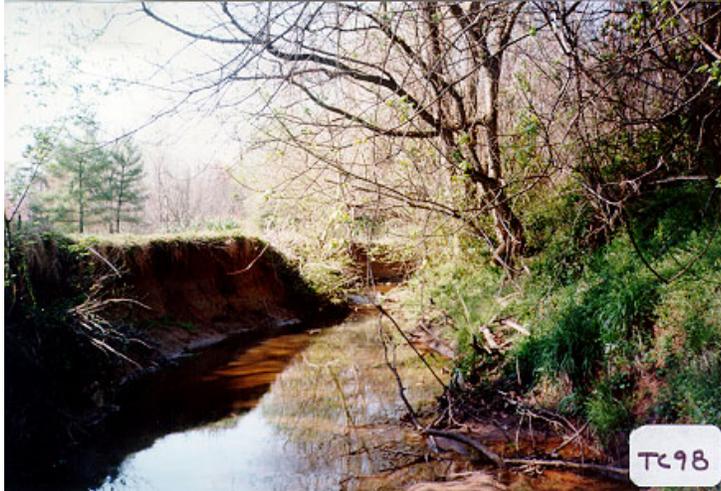
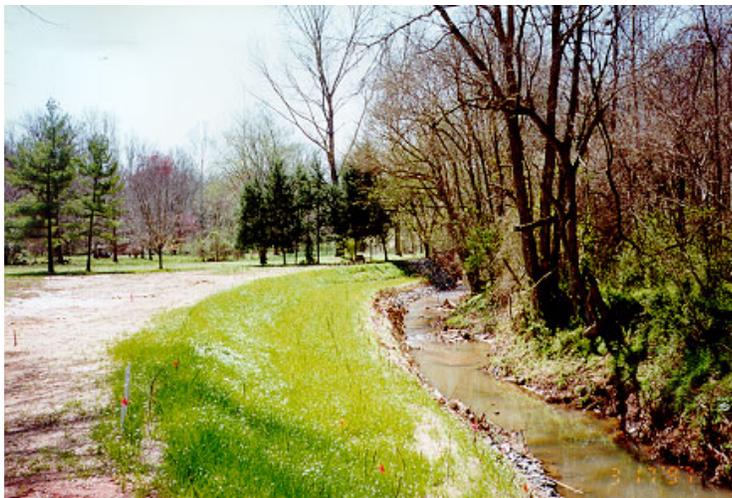
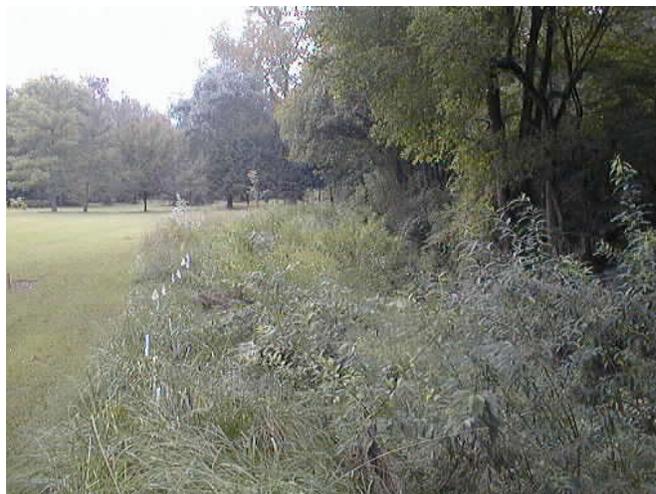
**Example Type 2 Stream Improvement Project**

Before, during, and after photos of a Type 2 restoration project depicts the construction of a bench for the stream re-establishing the floodplain at the existing elevation of the stream.

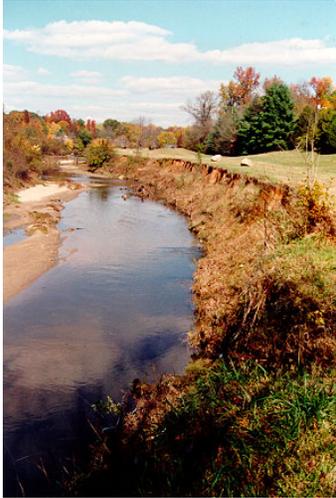
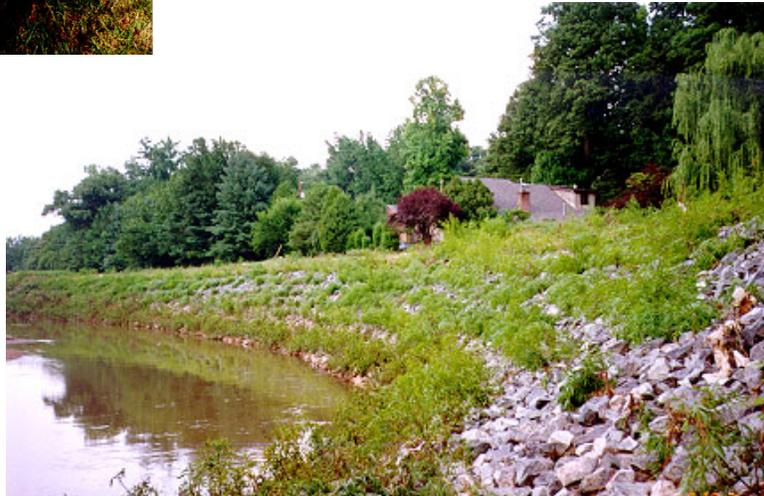
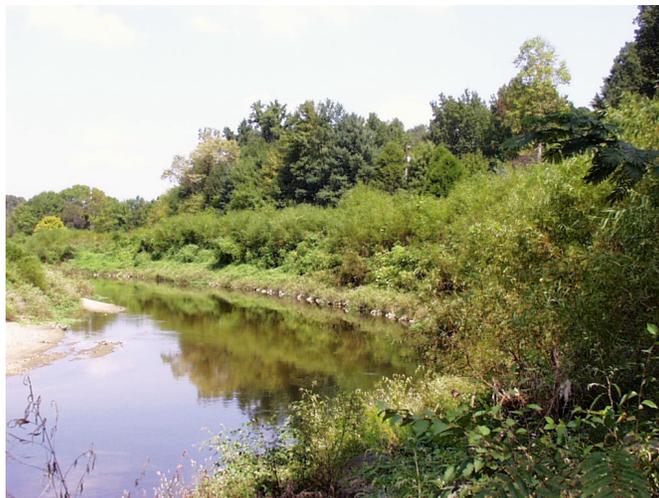
**FIGURE 20**

**Example Type 4 Stream Improvement Project**

Before, during, and after at a Type 4 restoration project depicts stabilization of the stream bank in place.

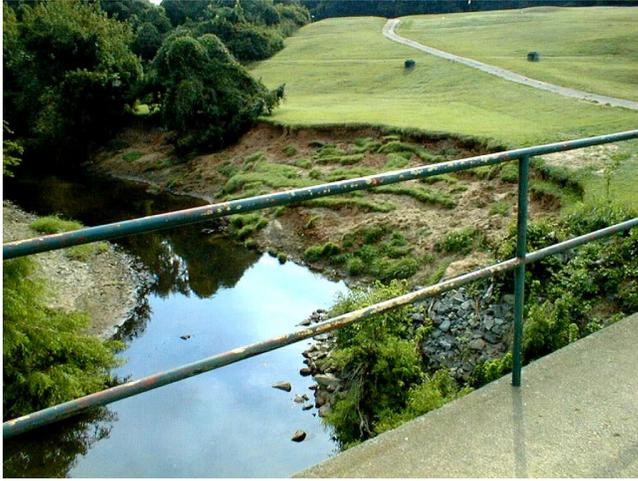
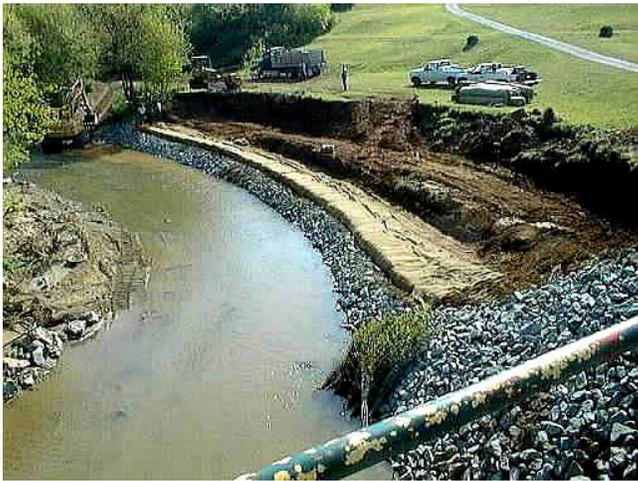
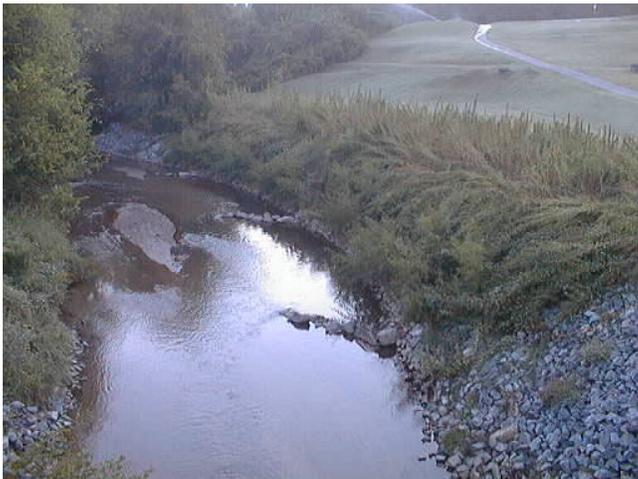
**FIGURE 21**  
Example Spot Repair Project  
Stream bank scour at the approach to a stream crossing is repaired using a vegetated lift soil bioengineering technique.

Spot repairs refer to the localized use of stabilization measures (soil bioengineering preferably) to stabilize stream banks. Spot Repair - Culvert addresses those erosion areas caused by scour at roadway culvert inlets and/or outlets. Figure 21 shows an example of a Spot Repair – Culvert. Spot Repair - Stream Bank addresses localized erosion areas along stream banks on stream reaches outside of the vicinity of roadway culverts.

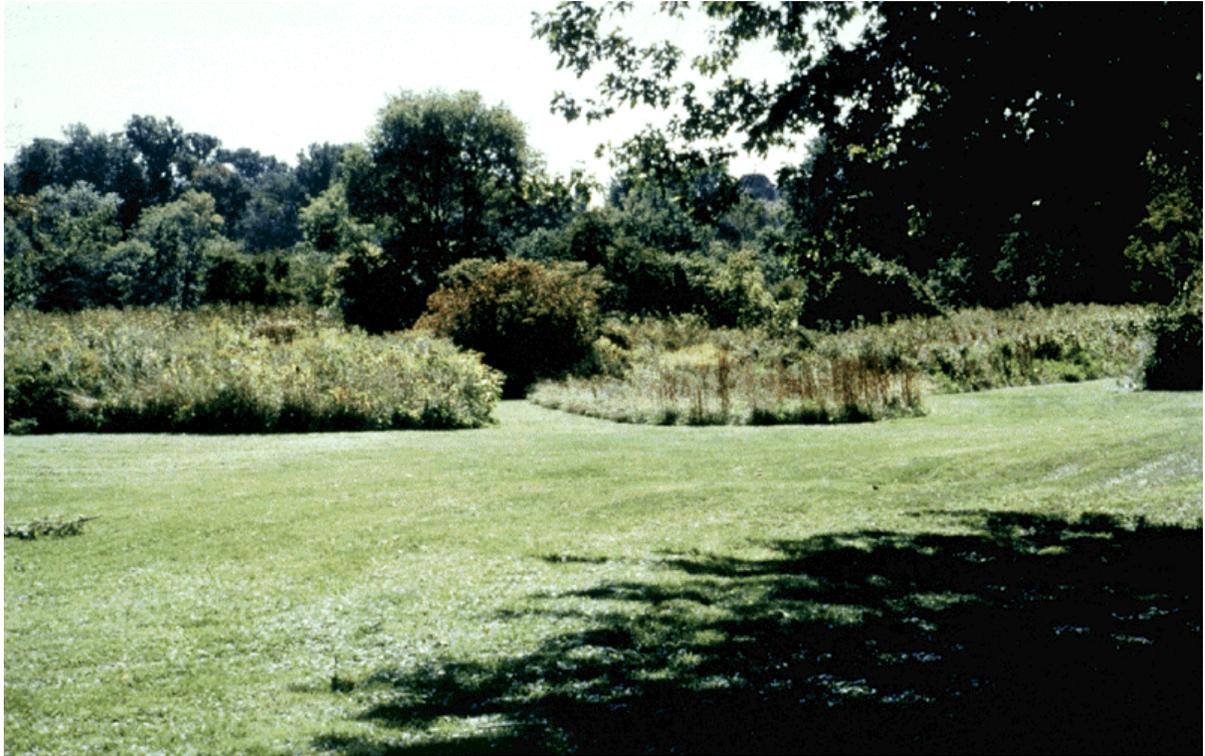
**FIGURE 22**  
Example Buffer Restoration Project

The buffer shown here contains a mixture of trees, shrubs, and grasses, and separates a mowed, fertilized lawn from the creek.

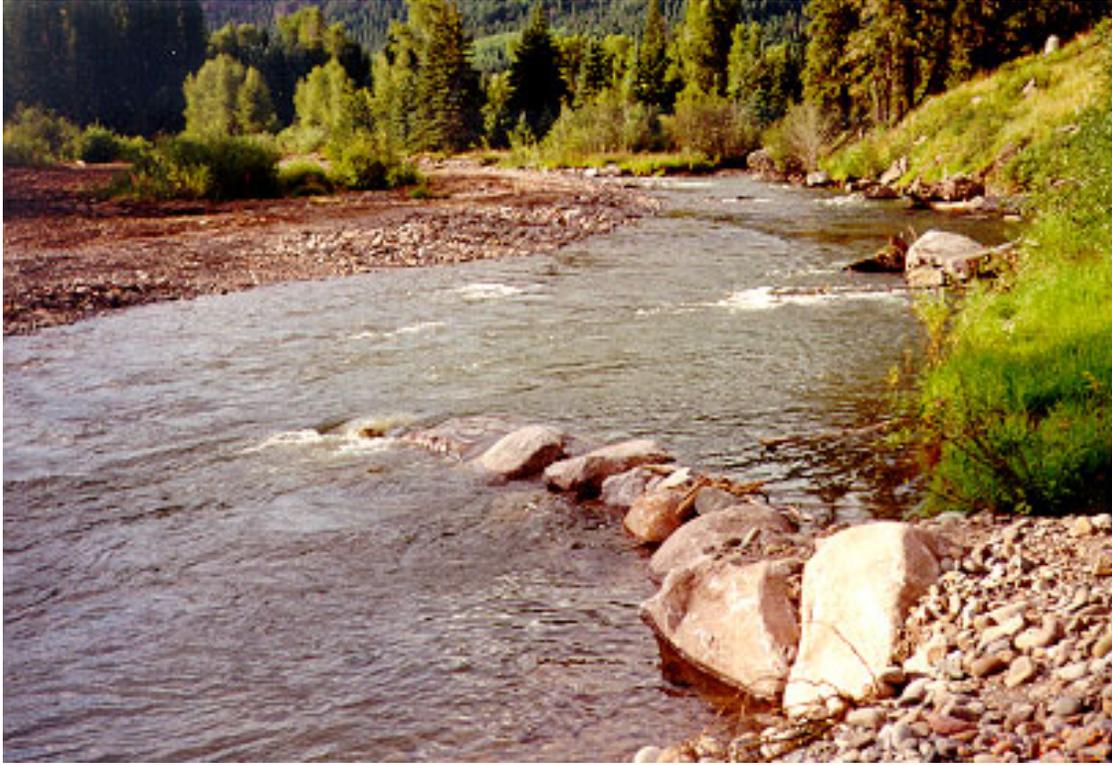
**FIGURE 23**

Example In-Stream Structure Project

A J-Hook Vane structure provides stream bank protection, preventing erosion.
