## DACULA PARK MASTER PLANS

**Dacula Park  
Gwinnett County, GA**

## DACULA PARK GWINNETT COUNTY, GA

The Jaeger Company  
Gainesville, Georgia

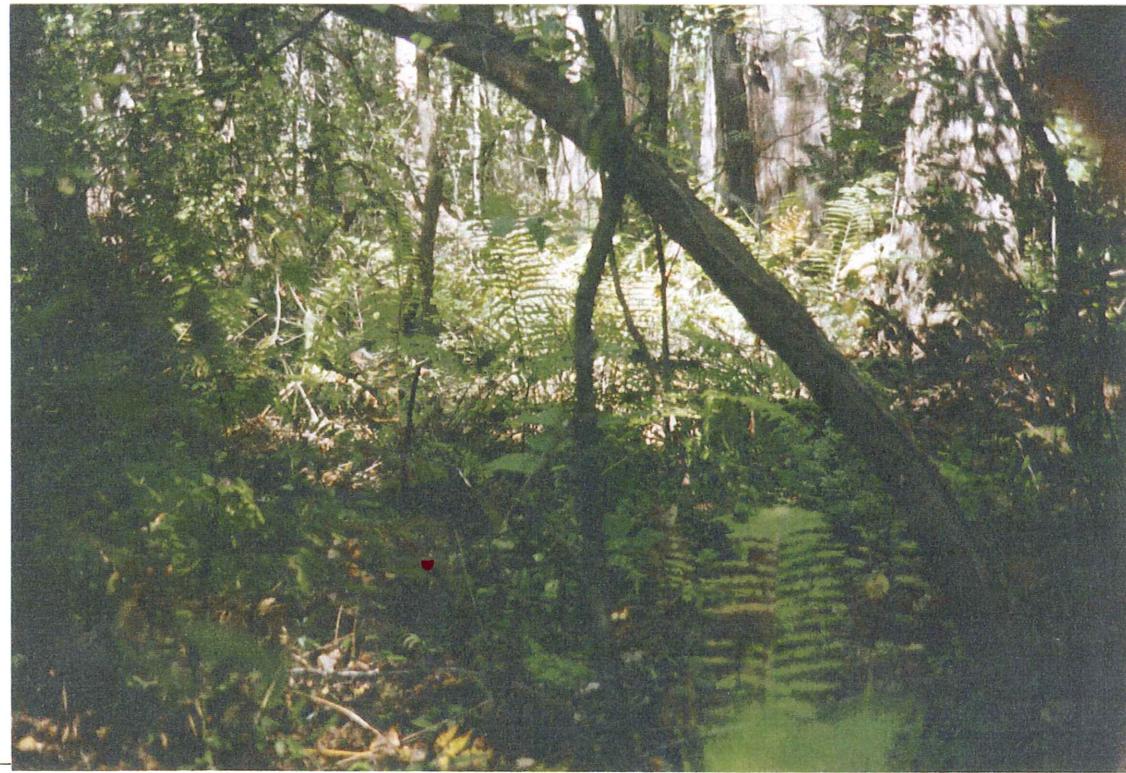
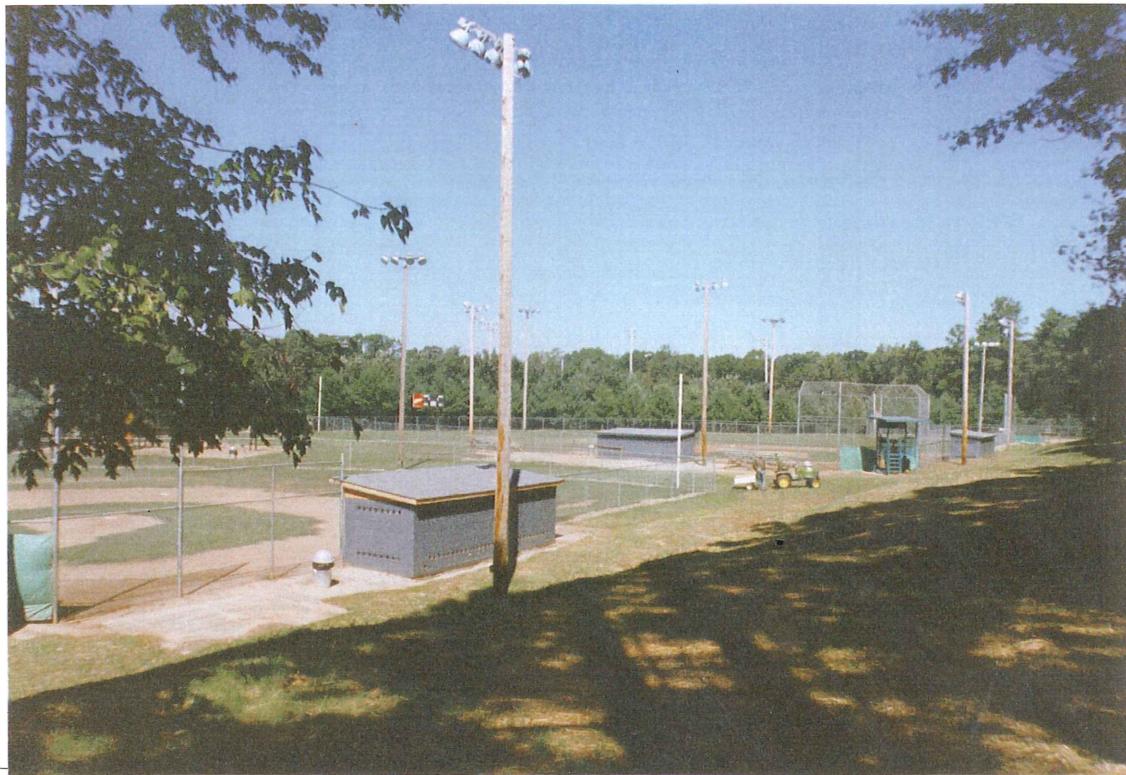
**Illustration 2:**  
Existing Conditions

Existing Fields

Existing Hardwood Forest

Topography varies from approximately 1,076 to 996 feet above sea level. There are two creeks which extend across the property in the eastern and northwestern portions of the site. The northern part of the creek in the east flows through a hardwood forest. The creek in the northwest is bordered by hardwood canopy trees. This area was apparently grazed in the past, then allowed into succession. Photographs taken in Fall 1996 show existing conditions of the fields on the upper plateau and the hardwood forest (*Existing Conditions: Illustration 2*).

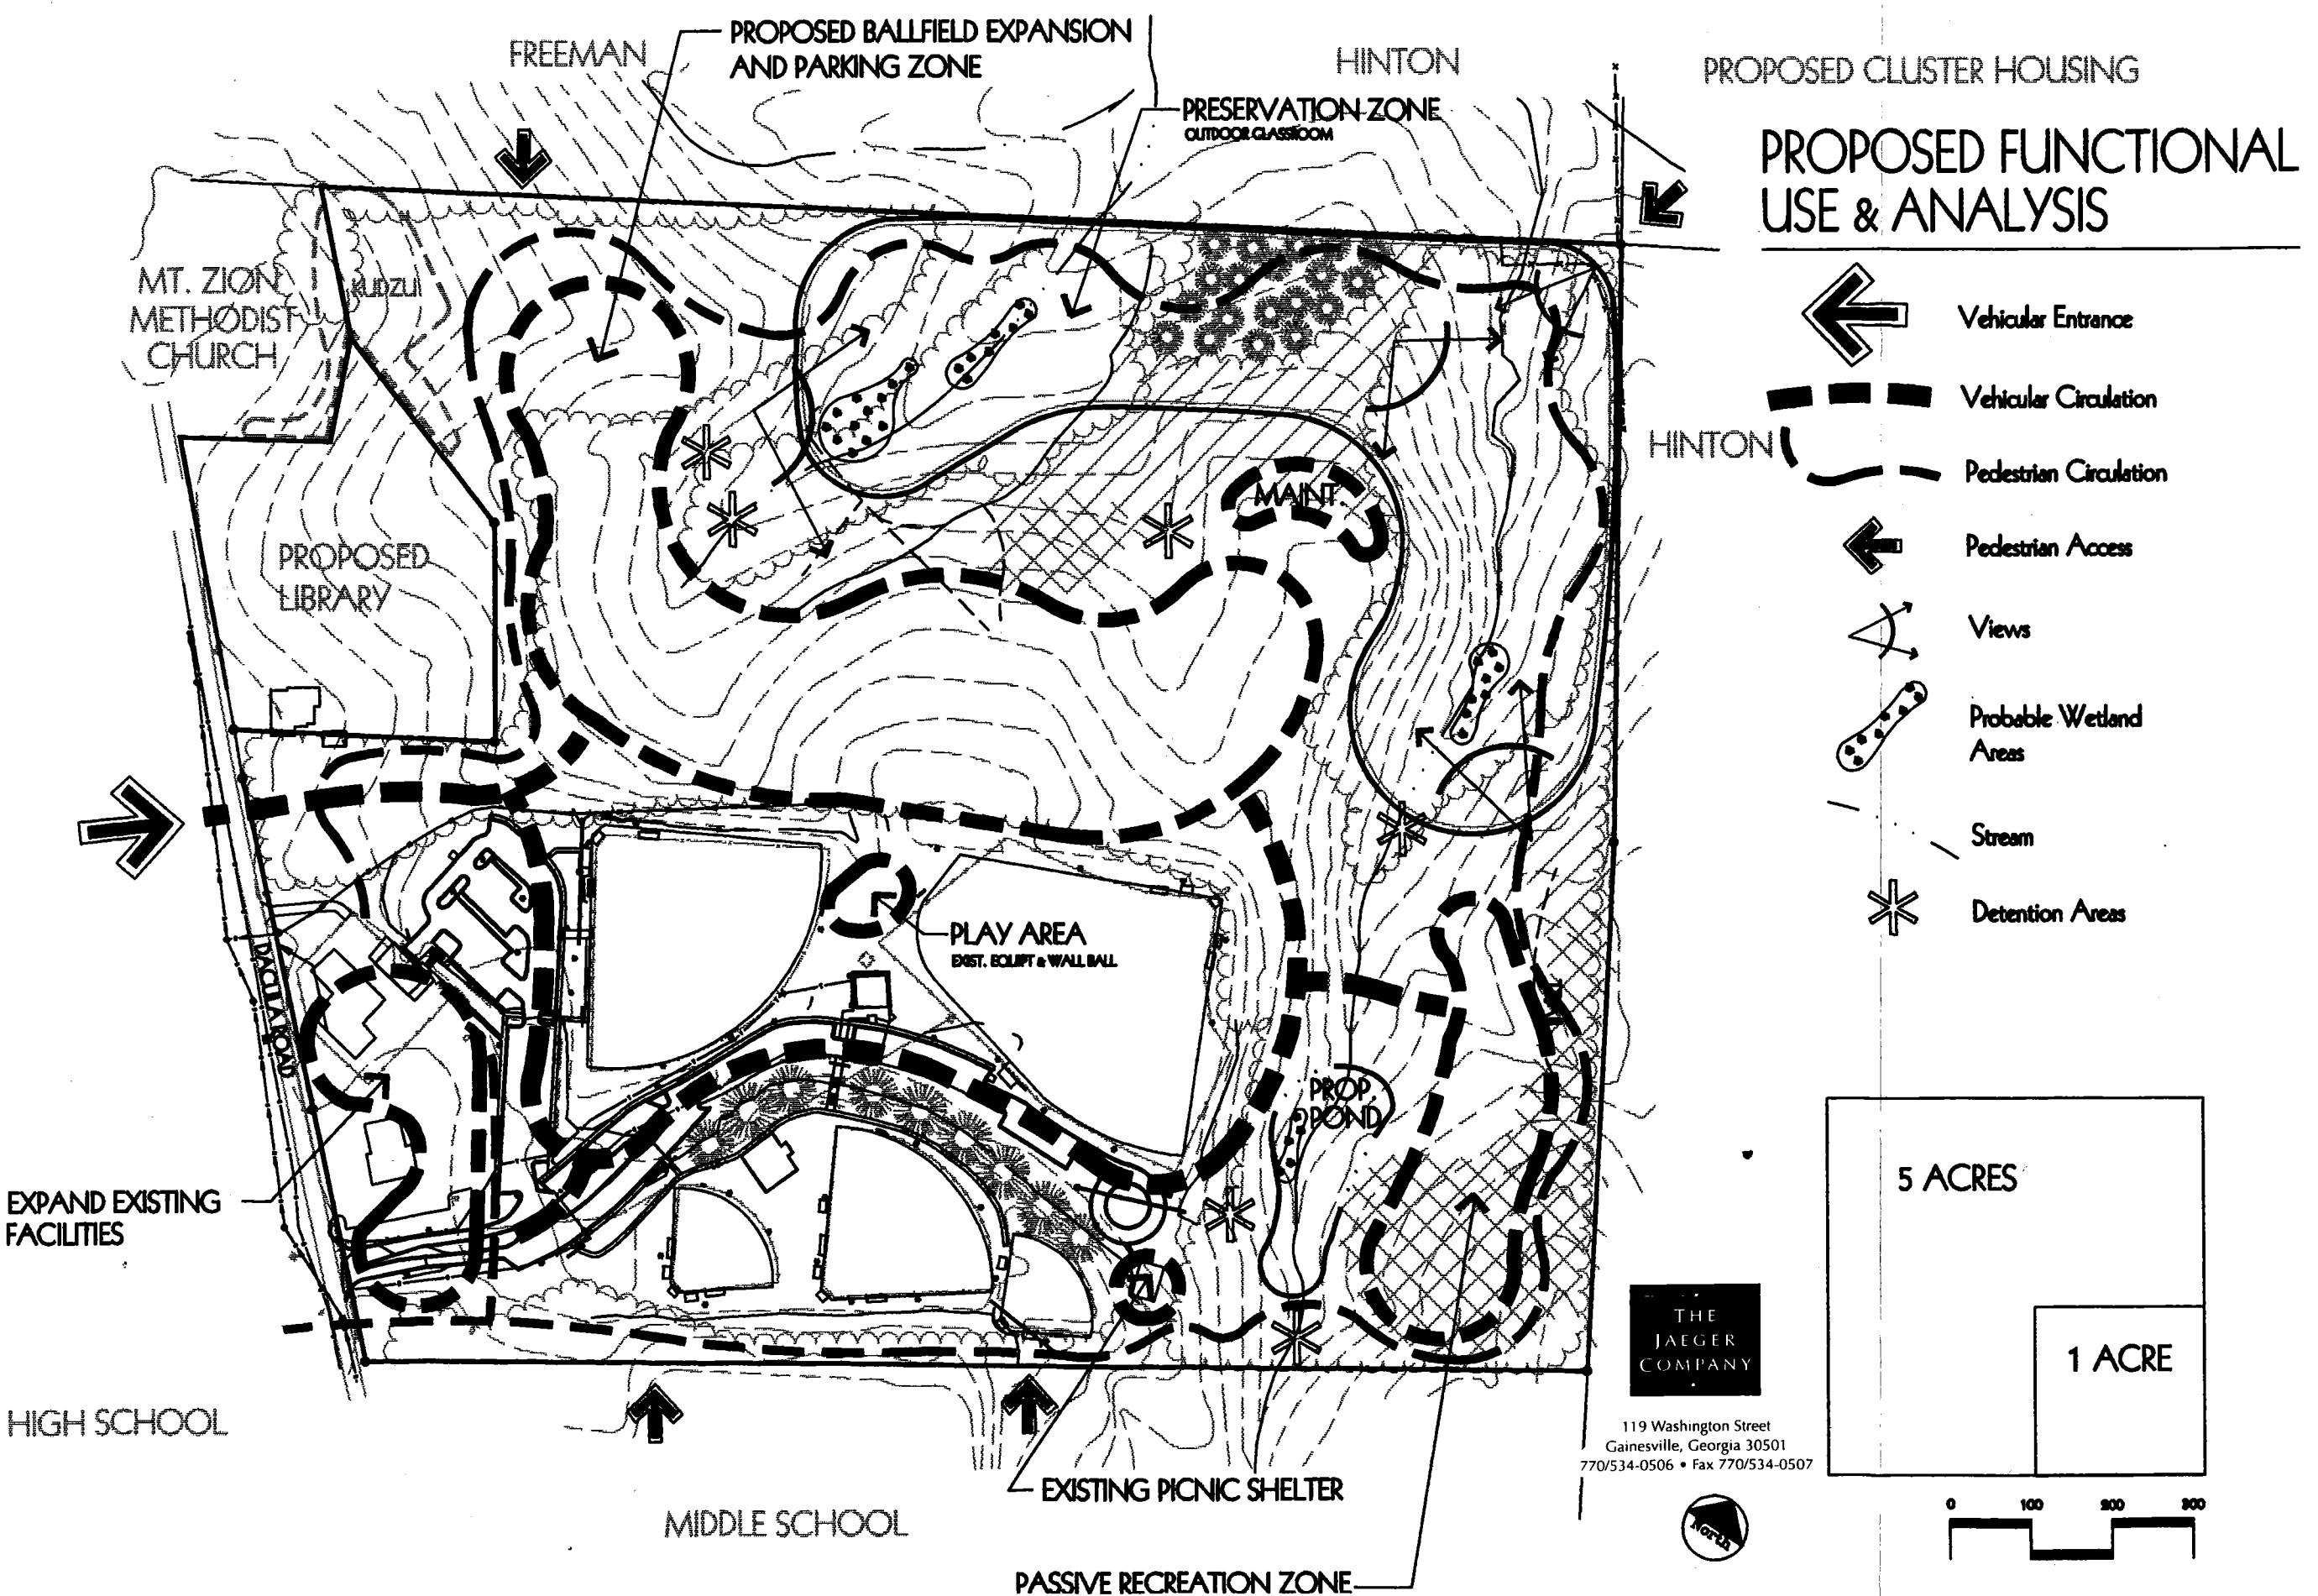
The functional plan illustrates vehicular and pedestrian circulation opportunities with the park; access points; and physical factors that might limit development, such as wetland areas and stream corridors. Potential detention areas to control future storm water were also noted. The plan also illustrated opportunities for expansion of the ballfields to the north of the existing ballfields and expansion of the pool facilities to the south of the existing pool complex and community building.

Analysis and base information were combined with the preliminary program requirements to form functional diagrams. The analysis and functional diagrams (*Proposed Functional Use & Analysis: Illustration 6*) were then presented to the Citizen's Committee for review on November 19, 1996.

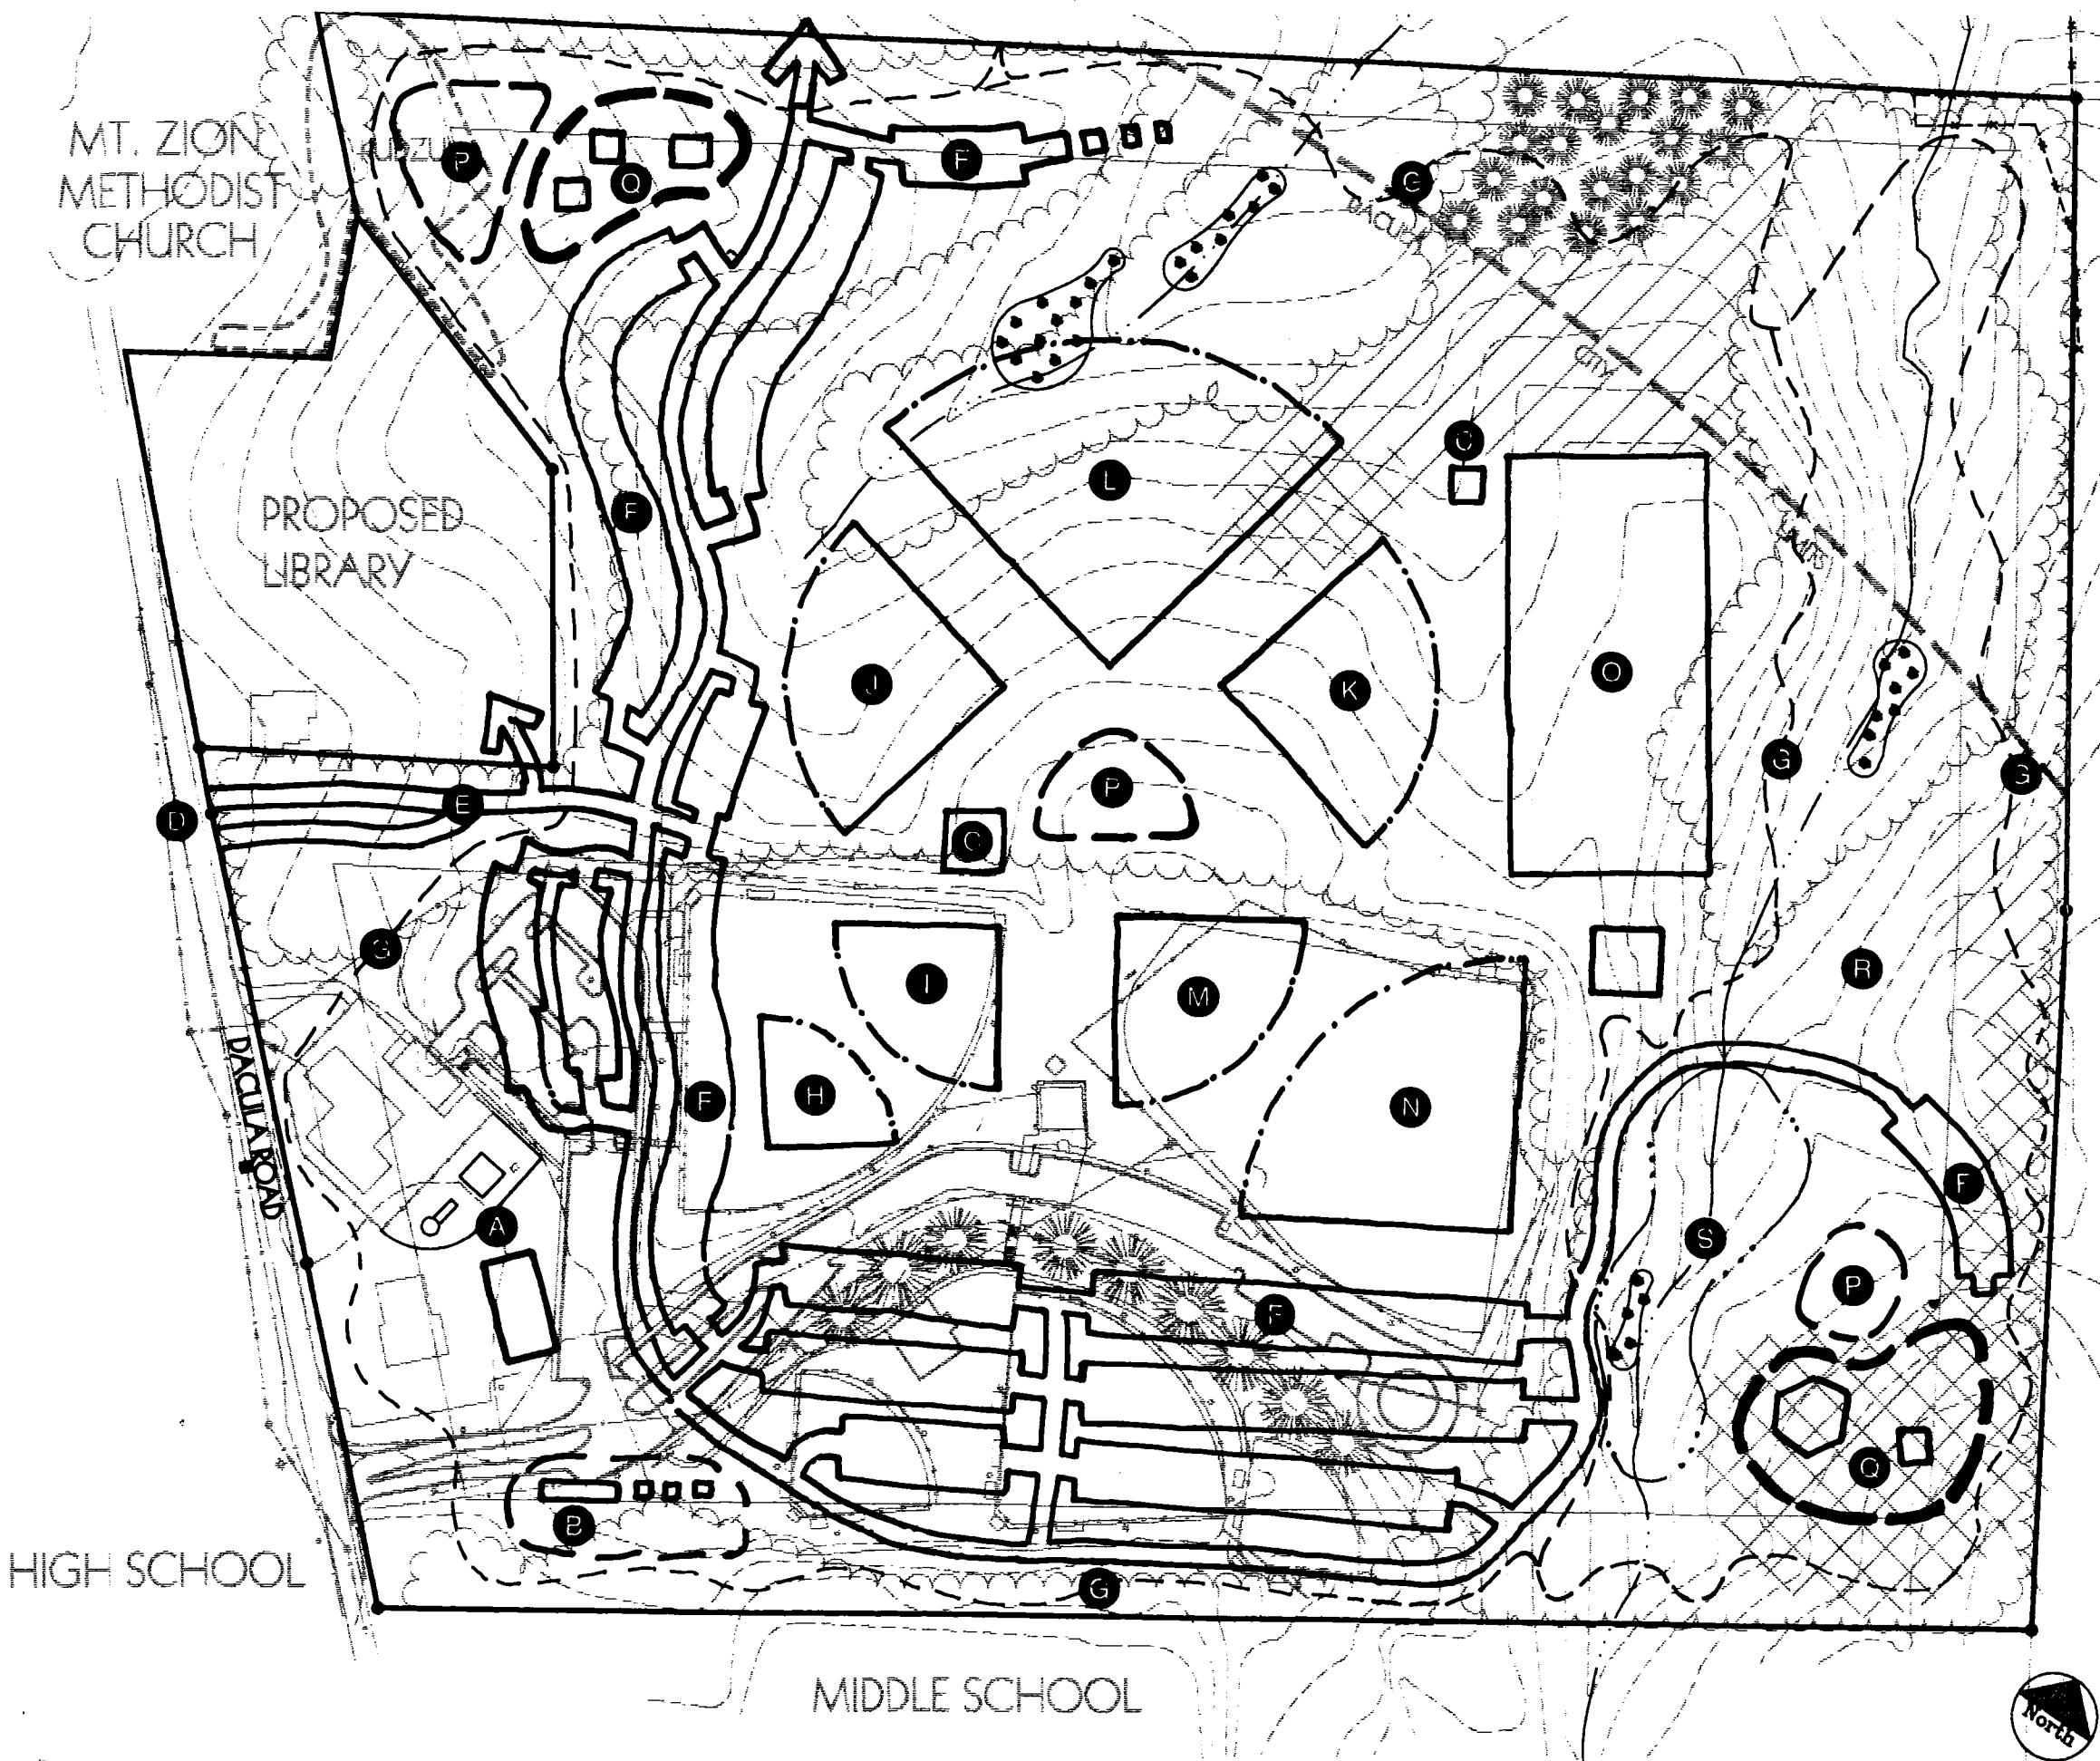
**Master Plan  
Alternate 2**

- (A) Langley Building/Aquatic Center/Basketball Court
- (B) Maintenance Building
- (C) Concession/Restroom Building
- (D) Park Entrance
- (E) Park Driveway
- (F) Parking
- (G) Walk/Jog Trail
- (H) T-ball Field
- (I) Pee-Wee Field
- (J) Minor Field
- (K) Major Field
- (L) Pony Field
- (M) Girl's Softball
- (N) Girl's Softball
- (O) Football Field
- (P) Playground
- (Q) Picnic Area
- (R) Outdoor Classroom/Green Space
- (S) Pond

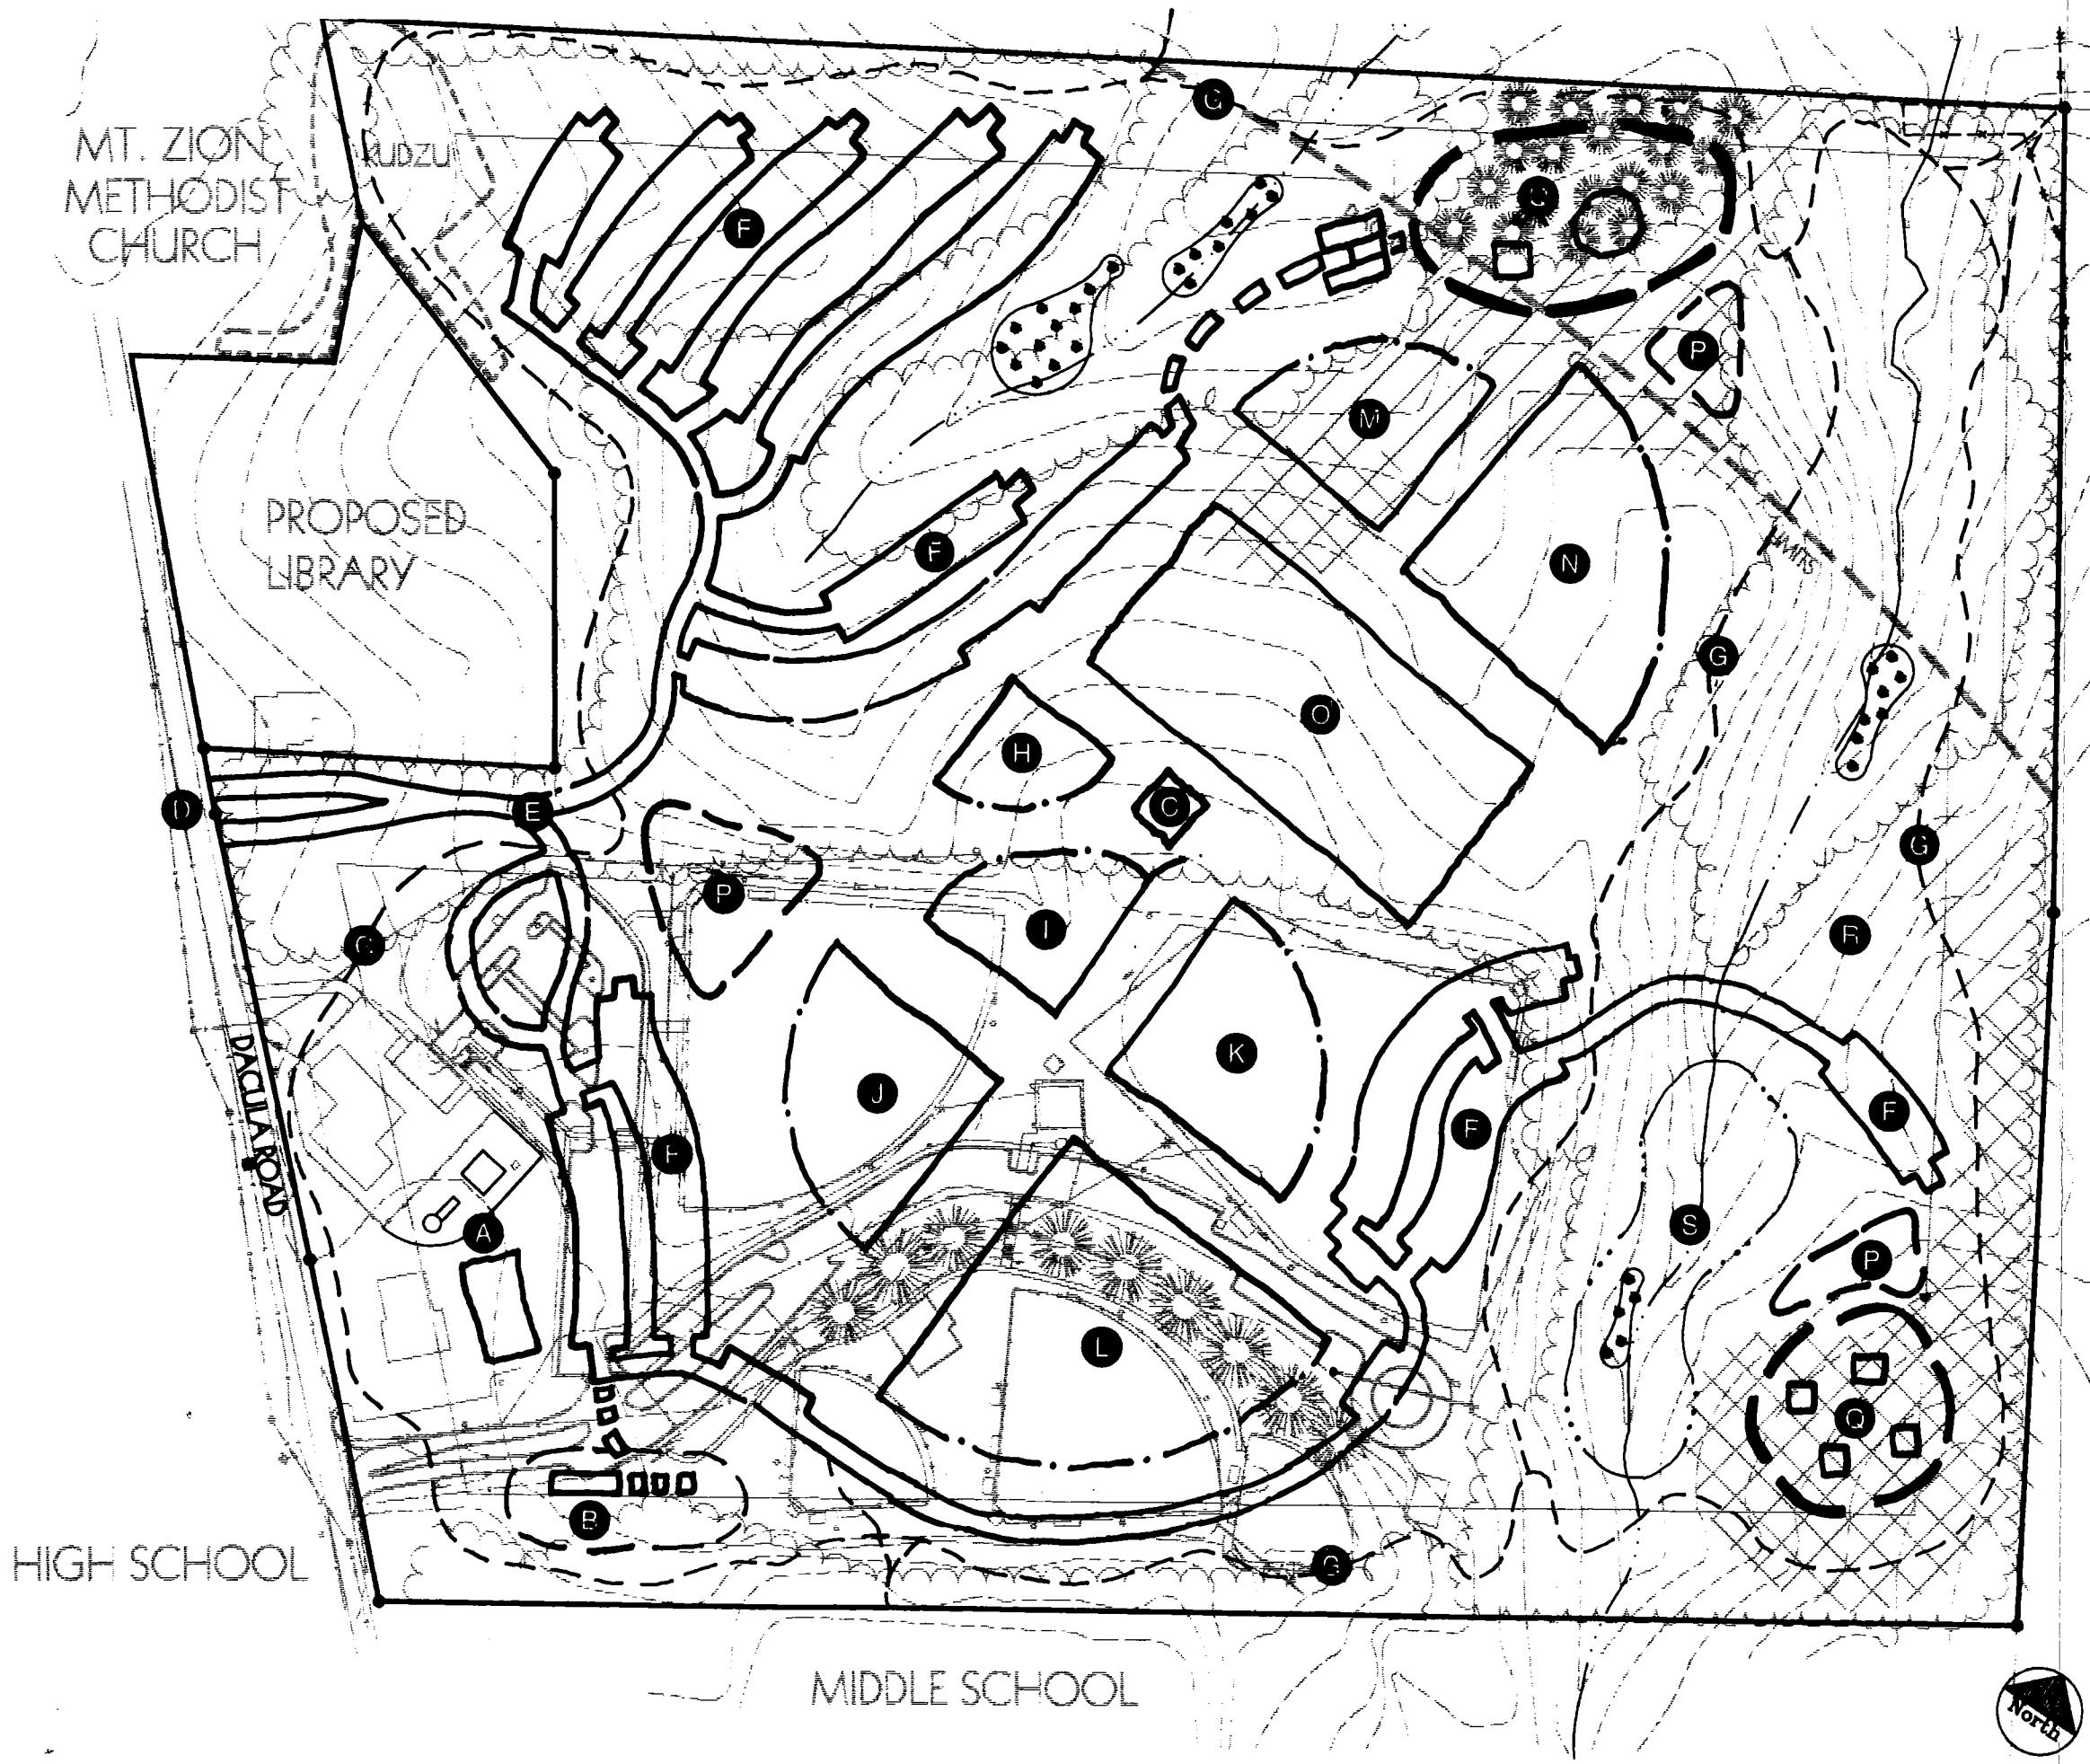
**Master Plan  
Alternate 3**

- (A) Langley Building/Aquatic Center/Basketball Court
- (B) Maintenance Building
- (C) Concession/Restroom Building
- (D) Park Entrance
- (E) Park Driveway
- (F) Parking
- (G) Walk/Jog Trail
- (H) T-ball Field
- (I) Pee-Wee Field
- (J) Minor Field
- (K) Major Field
- (L) Pony Field
- (M) Girl's Softball
- (N) Girl's Softball
- (O) Football Field
- (P) Playground
- (Q) Picnic Area
- (R) Outdoor Classroom/Green Space
- (S) Pond

**Master Plan Concept - Alternate 3: Illustration 9** - This concept proposes crescent parking with fields located in the center. This plan required clearing and regrading of the entire site to various plateaus. One disadvantage of this plan was that some parking was far removed from the ball fields. This concept also provided a minimal amount of greenspace.

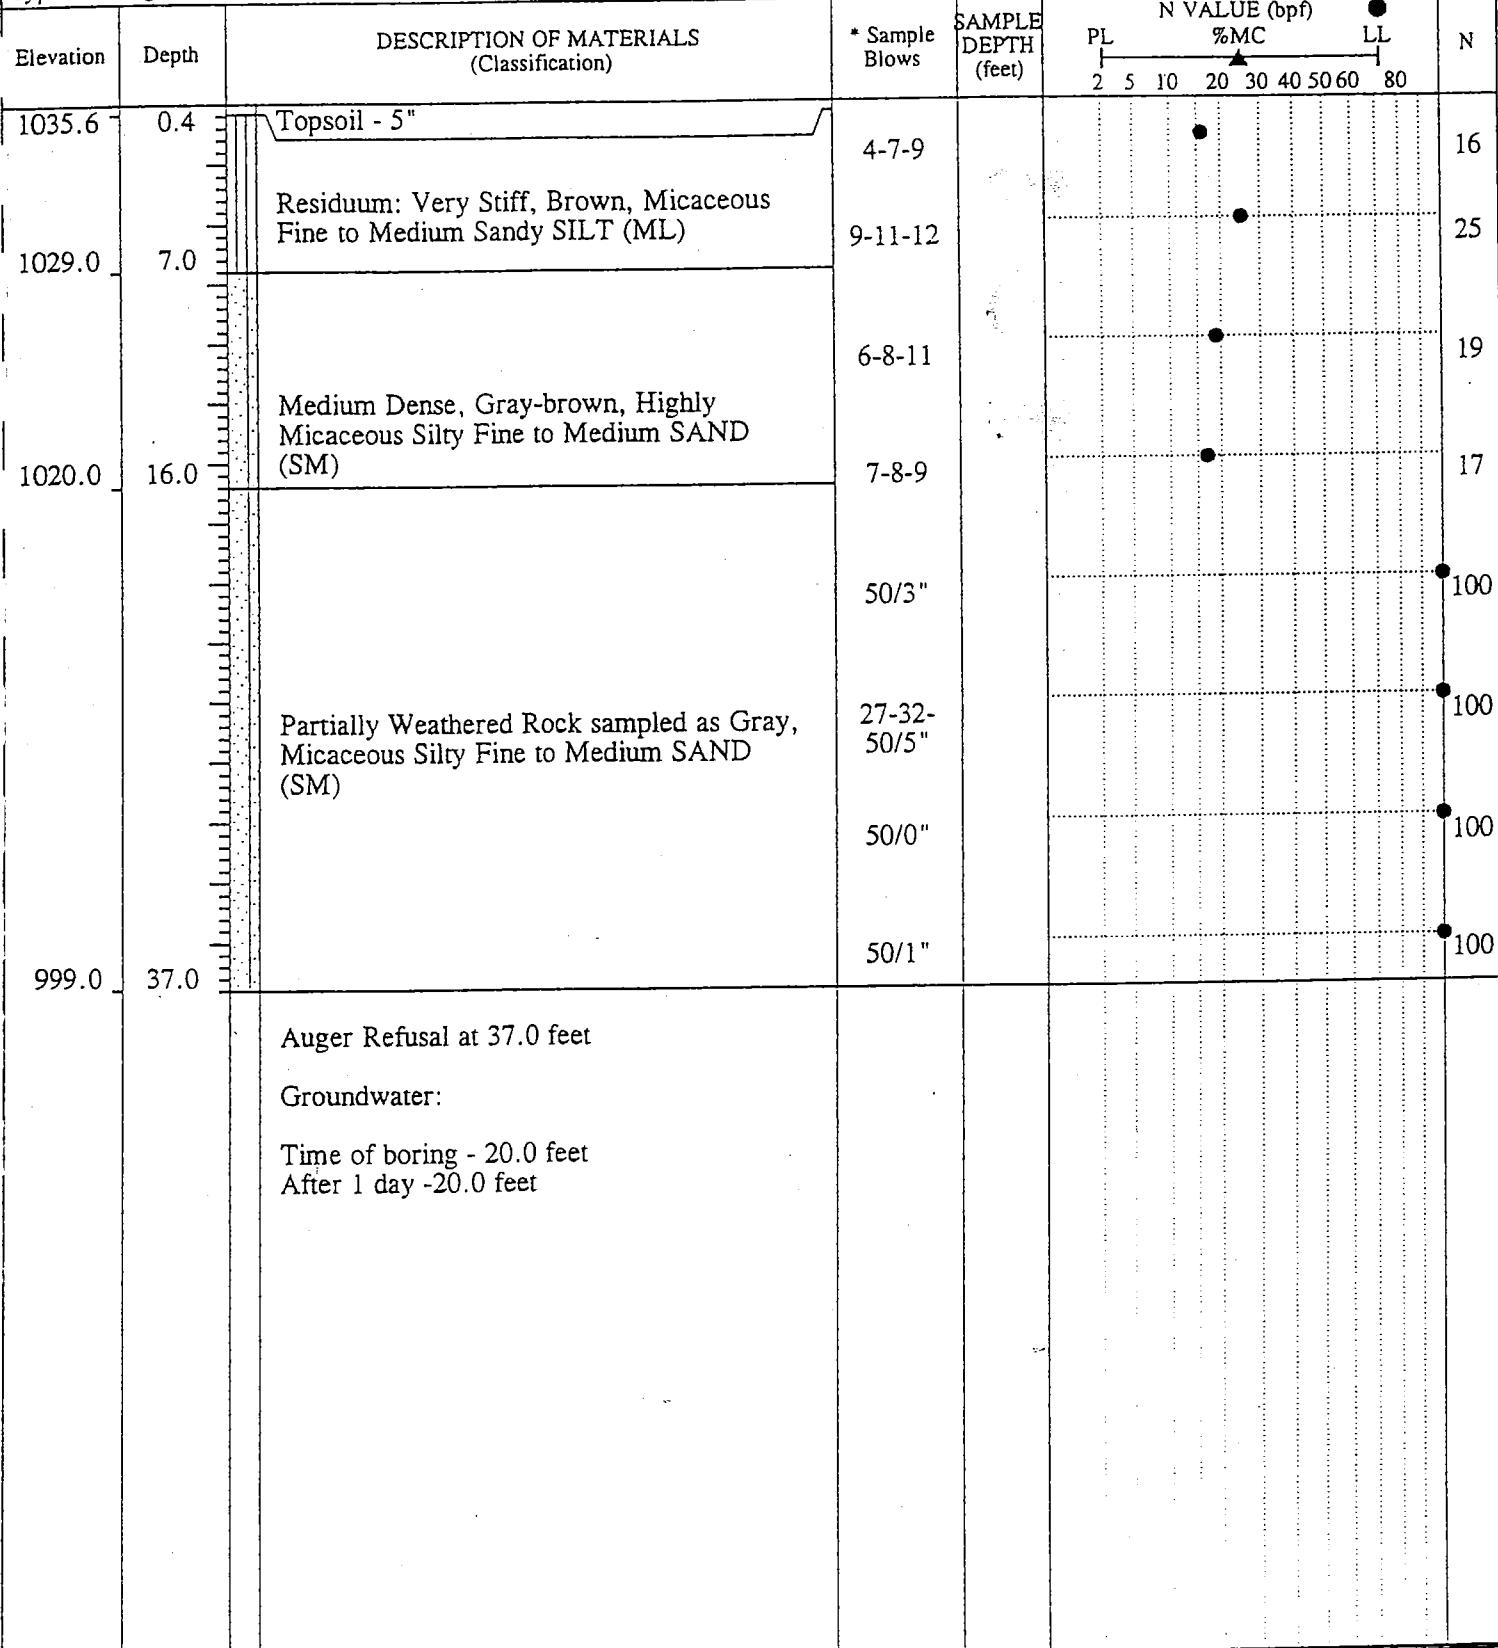
Boring No.: B-5	(1 of 1)	Total Depth 37.0'	Elev: 1036 ±	Location: See Boring Location Diagram
-----------------	----------	-------------------	--------------	---------------------------------------

Type of Boring: HSA	Started: 11/29/96	Completed: 11/29/96	Driller: R. Hunnicutt
---------------------	-------------------	---------------------	-----------------------

\* Number of blows required for a 140 lb hammer dropping 30" to drive 2" O.D., 1.375" I.D. sampler a total of 18 inches in three 6" increments. The sum of the last two increments of penetration is termed the standard penetration resistance, N.

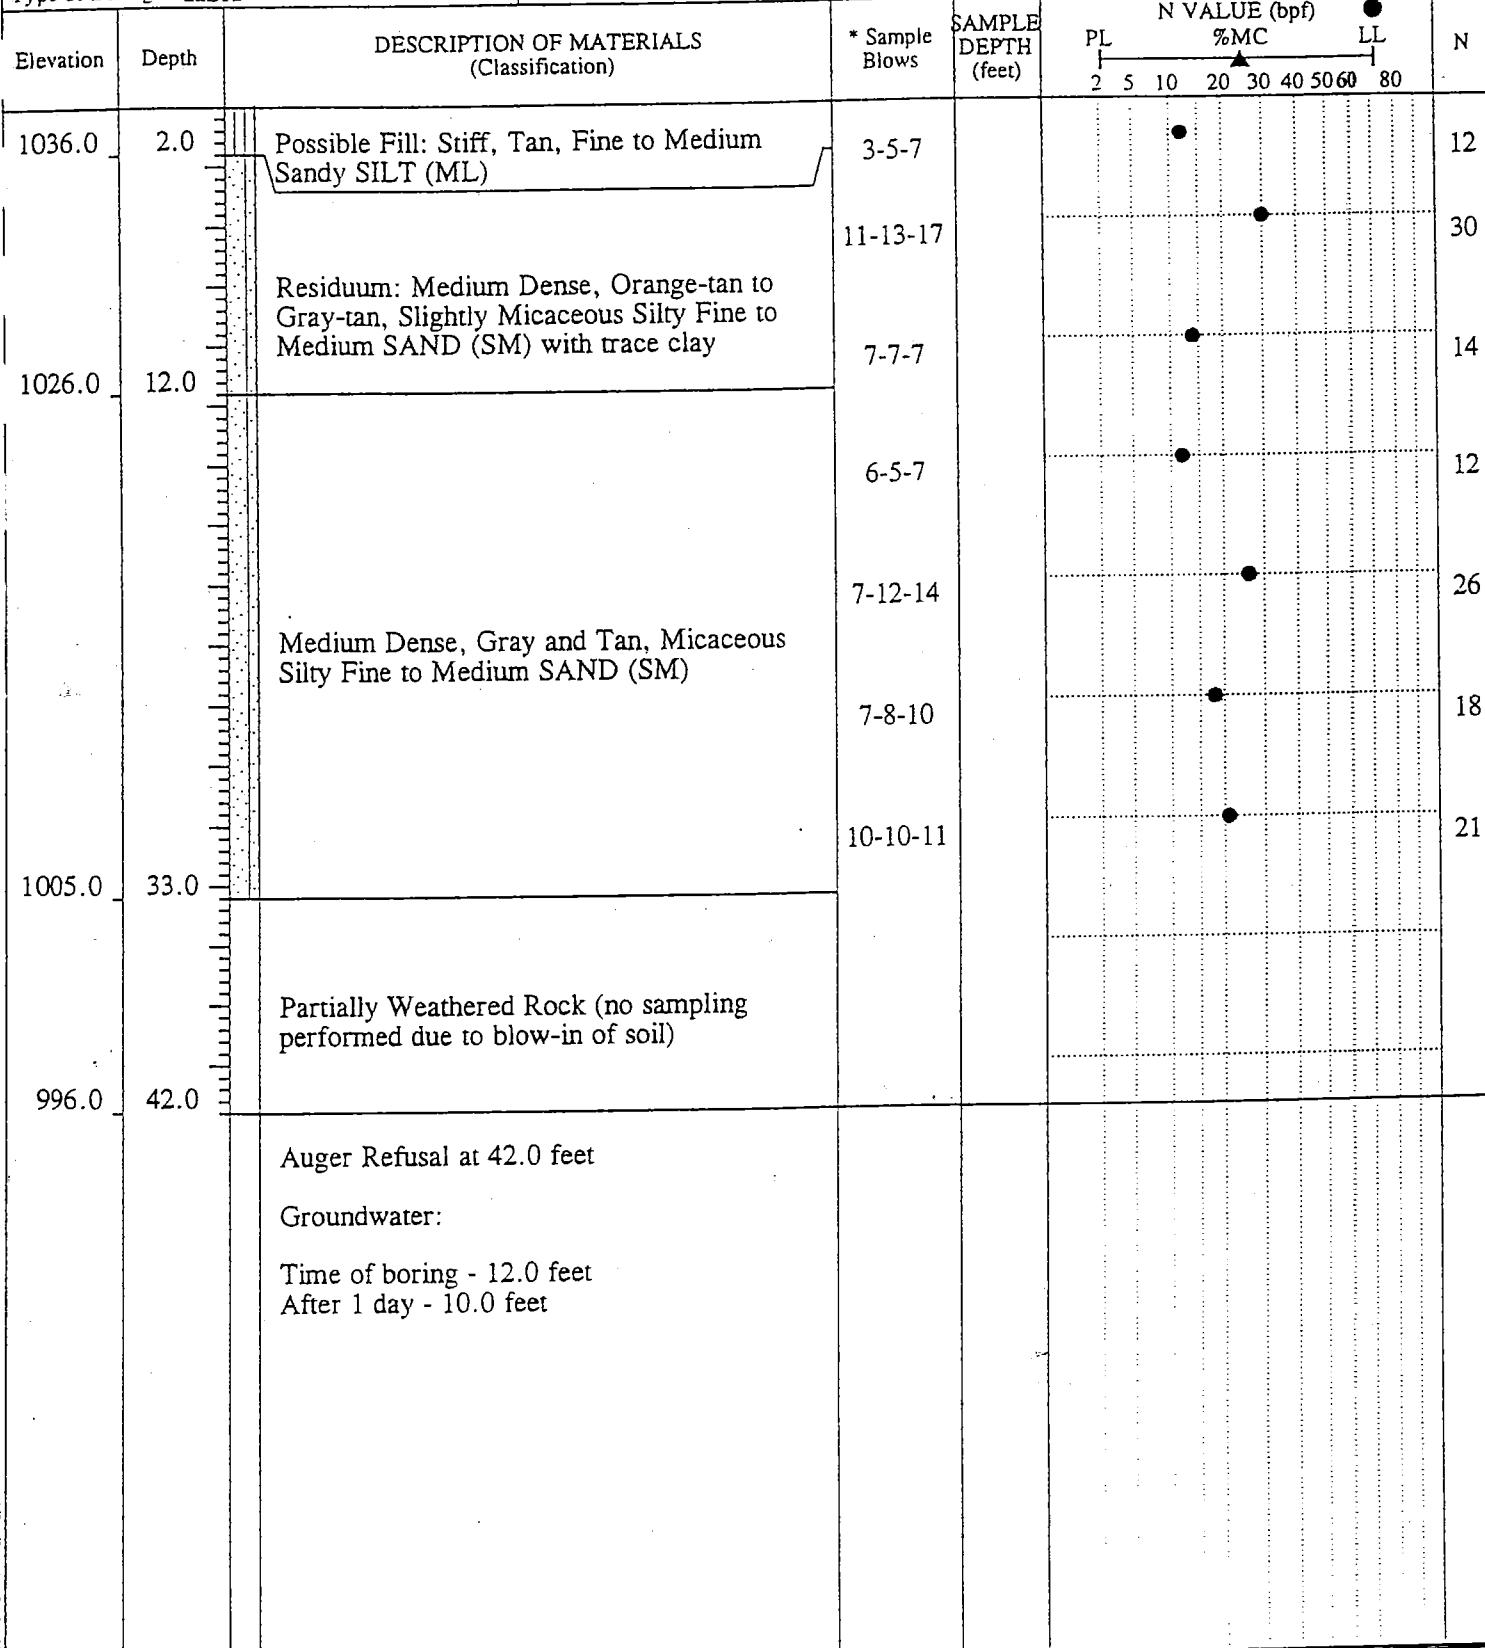
Boring No.: B-8 (1 of 1) Total Depth 42.0' Elev: 1038 ± Location: See Boring Location Diagram

Type of Boring: HSA Started: 12/5/96 Completed: 12/5/96 Driller: R. Hunnicutt

\*Number of blows required for a 140 lb hammer dropping 30" to drive 2" O.D., 1.375" I.D. sampler a total of 18 inches in three 6" increments. The sum of the last two increments of penetration is termed the standard penetration resistance, N.

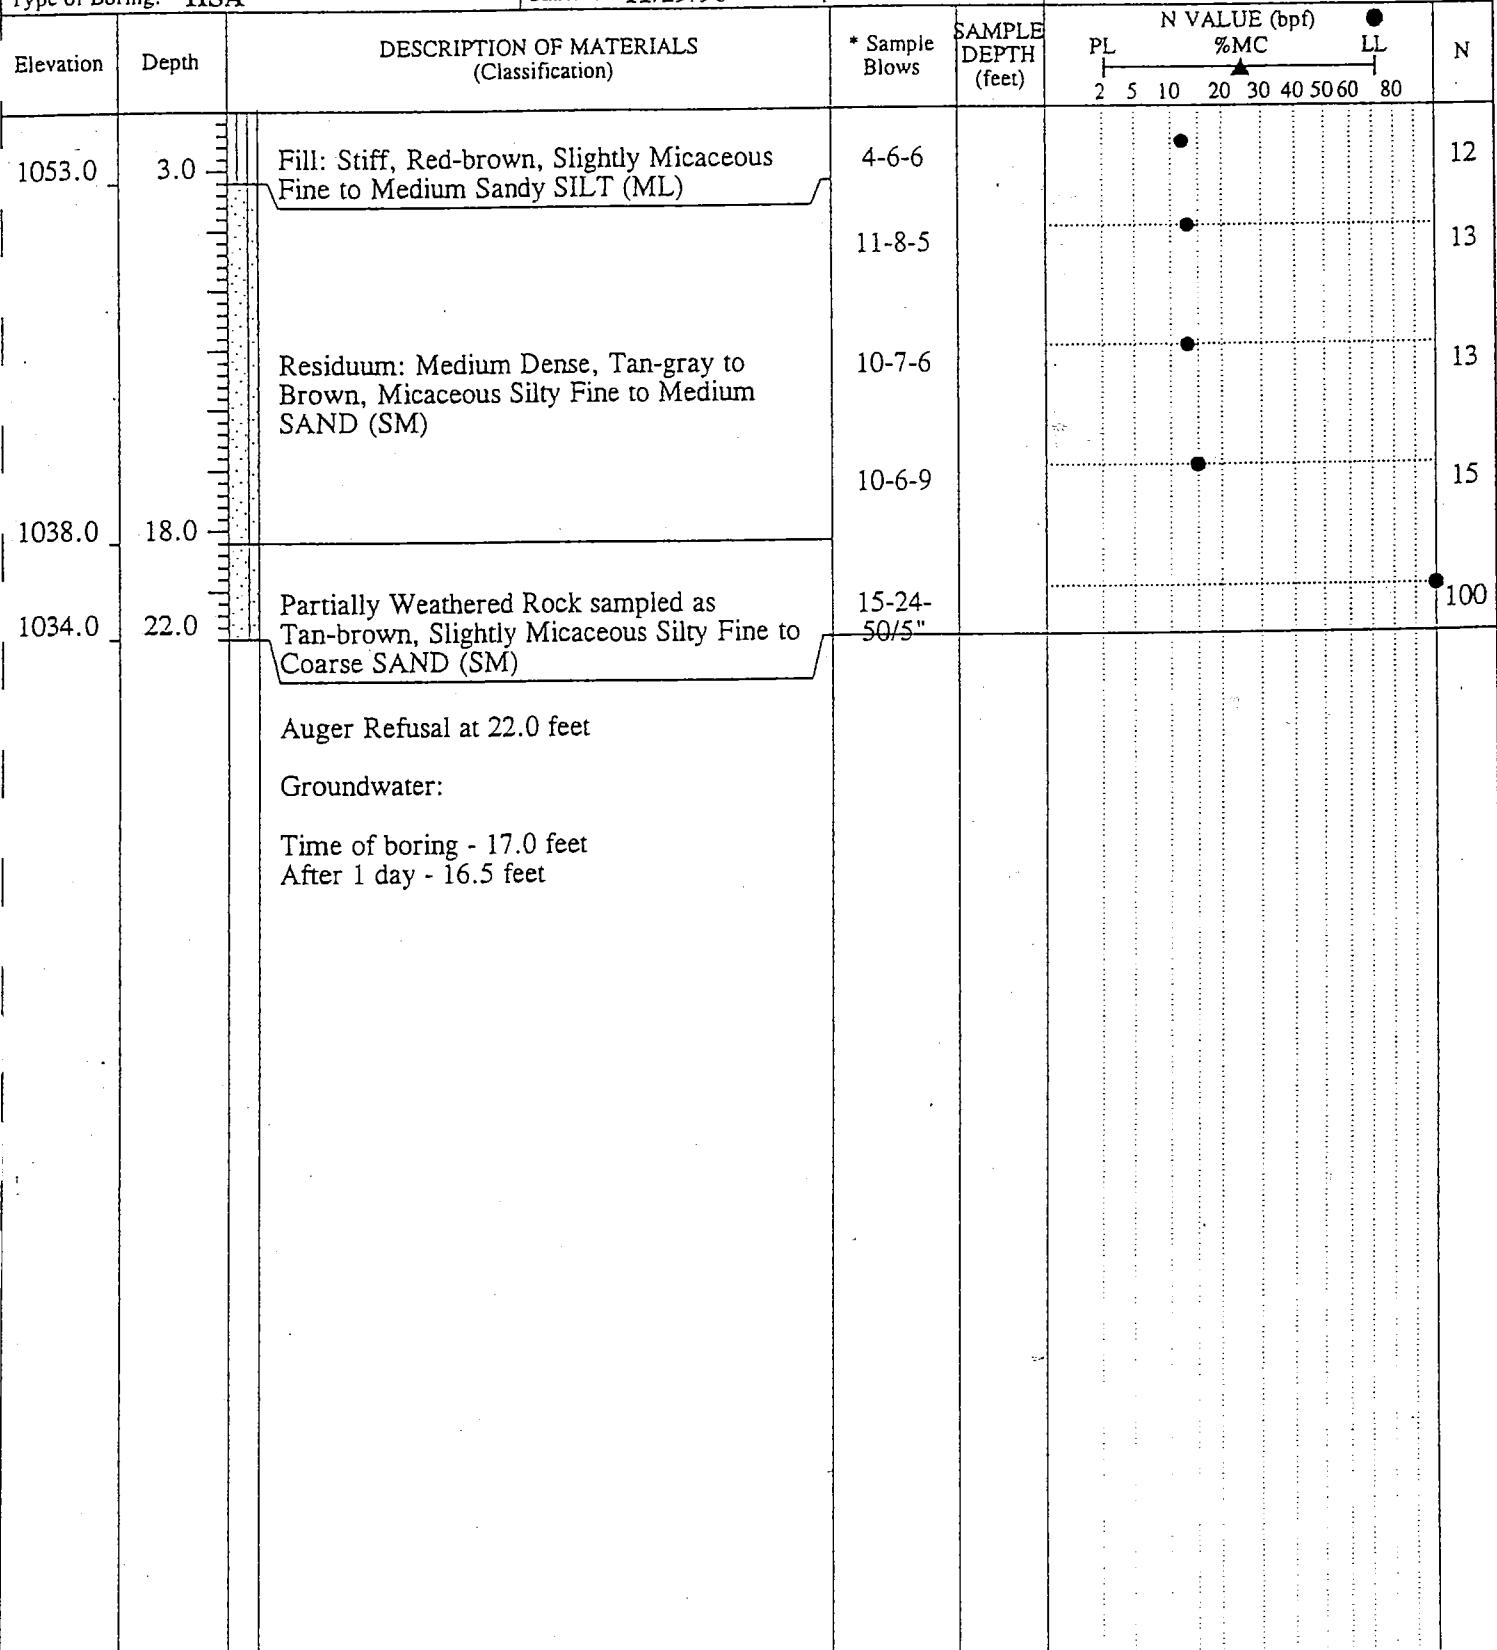
Boring No.: B-11 (1 of 1) Total Depth 22.0' Elev: 1056 ± Location: See Boring Location Diagram

Type of Boring: HSA Started: 11/29/96 Completed: 11/29/96 Driller: R. Hunnicutt

2/12/96  
1.3.6:  
\* Number of blows required for a 140 lb hammer dropping 30" to drive 2" O.D., 1.375" I.D. sampler a total of 18 inches in three 6" increments. The sum of the last two increments of penetration is termed the standard penetration resistance, N.
